# FACILITY CONDITION ASSESSMENT

FACILITY CONDITION ASSESSMENT  
OF  
FIRE STATION 1  
930 SEMINARY STREET  
NAPA, CALIFORNIA 94559

October 24, 2019

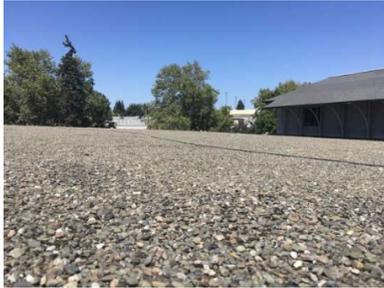
### Roof in Poor condition.

Built-Up  
Fire Station 1 Roof - Apparatus bay

The built up roof has rust and corrosion built up and have frequent leaks. - AssetCALC ID: 1342190

Uniformat Code: B3011  
Recommendation: **Replace in 2019**

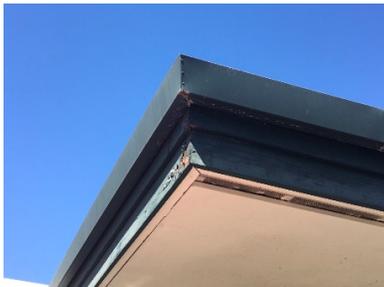
### Exterior Wall in Poor condition.

Rough Sawn  
Fire Station 1 Building Exterior

Fascia board has dry rot. - AssetCALC ID: 1342223

Uniformat Code: B2011  
Recommendation: **Repair in 2019**

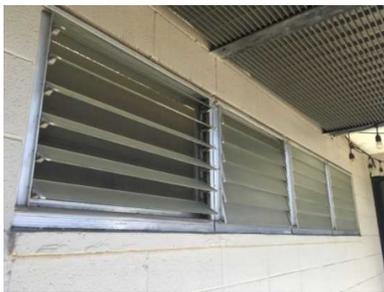
**Window in Poor condition.**

Aluminum Double-Glazed 12 SF, 1-2 Stories  
Fire Station 1 Building Exterior - South

According to the POC, the jalousie windows frequently break, leak, and have maintenance issues. - AssetCALC ID: 1342242

Uniformat Code: B2021  
Recommendation: **Replace in 2019**

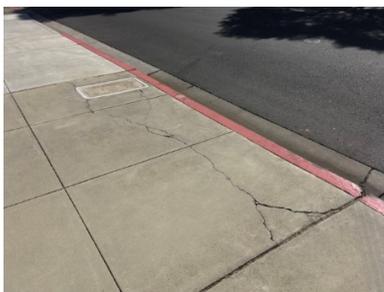
**Parking Lots in Poor condition.**

Concrete Pavement  
Fire Station 1 Site - West Entrance

Pavement is cracked and needs to be sealed. - AssetCALC ID: 1342179

Uniformat Code: G2022  
Recommendation: **Repair in 2019**

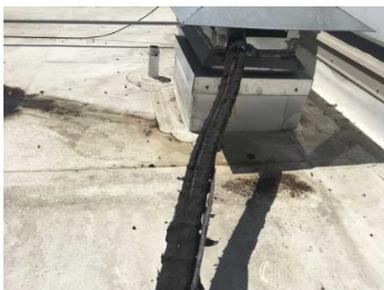
**Pipe Insulation in Poor condition.**

Fiberglass, Refrigerant  
Fire Station 1 Roof

The refrigerant piping insulation will need replacement. It has been damaged. - AssetCALC ID: 1342196

Uniformat Code: D2021  
Recommendation: **Replace in 2019**

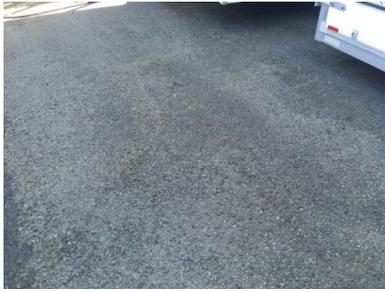
**Parking Lots in Poor condition.**

Aggregate/Gravel  
Fire Station 1 Site- Carport

The gravel is loose and will need replenishment. - AssetCALC ID: 1342243

Uniformat Code: G2022  
Recommendation: **Replace in 2019**

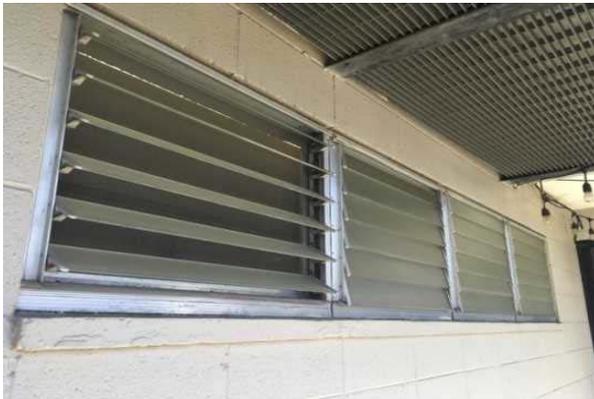
#9	DAMAGED WINDOWS
----	-----------------

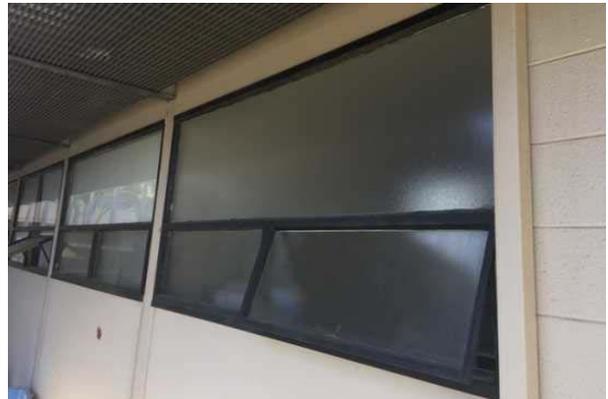
#10	LEAKY WINDOWS
-----	---------------

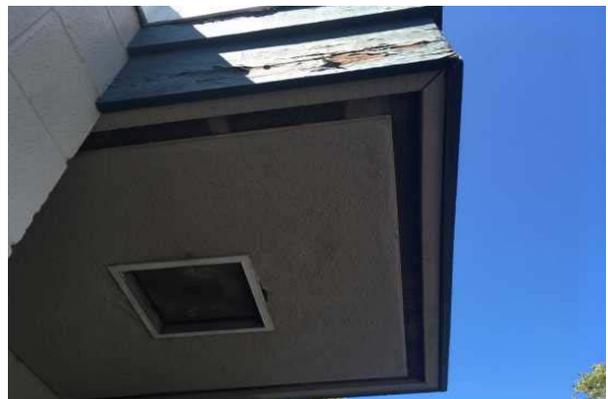
#12	FASCIA DAMAGE
-----	---------------

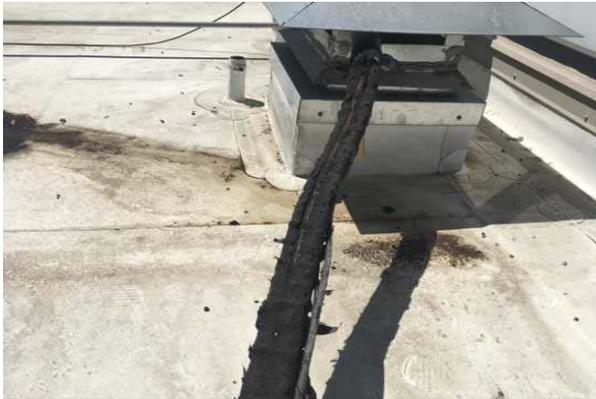
#17	DAMAGED INSULATION
-----	--------------------

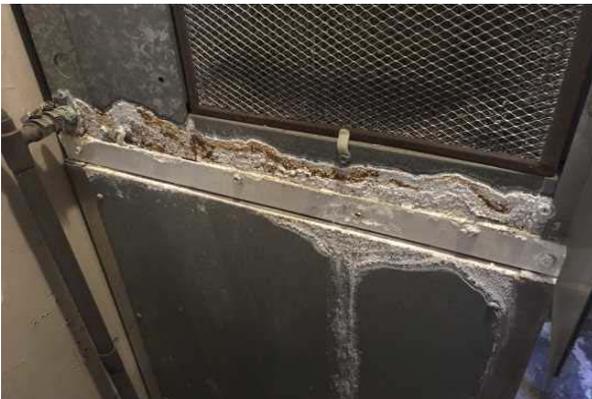
#23	CORROSION ON ICE MAKER
-----	------------------------

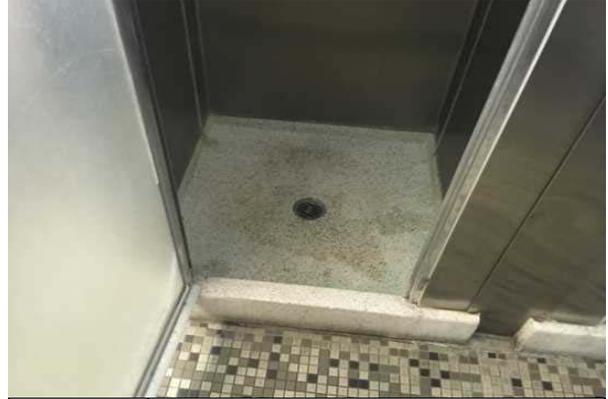
#26	PLUGGED DRAIN
-----	---------------

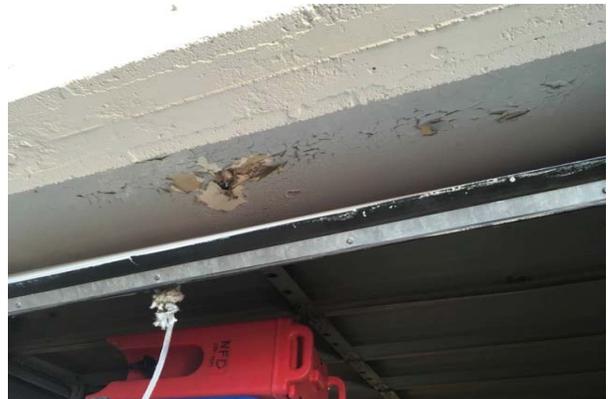
#30	DAMAGED CEILING TILE
-----	----------------------

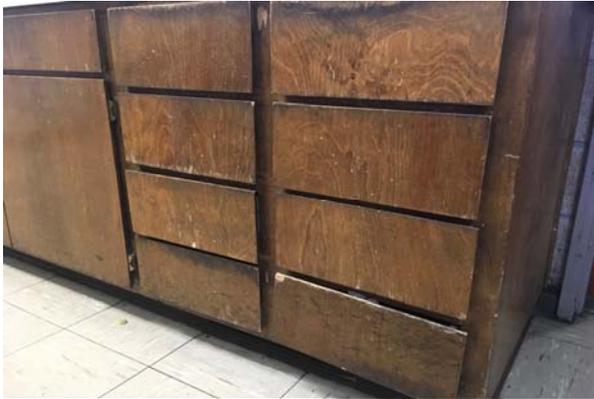
#33	DAMAGED CABINETS
-----	------------------

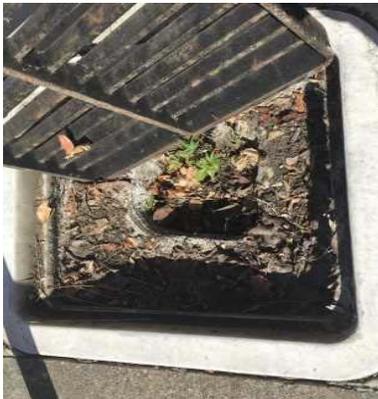
#39	CLOGGED DRAIN
-----	---------------
