**Arborist Report**

**Vintage Farm  
Napa, CA**

**April 2021**

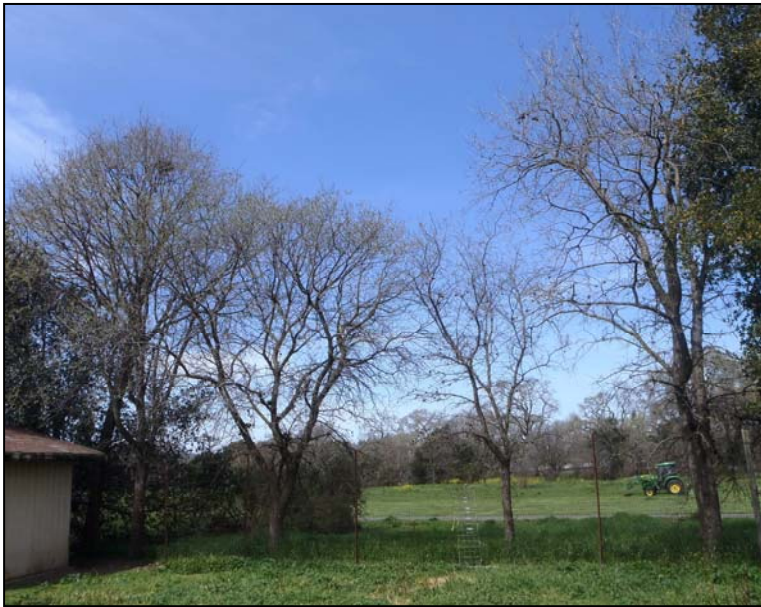
Six (6) valley oaks were assessed on the site, with 5 located between the corals and the bike path and #309 located near the end of Sierra Avenue. Those adjacent to the corals were all semi-mature (7” to 14” in trunk diameter) and in fair to good condition (**Photo 1**, following page). Valley oak #309 was mature at 23” and in good condition, although it had been pruned on the west side for the overhead utility lines.

**Photo 1:** Looking northwest at valley oaks #302 and 304-307 (R to L). These young to semi-mature trees were growing on the north side of the site, adjacent to the bike path. They were in fair to good condition.

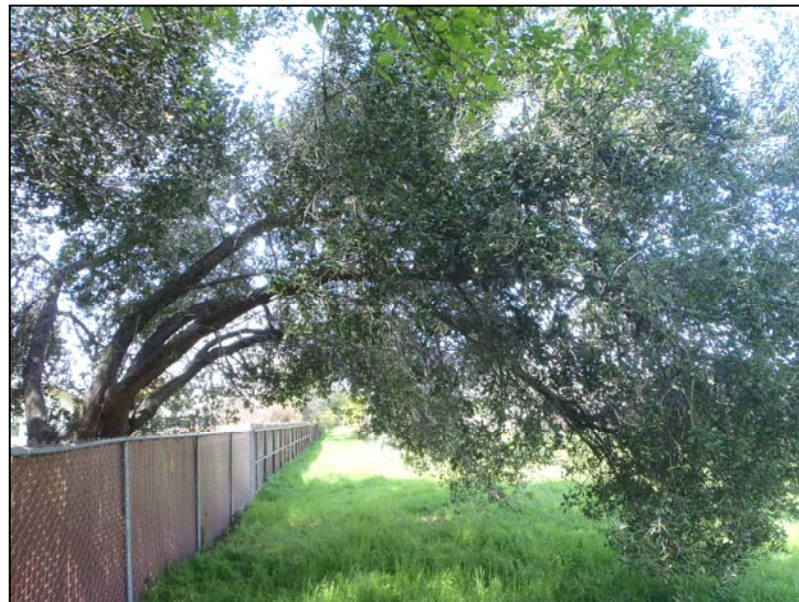
Five (5) coast live oaks were assessed, including 2 on-site trees (#301 and 308) and 3 off-site (#326, 328 and 329). On-site coast live oak #301 was mature and in good condition, while #308 was semi-mature and in fair condition. Condition of the off-site coast live oaks was poor. These trees were part of a small grove of off-site trees in southeast corner of the site. Due to the close spacing of the trees, coast live oaks #326, 328 and 329 all had strong leans or sweeps in their search for light and growing space. As a result, coast live oak #326 had approximately 90% of its crown extending over the development site (Photo 2), #328 had 100% and #329 had 80%. Pruning alone cannot correct these defects and as the trees get larger, their failure potential increases.

**Photo 2:** Looking northwest along the existing fence at the crown of coast live oak #326. I estimated that 90% of the crown extended approximately 23' east over fence and onto the development site. Pruning cannot correct this situation.

Off-site coast live oaks #326, 328 and 329 have been identified for preservation. However, all three trees had an estimated 80% to 100% of their crowns extending over the development site. Pruning will not address these imbalances and the potential for failure of trunks and branches will increase as the tree parts get larger and more overextended. These trees should be considered for removal, all of which qualified as *Native Protected* trees.

2. Evaluate the possibility of removing off-site trees #326, 328 and 329. Given their form and structure and the increasing likelihood of failure as they get larger and more over-extended, removal is the prudent course of action.
