City Council of the City of Napa
Regular Meeting

HERITAGE HOUSE
VALLE VERDE PROJECT

Salvador Creek and Heritage/Valle Verde Project; City File No. PL17-0114

RE: Salvador Channel Stability Assessment at the Proposed Valle Verde and Heritage House Continuum of Housing Project, 3700 Valle Verde Drive, Napa, CA

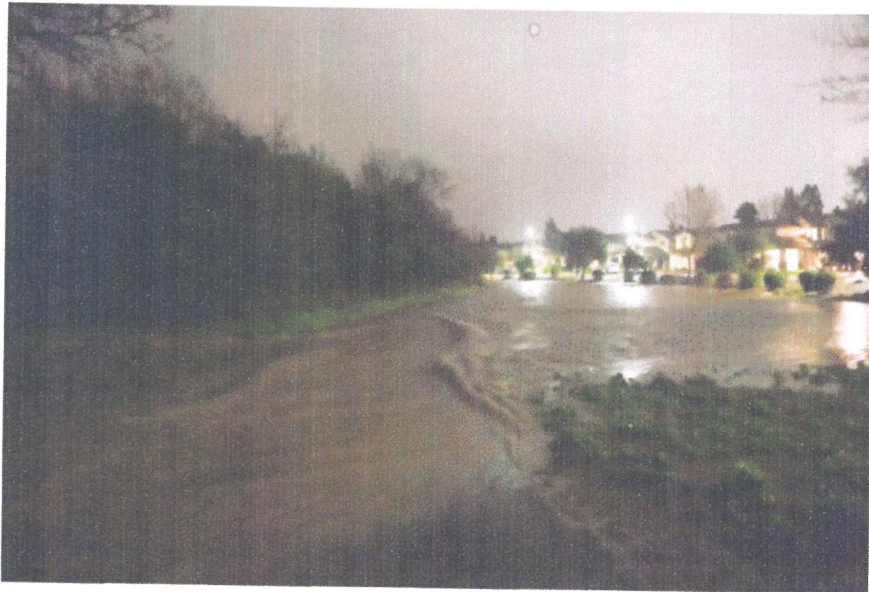
01-2019 Backside of Summerbrooke Circle facing East to See footpath flooded

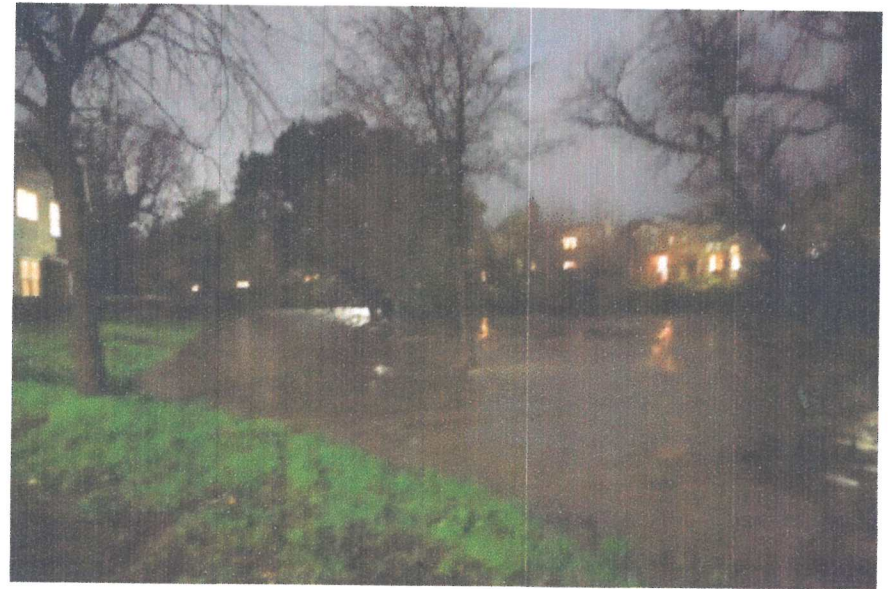
01-2019 Backside of Summerbrooke Circle facing West to See footpath flooded

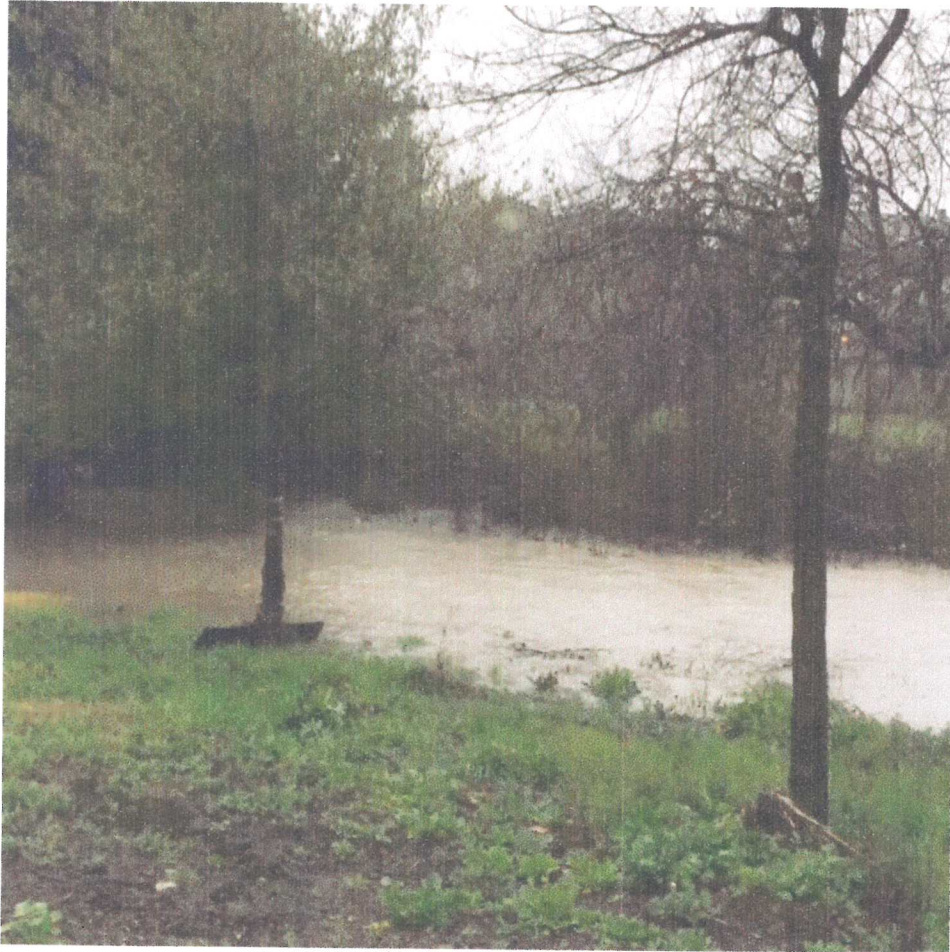
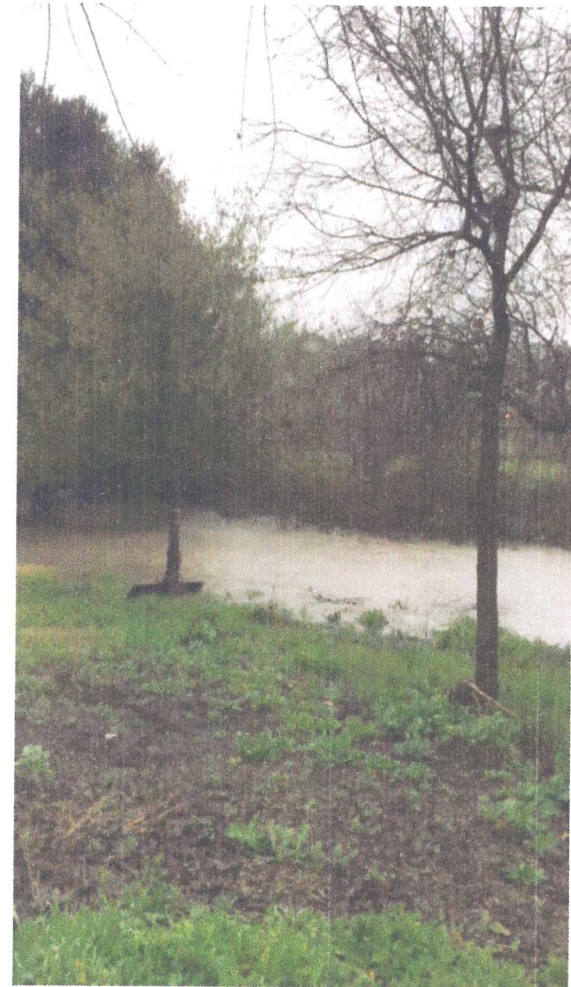
01-2017 Summerbrooke Circle Flooded

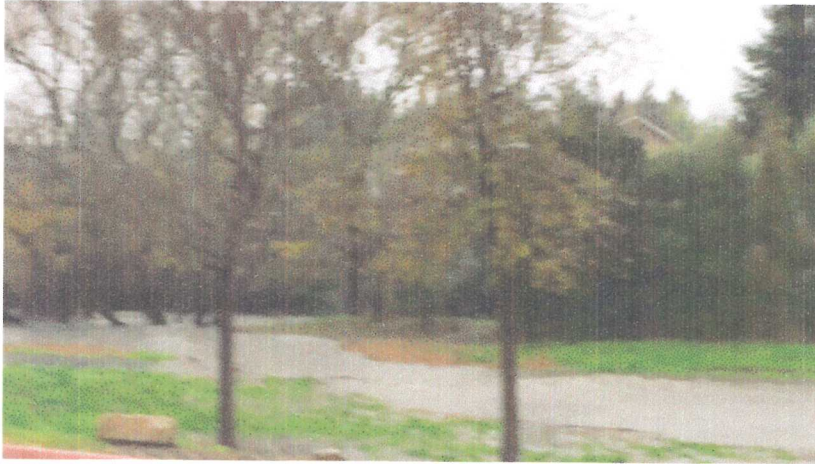
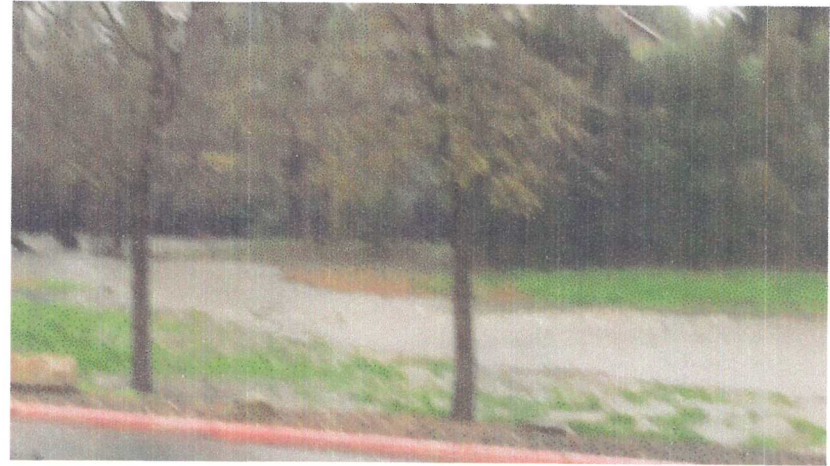
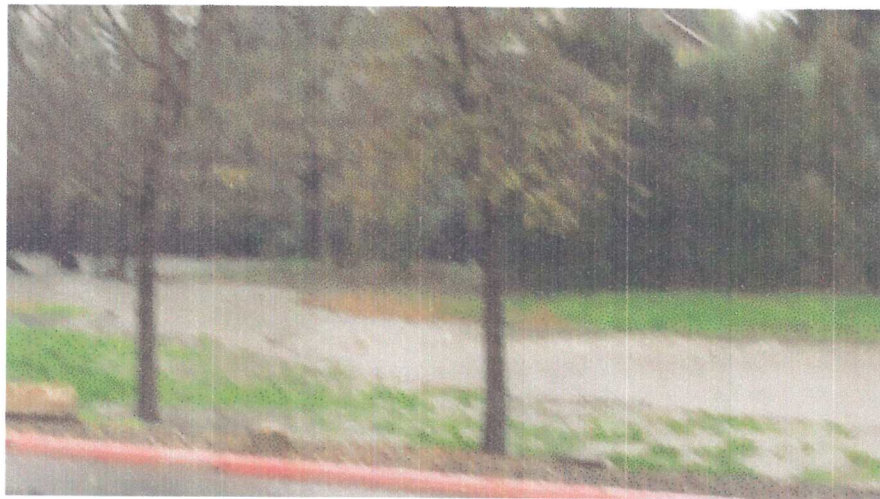
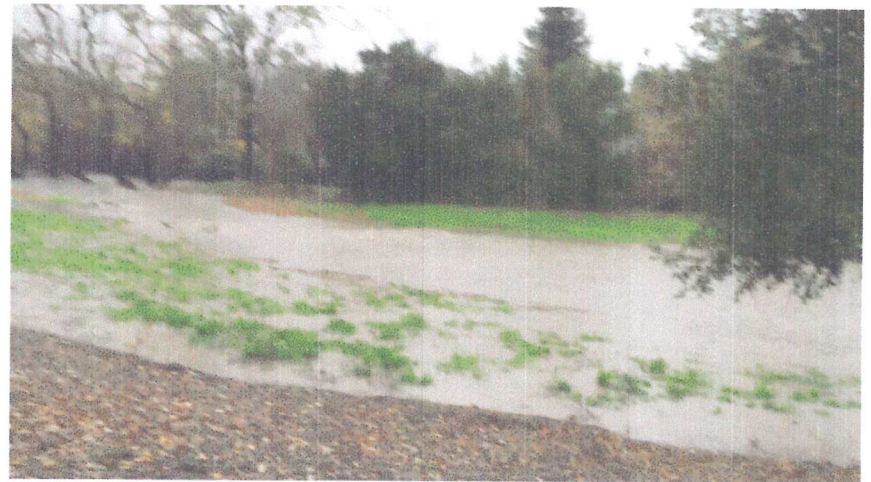
12-2014 Summerbrooke Circle Footpath Flooded

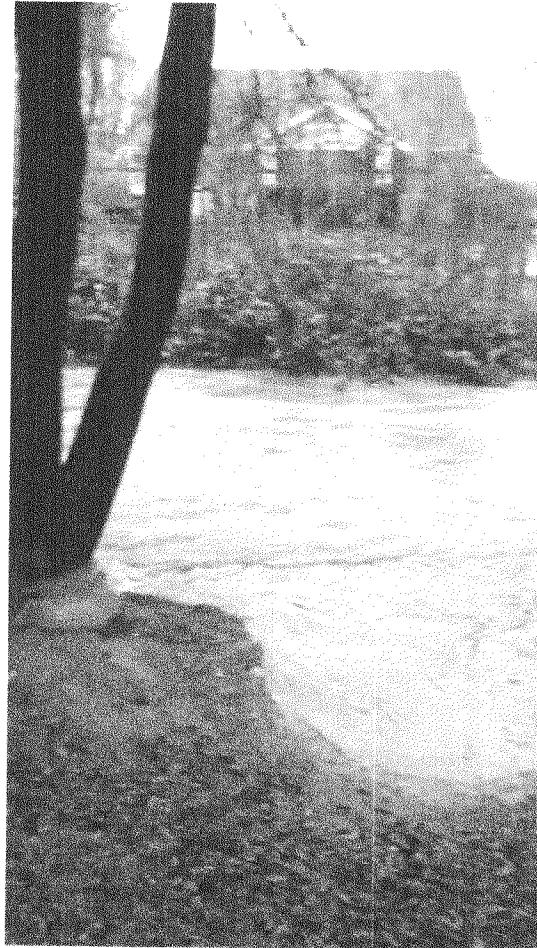
01-2019 Area around Summerbrooke and Sunrise Property Flooded

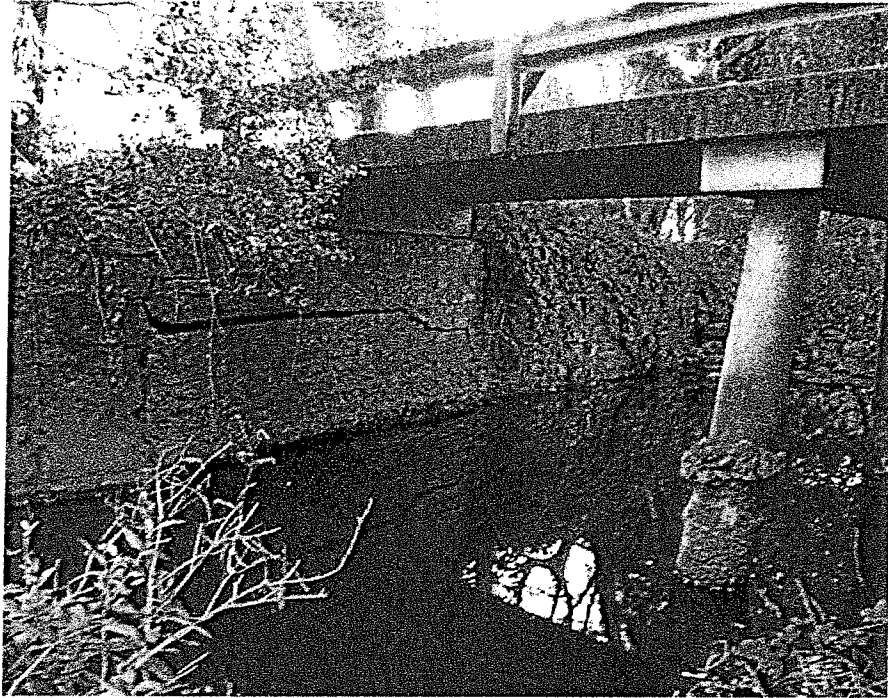
CH inspected the reach of the Salvador Channel extending from the old bridge upstream of the project site to just downstream of the vacant Sunrise assisted living facility building. The existing bridge lies just upstream of the Project boundary, although it has been proposed for partial removal in association with Project implementation. Concrete bridge abutments support the existing bridge, and a 2-3 ft. high grouted rock wall constructed just downstream of the bridge serves as a local grade control to protect the bridge piers and east abutment from excessive channel scour (Photo 1, see attached Photo Log). As can be inferred from Photo 1, the rim of rough grout visible around the piers coincided with the original level of the bridge undercrossing, which probably consisted of a grouted concrete lining that deteriorated and failed at some point in the past. The photo also depicts the severity of the cracking of the east abutment. *Vandivere's Sept. 2019 re-inspection of the channel reach revealed that a portion of the cracked east sidewall below and immediately upstream of the abutment has now broken away from the downstream portion that underlies the east bridge abutment. Once this failed portion of the mortared sidewall fails completely, it will collapse into the channel and will expose the remainder of the downstream portion of the wall to backcutting, which will accelerate the failure of the remaining side wall.*

Photo 1: Downstream oblique view of Salvador Channel at the existing bridge crossing and the severely cracked east abutment. Note the remnant ring of grouted rock on the bridge pier, approximately two feet above the ponded water level.

- Removal of the Zerba Bridge, which will improve local flood conditions overall, will likely need to include removal of the failing west bank wall that supports the current bridge foundation. Its removal will require provisions for streambank stabilization using biotechnical means and acquisition of regulatory and resource agency permits.

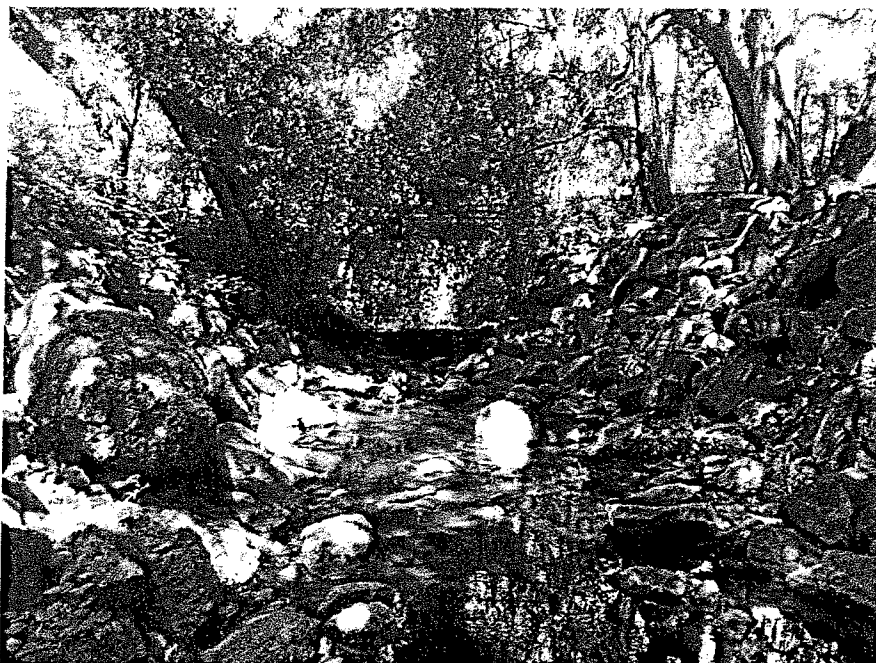
Downstream of the grade control, both the east and west banks are lined with large 1-3 ft. diameter rip-rap (Photo 2), the placement of which may have been concurrent with the bridge construction, or it was necessitated by increased scour downstream of the concrete armored bridge crossing.

While the actual chronology of the stabilization efforts at and downstream of the bridge are unknown, the downstream extent of the riprap placement (roughly 100 ft. in length) strongly suggests that the riprap was placed in response to local bank failures. This patchwork of riprap installation is typical of incised stream channels in the Bay Area that have undergone significant urbanization since the 1950-60s. Based on the level of the rough ring of grout around the bridge piers, the downstream channel has likely incised 3-4 feet over that time period.

Photo 2: Upstream view along the Channel reach immediately downstream of the existing bridge, which is visible behind the tree foliage. The 2-3 ft. high grouted rock wall/grade control structure crosses the channel at the shaded center of the photo.

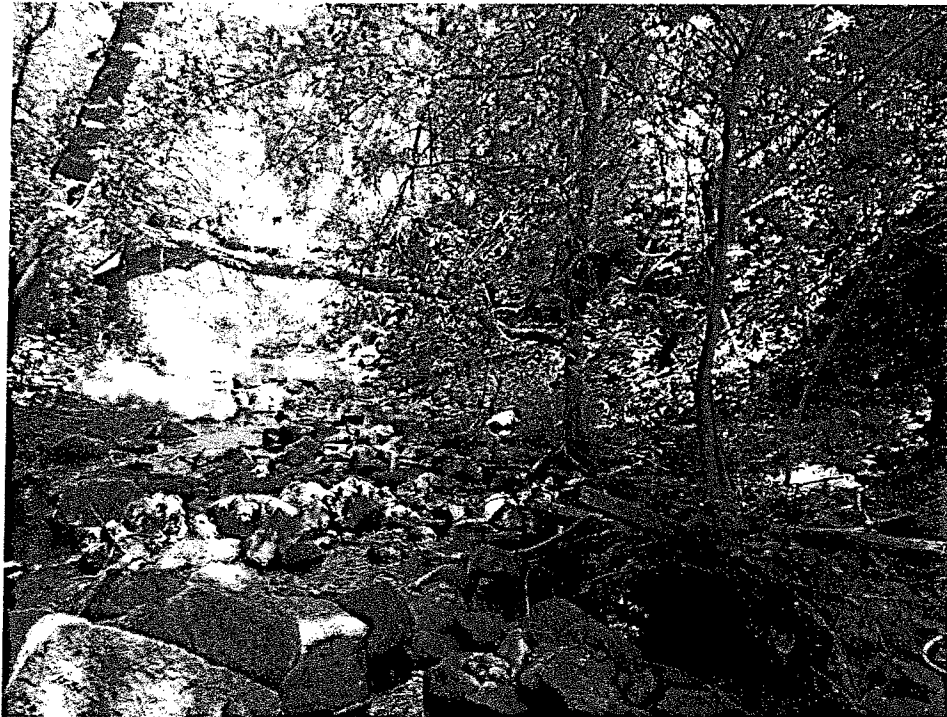
It appears that a portion of the rip-rap placed downstream of the bridge has dislodged and fallen into the center of the channel. Some of this dislodged rock was subsequently transported downstream during major floods and has formed the skeletal elements of a roughly longitudinal and discontinuous mid-channel bar that extends downstream past the northern boundary of the abandoned assisted living building parcel (Photo 3). The larger boulder-sized elements have forced low flows to bi-furcate to either side of the bar.

Photo 3: Downstream view along the roughly longitudinal and discontinuous mid-channel bar formed by collapsed boulders transported a short distance downstream from the upstream riprap revetments.

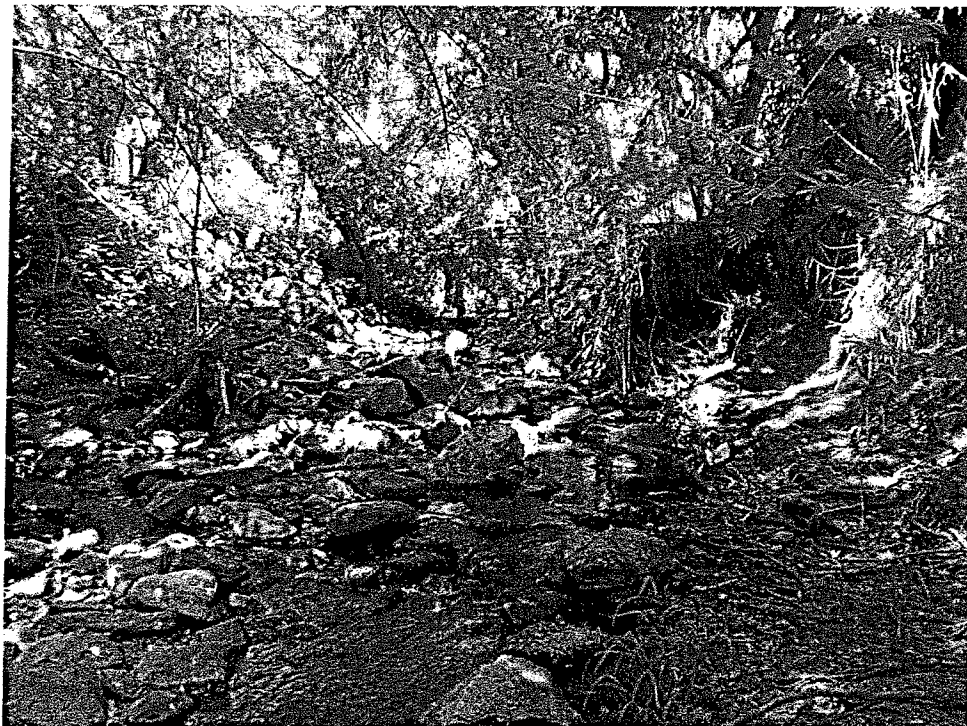
Immediately downstream of the main riprap installation, portions of the east bank have been severely eroded (Photo 4). West bank erosion is also evident in this reach, which extends onto

Photo 4: View looking upstream from the analyzed cross-section. Note the severe erosion along the east bank (at right), immediately downstream of the riprapped banks.

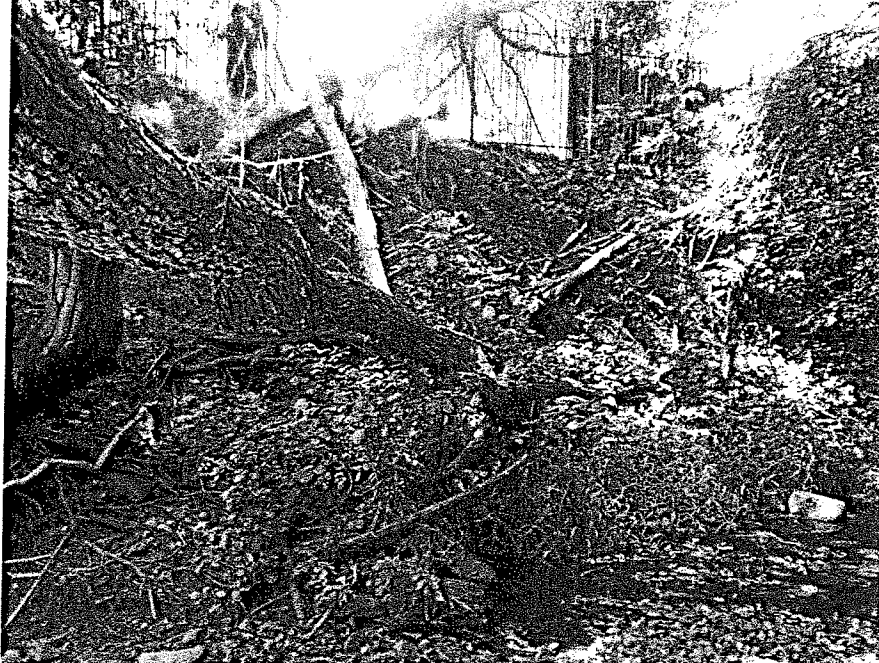
the channel reach adjoining the vacant Project building. The west bank is higher than the east bank and the erosion that has occurred has produced a more precipitous, near-vertical slope. Several trees have been undermined and have fallen into the channel within this section of bank. It should be noted here that the current project EIR states that the Salvador Channel is less than 8 ft. deep and

The channel cross-section selected for the 2014 stability analysis was taken through this short reach, as shown in Figure 2. Photos 5 and 6 show the local west bank condition. Photo 5 is an oblique view of the west bank that depicts the steep local slope (approx. 0.5:1 H:V) and the proximity of the top of bank to the asphalt parking area. The total station visible at the upper left of the photo was set atop the asphalt adjacent to the curb, about five feet from the fence. The cross-section extended directly across the channel from the set-up position. Photo 6 is a close-up of the bank immediately downstream of the analyzed cross-section, which was unvegetated, but of similar composition to the bank at the section location. The photo shows the low and mid-bank region, including a lens of fine grained sediment infused with gravel and cobble. This lens likely represents a low terrace deposit of alluvium that with incision has been eroded, along with the finer-grained material that overlies it further upslope. The thickness of this lens is approximately 3-4 feet and is underlain by a more resistant claystone. The claystone layer was also observed further downstream where the local west bank is vertical and overlain by similar fine-grained material, as well as across the channel where it forms stable low terraces. The tree rooting evident in Photo 6 is an extension of one of the dead trees visible in Photo 5, and has been lending some stability to the low bank zone. However, as these trees are sufficiently undermined and collapse during significant flood events, the root systems can also be upended and create local obstructions to flow and diversion of these flows onto the exposed banks, resulting in substantial bank erosion and/or slump failures.

Photo 5: Oblique upstream view of the west bank- the analyzed cross-section extended as a straight line along the line-of-sight of the total station at top left.

- Instead of implementing a biotechnical approach, including bridge removal, only along the currently undeveloped northern portion of the Project property, CH recommends that biotechnical measures be applied to stabilize the west bank of Salvador Channel throughout the Project reach. This could be done, if the Project parking were accommodated in a different configuration, providing a setback corridor for biotechnical stabilization and riparian corridor enhancement.

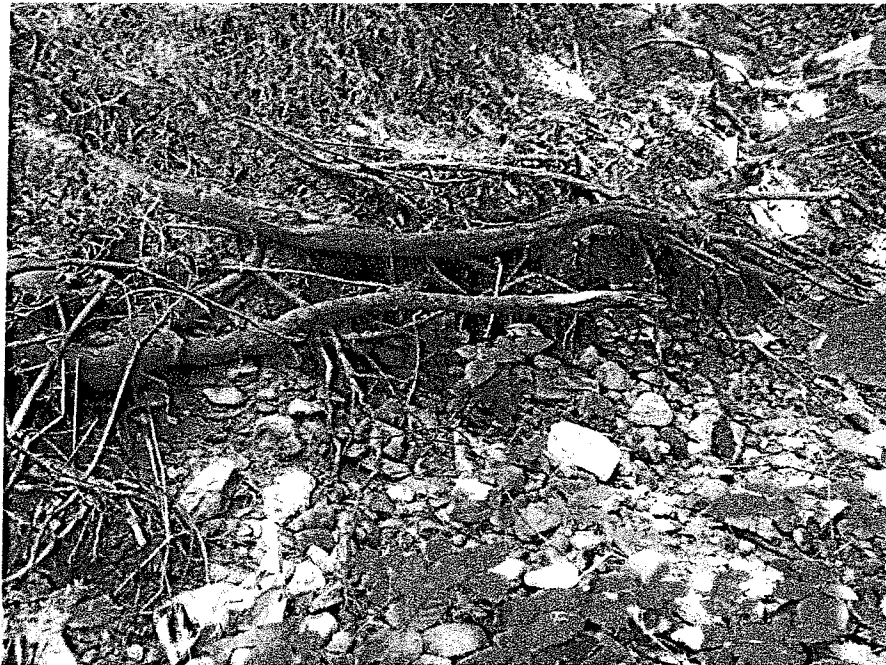
Photo 6: A close-up of the low to mid-bank zone of the west bank, immediately downstream of the analyzed channel cross-section location. Note the patch of still-intact bank soil infused with large gravel and cobble at mid-left under the tree root. Erosion of this lens of material produced the loose gravel and cobble on the lower terrace. The larger gravel-cobble component is absent in the mid-bank soils.

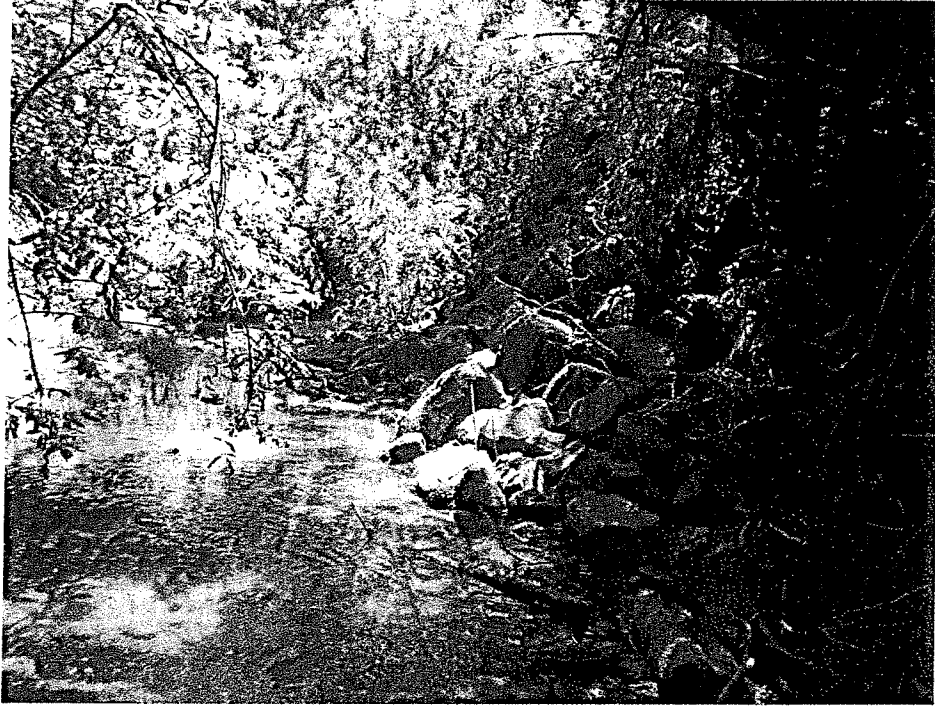
Rip-rap has been placed along a 40-50 ft. long section of the right bank, adjacent to and just downstream from the unrocked section that encompasses the analyzed cross-section (Photo 7). It appears that this rock was haphazardly dumped in response to localized bank erosion. Whereas the west bank riprap installed downstream of the bridge was placed with some attention to three-point bearing, a more stable method of placement, this downstream rock revetment is more uneven and no subgrade keying of the revetment is evident. Both lobes of the dumped rock extend out into the low flow channel.

Photo 7: Downstream view along 40-50 ft. riprap treatment of the west bank adjoining the vacant Project building's rear parking area. Note the boulders encroaching on the active flow zone of the channel.

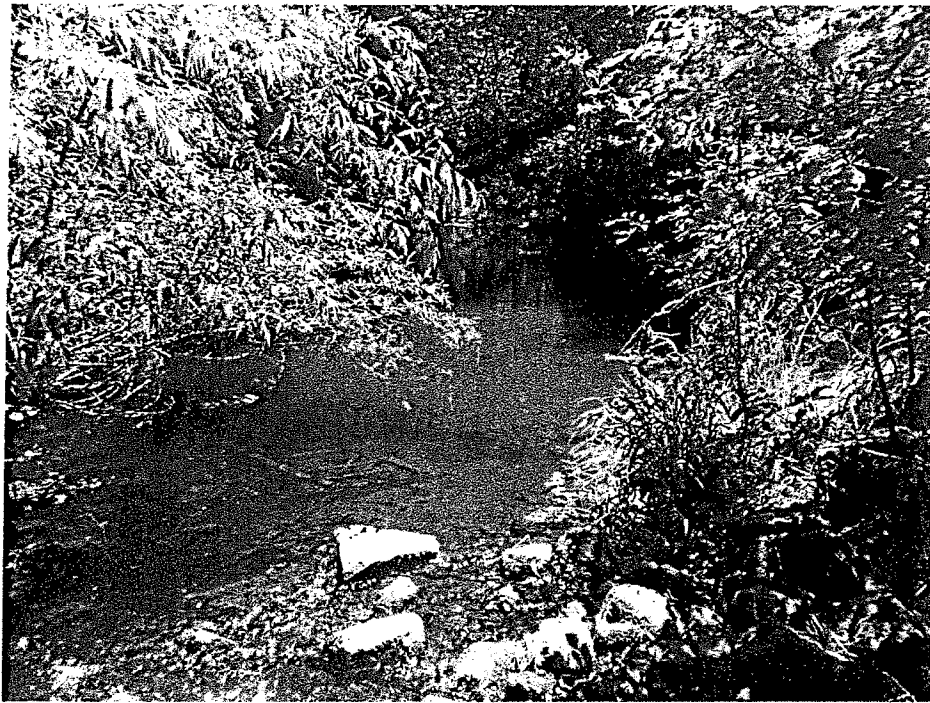
Immediately downstream of the west bank riprap shown in Photo 7, the channel bed form transitions from a very roughened riffle, with a local slope of 2.4 percent, to a long pool (Photo 8) with a milder slope. The pool extends downstream for a distance of 150-200 ft. before the channel enters a bend toward the southern property boundary. Within the pooled reach, the west bank is unarmored and vertical to nearly vertical. Non-native, invasive vines (e.g. ivy) are the dominant vegetal cover, where such cover exists. Some smaller concrete rubble was observed along the channel bottom through the pool reach. The second west bank soil sample was taken in a bare area toward the head of this reach.

Photo 8: Downstream view of lower end of the long riffle and the transition to the long pool that extends downstream from the lower end of the riprap zone in Photo 7 to roughly the southern property boundary.

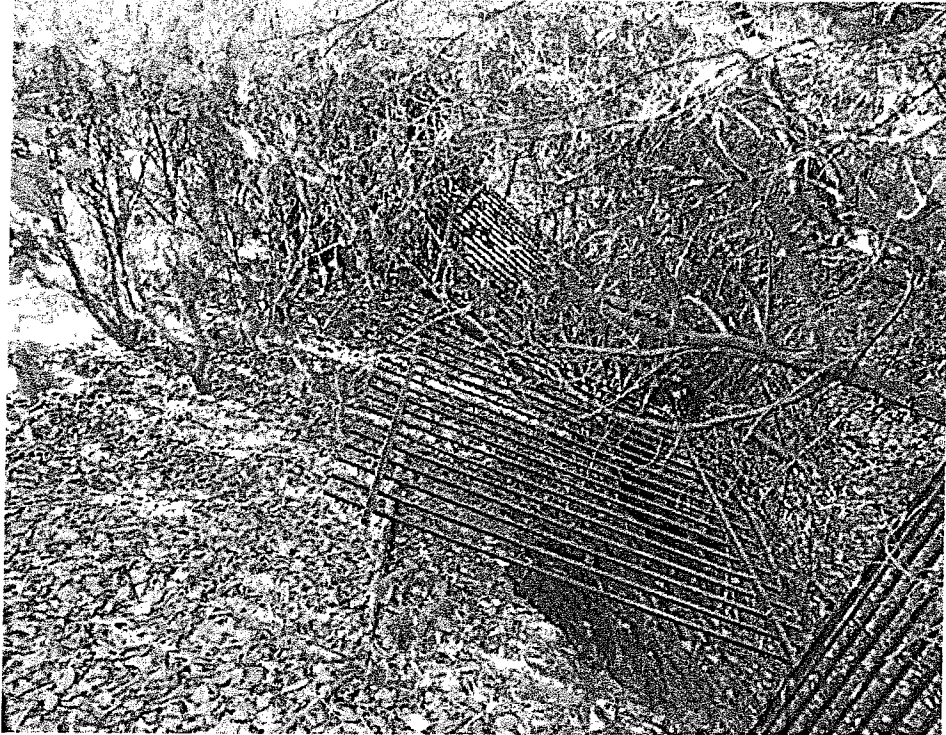
Downstream of the pool reach, the west bank forms the outer radius of a channel bend, which is typically more prone to bank erosion. The local west bank has experienced significant erosion through this bend and has undermined the iron property fence, as shown in Photo 9.

Photo 9 (Couresty of W. McGuire): Upstream view of the eroded west bank through a failed section of the existing property fence.
