Re Tree Addendum Correction

Re: Tree inventory addendum

Re: 2344 Old Sonoma Road, Napa

TREE INVENTORY
2344 Old Sonoma Road, Napa, CA

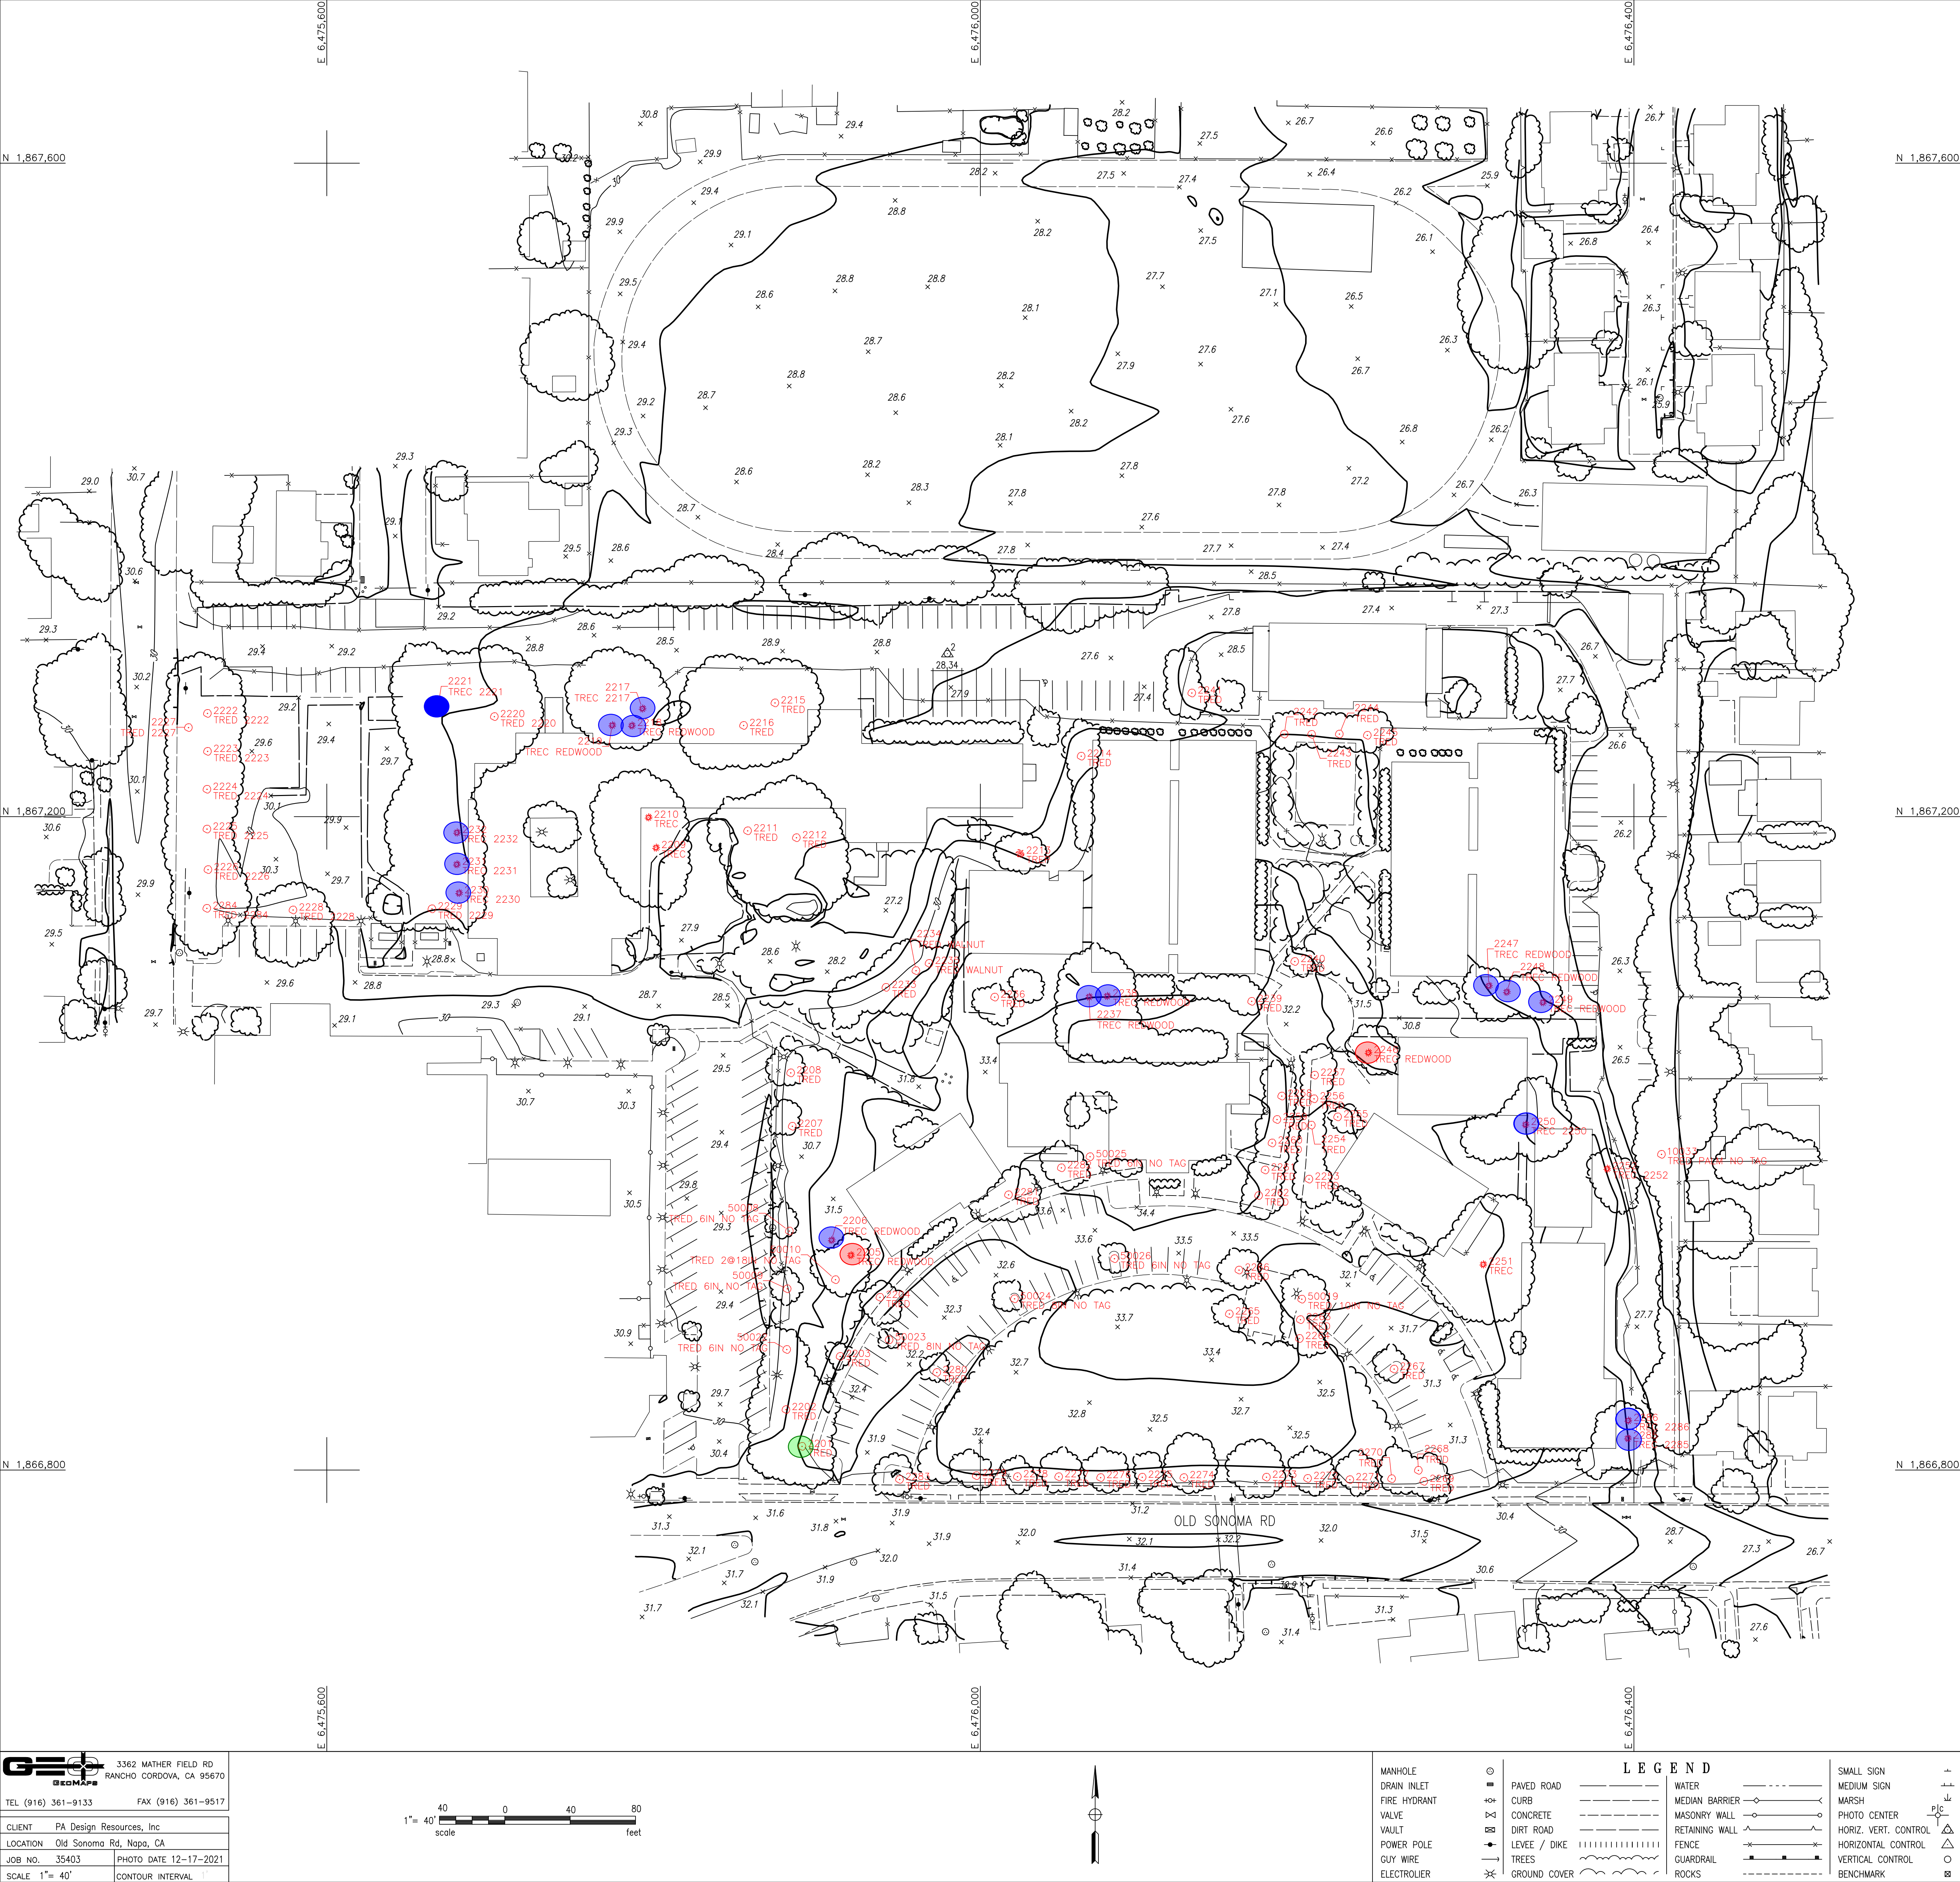
Smaller landscape trees are identified for reference only and are also included in Appendix A. The City does not regulate these landscape trees. All tagged trees are identified on the project survey map.

- Coast Live Oak
- Redwood (Good condition)
- Redwood (Poor condition)

At the time of the field inventory, the ordinance trees that might be removed or impacted were not determined. Tree protection measures must be included on the approved site plans and installed prior to any site grading or clearing. Tree protection measures shall include orange protection fencing securely attached to steel T-drive posts firmly driven in to the ground on 6 foot centers at or near the limits of the driplines. This protection fencing will be inspected by ROC and approved and confirmed in writing. The fencing shall be installed around the entire clumps of redwoods. The fencing shall remain effective through the entire project construction process. If the fence is damaged, it shall be reported to ROC and repaired immediately. Several of the redwoods are located adjacent to the modular buildings where equipment operations should be subject to monitoring by ROC. In the grading and site preparation work, any regulated tree roots over 3 inches in diameter shall be clean cut and not exposed to drying. Exposed roots shall be kept moist with wet fabric or mulch. Should tree crown pruning be required for clearances, it shall be completed by a qualified contractor under the direct supervision of ROC.
