THE GORDON BUILDING

Building Shell Eart
Repair and Restic
for Historic
Gordon Building

1130 First Street Napa,
CA 94559

EXISTING BASEMENT
PLAN W/ REPAIR AND
IMPROVEMENTS NOTED

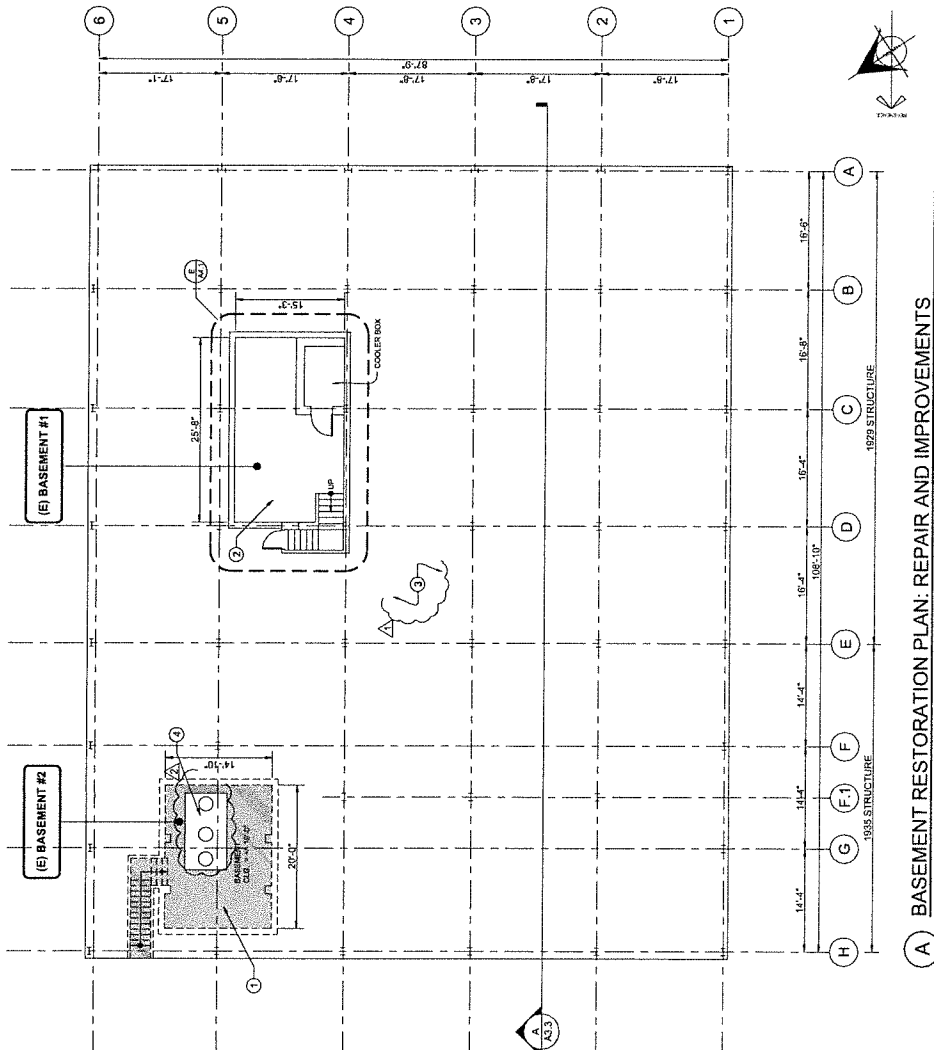
(A) BASEMENT RESTORATION PLAN: REPAIR AND IMPROVEMENTS
SCALE: 1/8" = 1'-0"

- KEY NOTES AT BASEMENT:**
- (E) BASEMENT FILLED W/ CLASS II CEL. CRETE (4000 PSI MIN. COMPRESSIVE STRENGTH, 30 PSI MAX. WEIGHT) S.S.D.
 - ORIGINAL CONCRETE BASEMENT WITH WOOD FRAMED STAIR AND LANDING AND WOOD FLOORS TO BE REPAIRED AND REPAIRED. SEE BASEMENT FLOOR PLAN SHEET A2.1
 - NO DAMAGE OCCURRED TO (E) BASEMENT #1 IN THE SEISMIC EVENT OF 2014
 - 1500 GALLON GRAVITY GREASE INTERCEPTOR WITH GAS TIGHT AND WATER TIGHT RISER S.P.D.

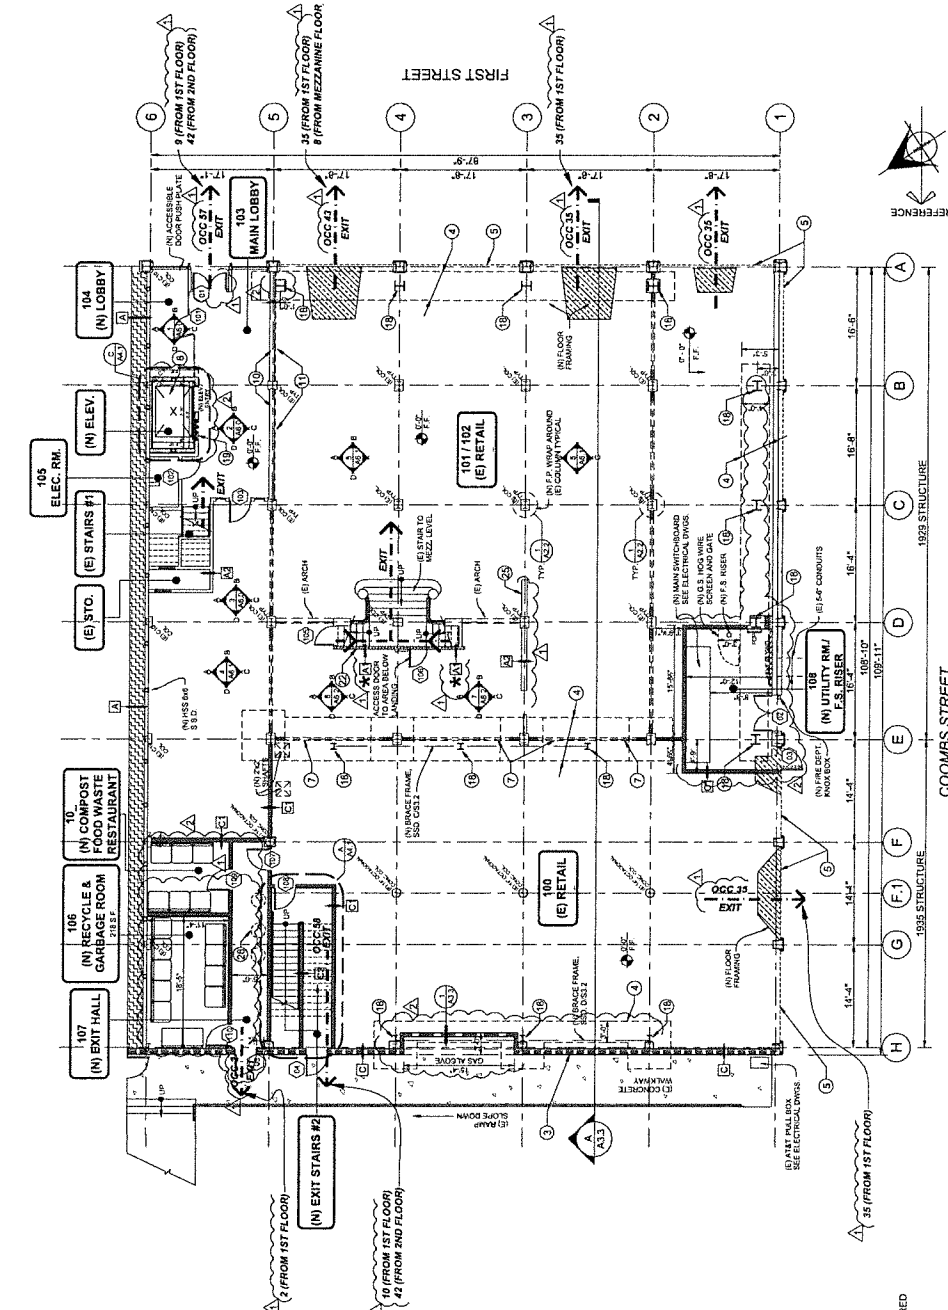
A FIRST FLOOR RESTORATION PLAN: REPAIR AND IMPROVEMENTS
 SCALE: 1/8" = 1'-0"

- KEY NOTES:**
- REMOVE ALL WALL FINISHES, FRAMING AND ORBITALS TO ACCESS SEVERELY DAMAGED HISTORIC STONE WALL. FIELD INVESTIGATION FOUND SIGNIFICANT DAMAGE ESTIMATE FOR COST PURPOSES 50% OF STONE WALL TO BE REPAIRED. DAMAGE MAY BE MORE EXTENSIVE. S.D. SHEET S2.1. REPLACE AND REPAIR WOOD FRAMING AND WALL FINISHES UPON COMPLETION OF SEISMIC REPAIRS. SEE SHEET S2.2 FOR REPAIR OF URM.

- (E) TEMPORARY PLYWOOD BARRICADE AT (E) OPENINGS FOR NEW FUTURE STOREFRONTS.
 - NOT USED.
 - FRAMED OPENING TO DEPICT EXISTENCE OF PREVIOUS URM WALL REMOVED DUE TO STRUCTURAL AND SEISMIC FAILURE.

- 10\"/>
 - HOLLOW CLAY TILE WALL RECEIVED SIGNIFICANT SEISMIC DAMAGE. REPAIR AND RECONSTRUCTION REQUIRED WITH NEW SEISMIC BRACING. S.D. S2.1
 - SEISMIC REPAIR AT HOLLOW CLAY TILE ALONG THIS EDGE OR SIDE OF WALL. S.D. S2.1

- (E) HISTORIC STONE WALL TO BE PINNED ALONG ITS ENTIRE WIDTH AND HEIGHT AT 48\"/>
 - NEW 9\"/>
 - NEW FOUNDATION AND FLOOR FRAMING WORK TO SUPPORT NEW SEISMIC SUPPORT SYSTEM. S.D. SHEET S2.1

- NOT USED.
 - NOT USED.
 - ADD (N) PLYWOOD TO REAR OF (E) MEZZANINE STAIRS. S.D. S2.1.
 - NOT USED.
 - NOT USED.
 - REPAIR AND RETAIN WING WALLS WHERE INDICATED.

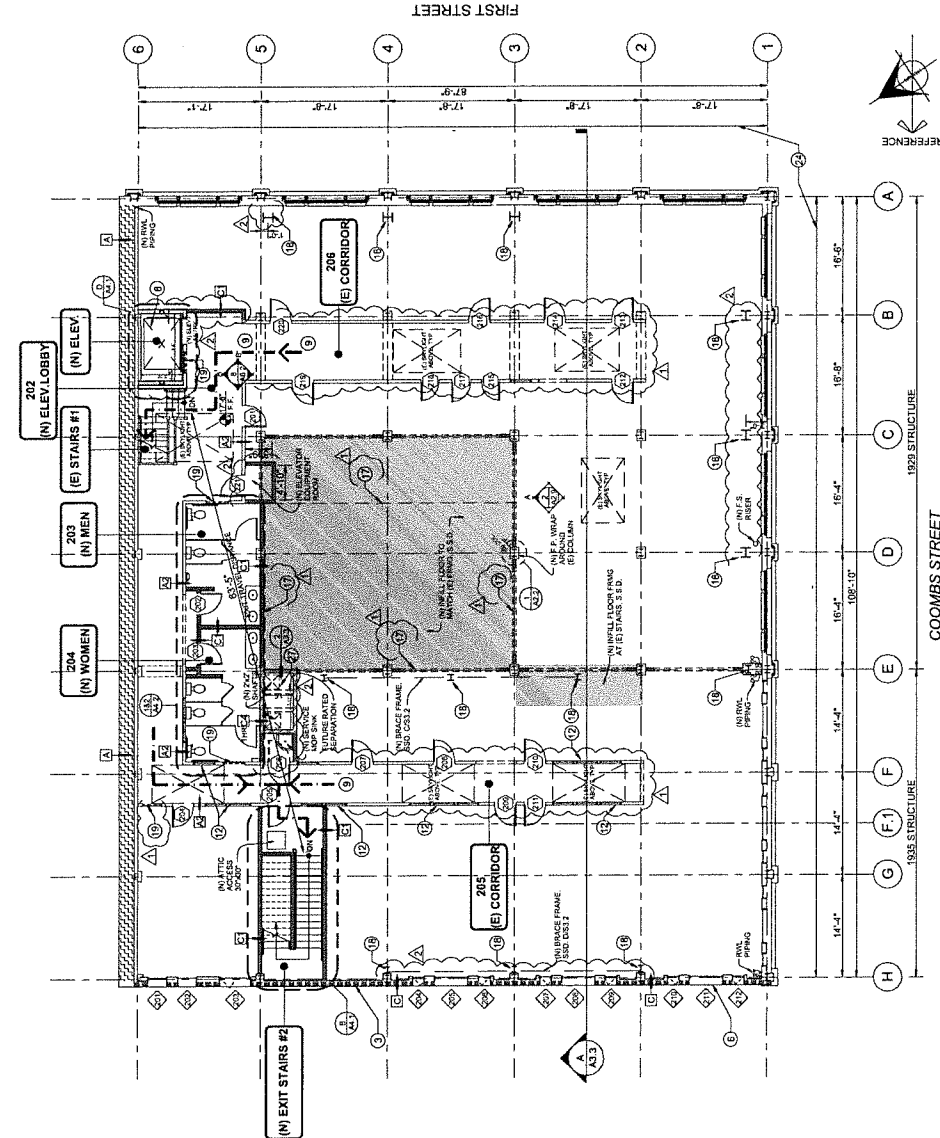
SECOND FLOOR RESTORATION PLAN: REPAIR AND IMPROVEMENTS
SCALE: 1/8" = 1'-0"

- KEY NOTES:**
1. REMOVE ALL WALL FINISHES, FRAMING AND OBSTACLES TO ACCESS SEISMIC DAMAGED HISTORIC STONE WALL. FIELD INVESTIGATION FOUND SIGNIFICANT DAMAGE ESTIMATE FOR COST PURPOSES 50% OF STONE WALL TO BE REPAIRED. DAMAGE MAY BE MORE EXTENSIVE. S.S.D. SHEET S2.1. REPLACE AND REPAIR WOOD FRAMING AND WALL FINISHES UPON COMPLETION OF SEISMIC REPAIRS. SEE SHEET S0.2 FOR REPAIR OF URM.

10. HOLLOW CLAY TILE WALL RECEIVED SIGNIFICANT SEISMIC DAMAGE. REPAIR AND RECONSTRUCTION REQUIRED WITH NEW SEISMIC BRACING. S.S.D. S2.1.
 11. SEISMIC REPAIR AT HOLLOW CLAY TILE ALONG THIS EDGE OR SIDE OF WALL. S.S.D. S2.1.

12. (E) INTERIOR CLERESTORY WINDOWS IN METAL FRAMES TO REMAIN.
 13. NOT USED.
 14. NOT USED.
 15. NOT USED.
 16. NOT USED.
 17. (E) INFILL FLOOR AND ROOF DIAPHRAGM. MASONRY WALLS COLLAPSED OR WERE SEVERELY DAMAGED DURING THE 2014 SEISMIC EVENT.

2. (E) HISTORIC STONE WALL TO BE PINNED ALONG ITS ENTIRE WIDTH AND HEIGHT AT 48" O.C. EACH WAY. S.S.D. SHEET S2.1.
 3. NEW 16" METAL STUD OR 2x4 WOOD FRAMING AT 16" O.C. S.S.D.

24. (E) WOOD SASH AND GLAZING TO BE REPAIRED, REFINISHED AND RECONDITIONED TO USABLE OPERABLE CONDITION.
 25. NOT USED.
 26. NOT USED.
 27. EXHAUST SHAFT SEE MECHANICAL AND DETAIL --

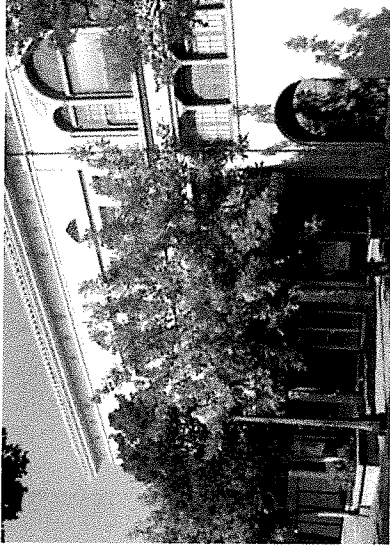
Rear half of Gordon Building was formerly used as the Empire Theatre. Note simple decoration and alterations to storefronts.
