## **Certificate of Appropriateness**

# FRANKLIN STATION

CERTIFICATE OF APPROPRIATENESS | AUGUST 28, 2025

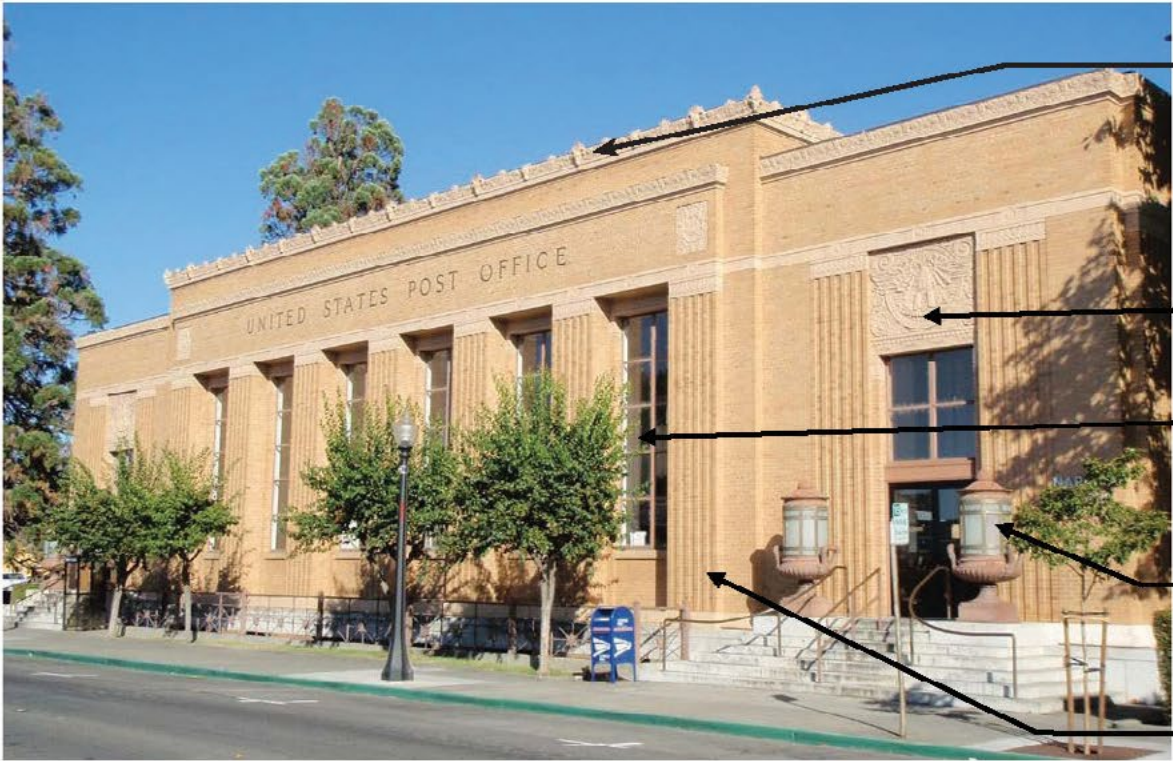
U.S. POST OFFICE, FRANKLIN STATION  
1351 Second Street

Conserve the cornice extending from the roofline formed of terracotta rams and cow heads, along with the ornamentation that consists of decorative brickwork and terracotta panels in a geometric motif.

Retain Art Deco details, including fluted pilasters and stylized terracotta eagle panels above each door.

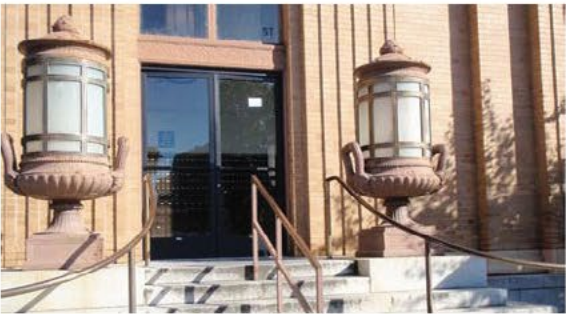
Detail of historic granite stair and lanterns.

No modifications are proposed to the existing lanterns, repairs to bring lanterns back to a functioning state will be carried out per the historic guidelines.

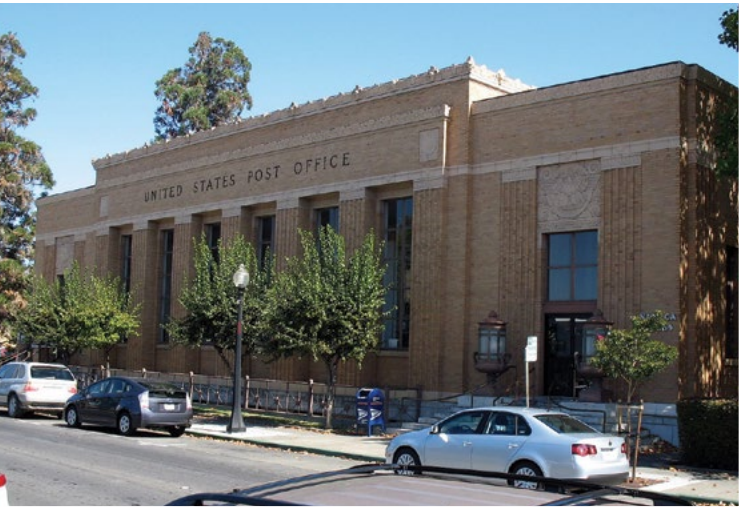
FEATURE 01

Simple Geometry of the buildings massing.

This expression is further reinforced by utilizing a light curtain wall system to allow the existing facade of the post office to be expressed on the interior.

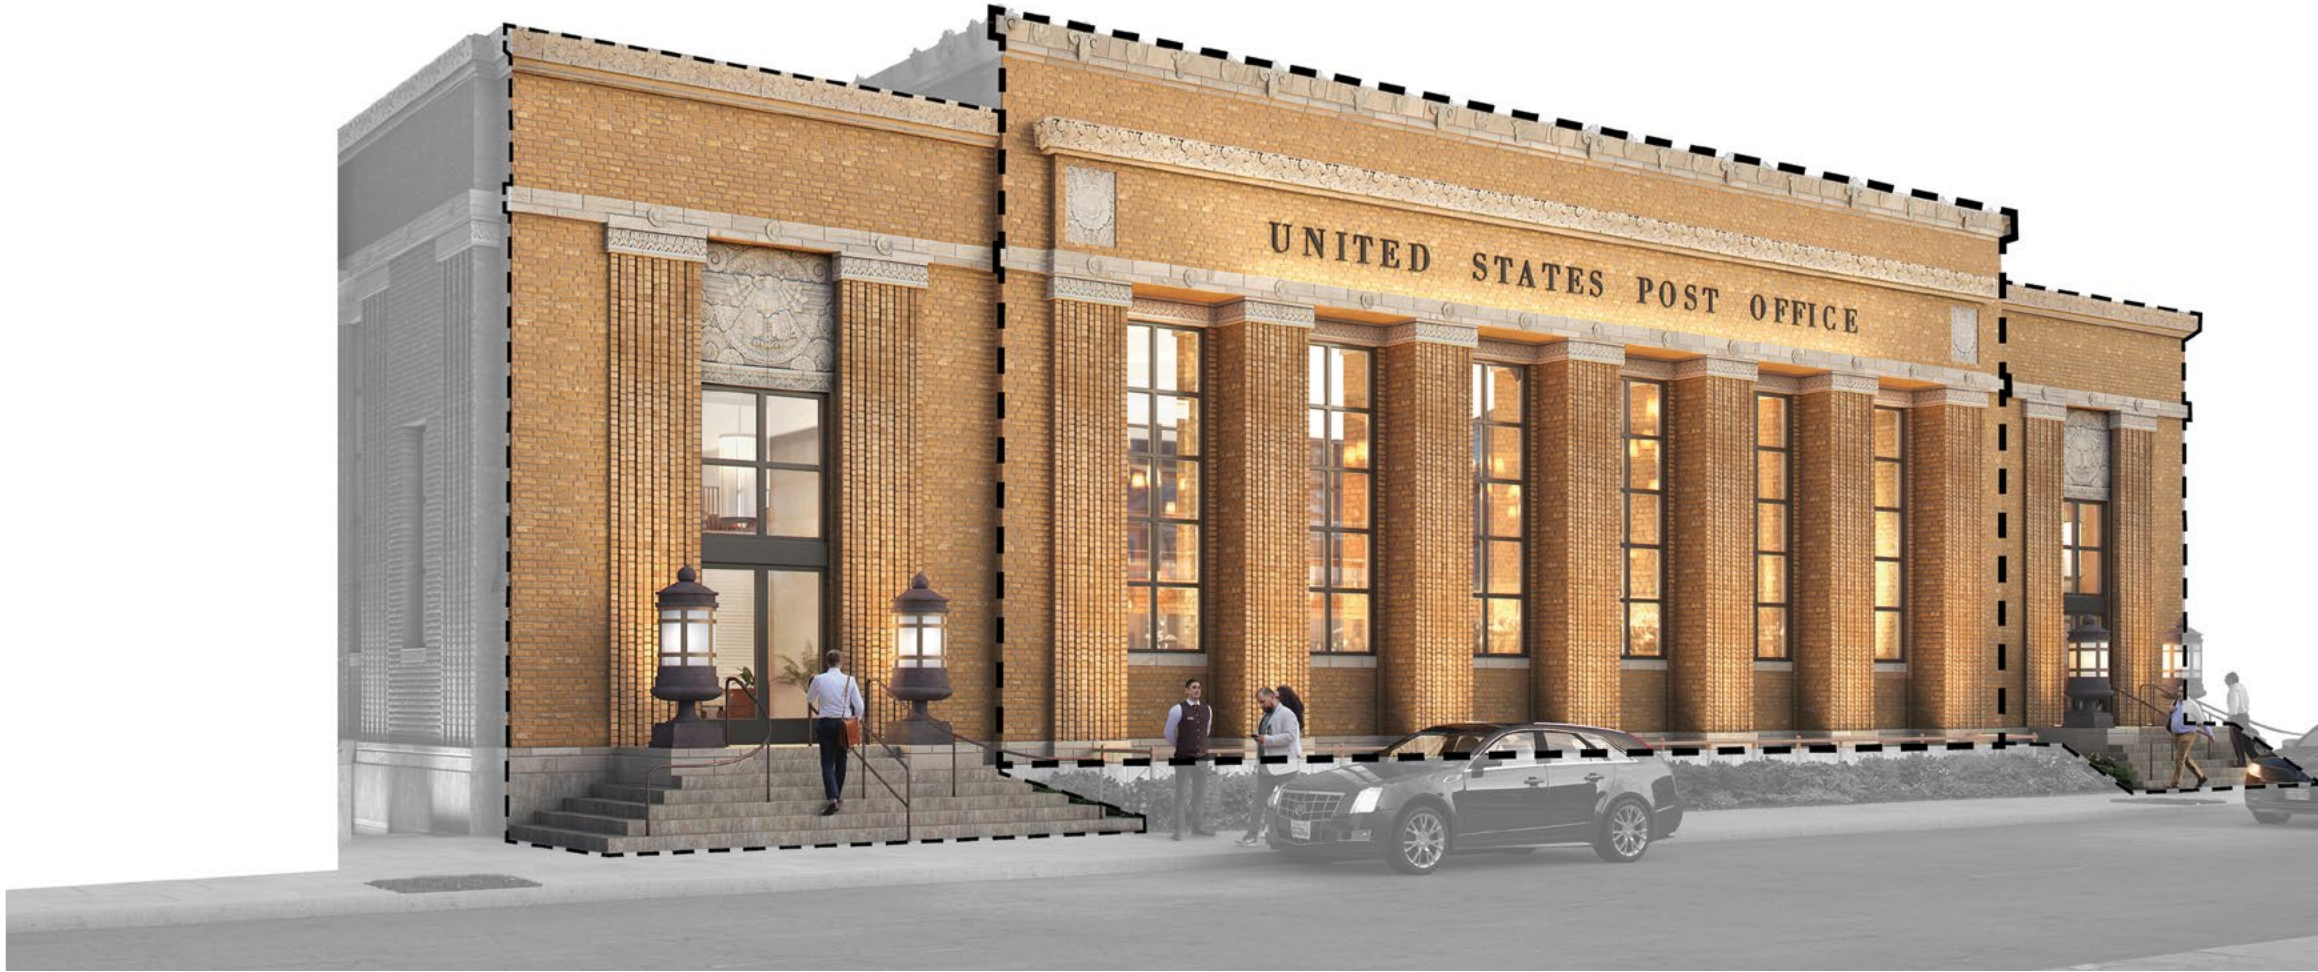
FEATURE 02

Projected central area flanked by two recessed wings.

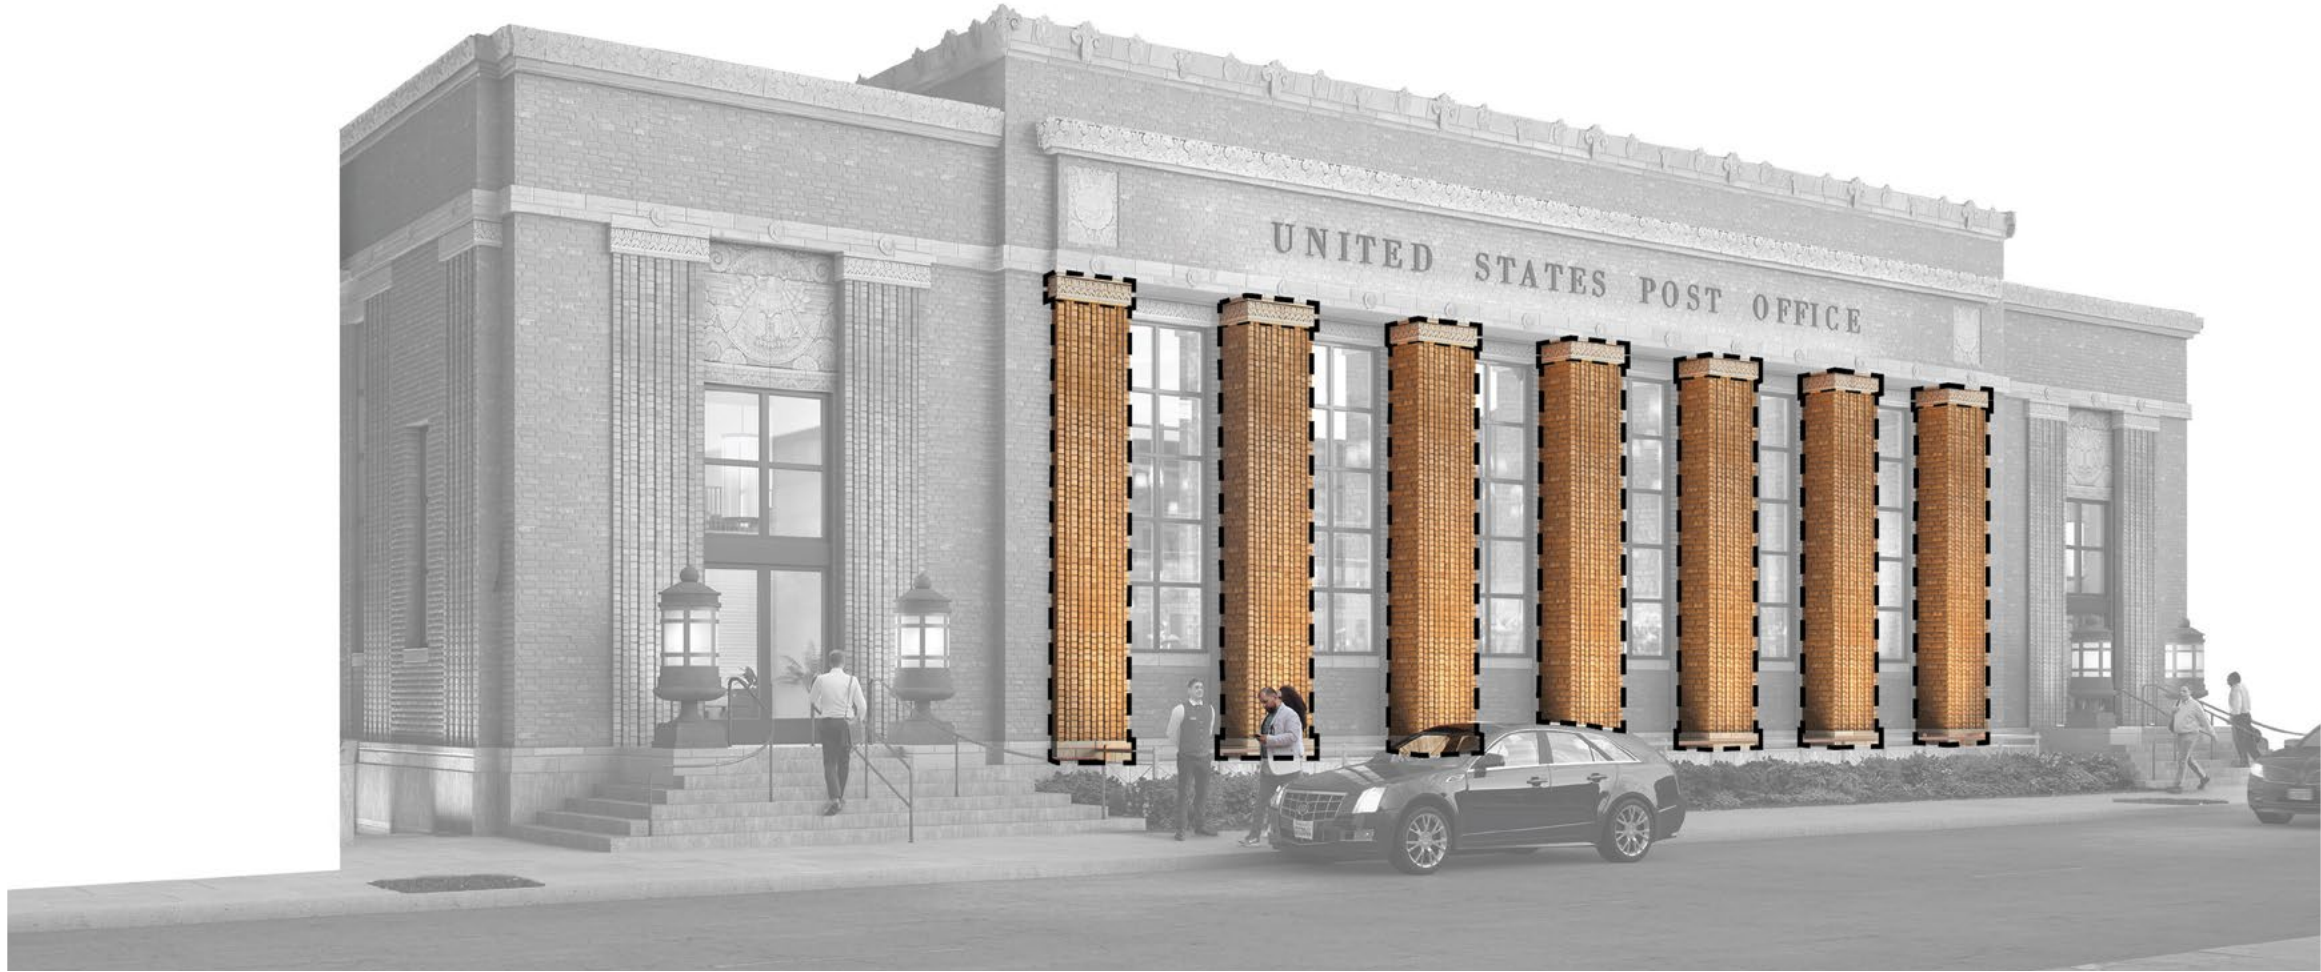
FEATURE 03

Seven piers topped by terracotta “capital” in a stylized floral motif.

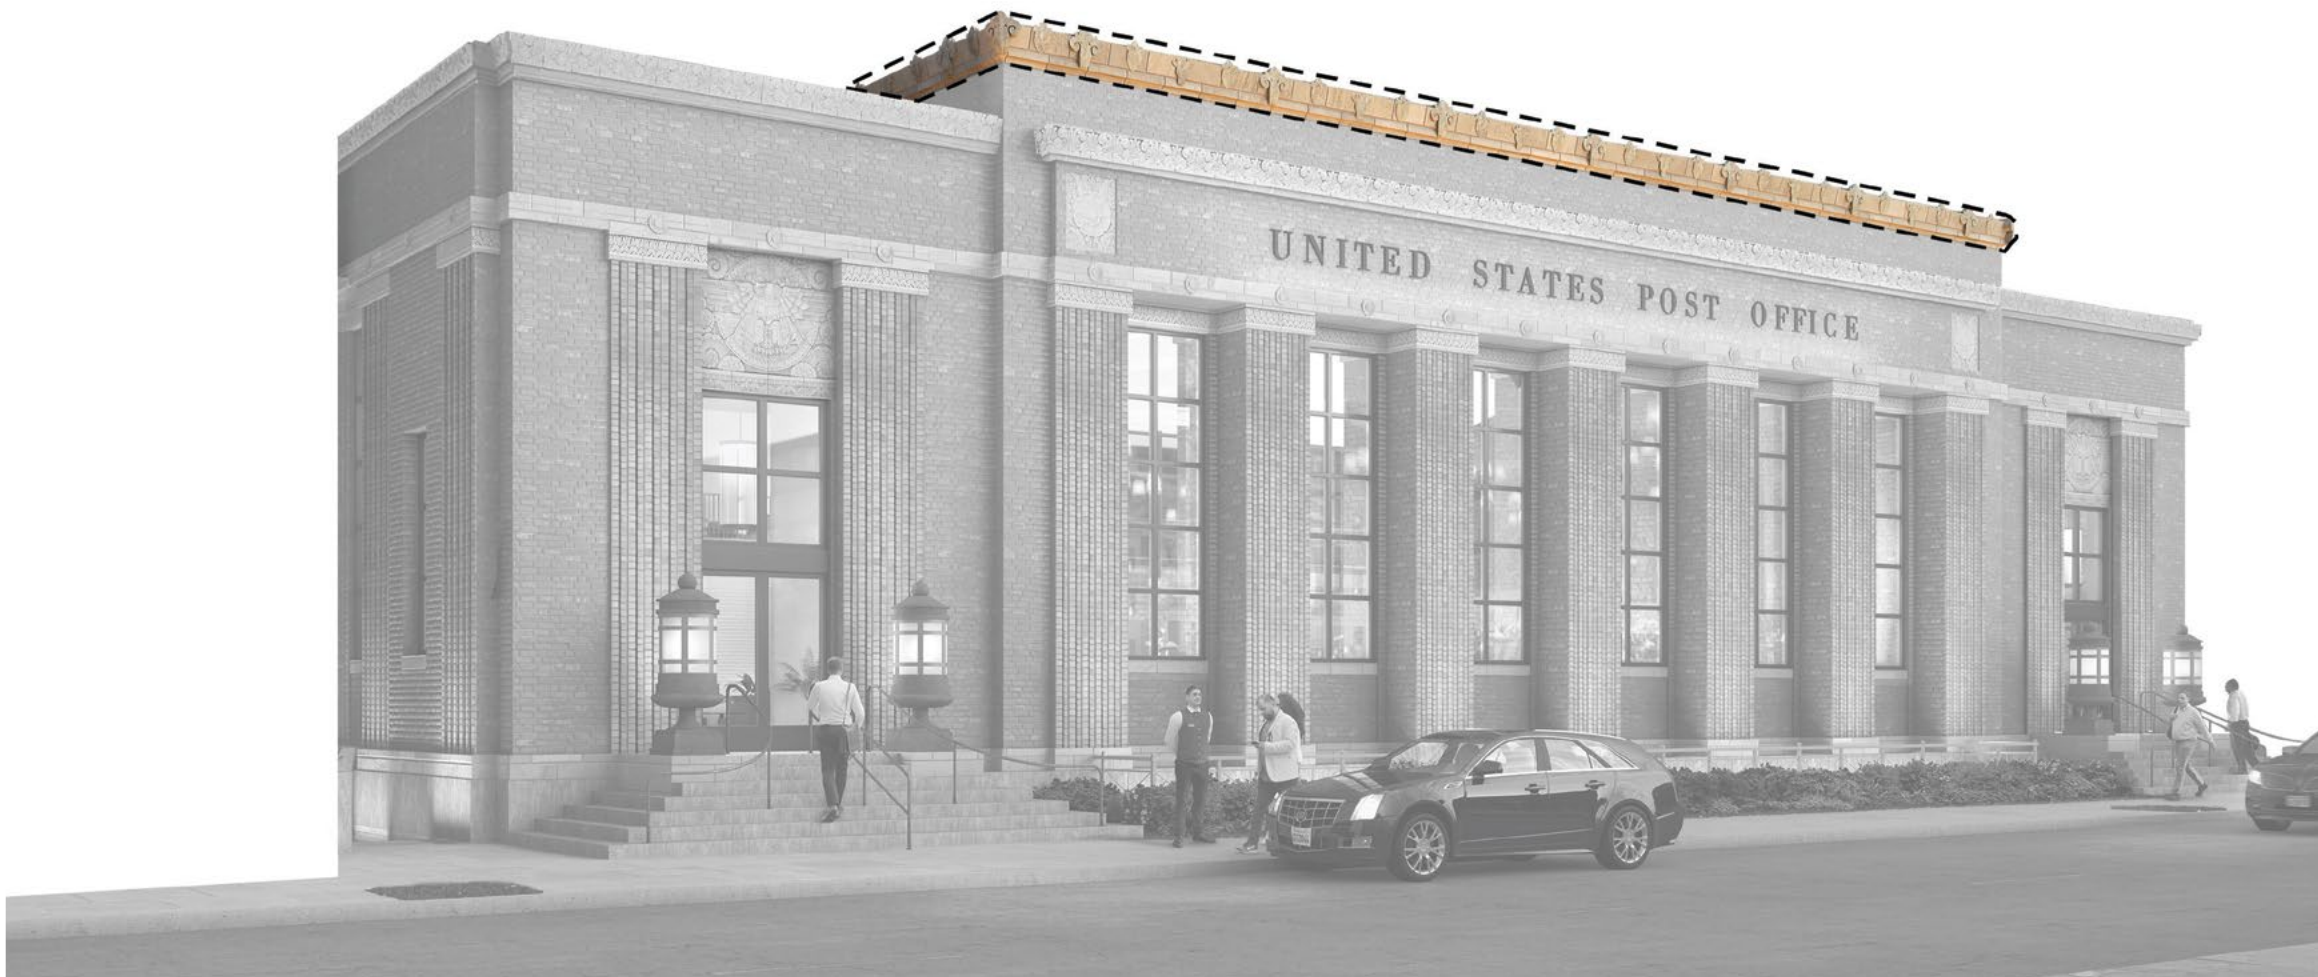
FEATURE 04

Cornice extending from the roof-line formed of terracotta rams and cows heads.

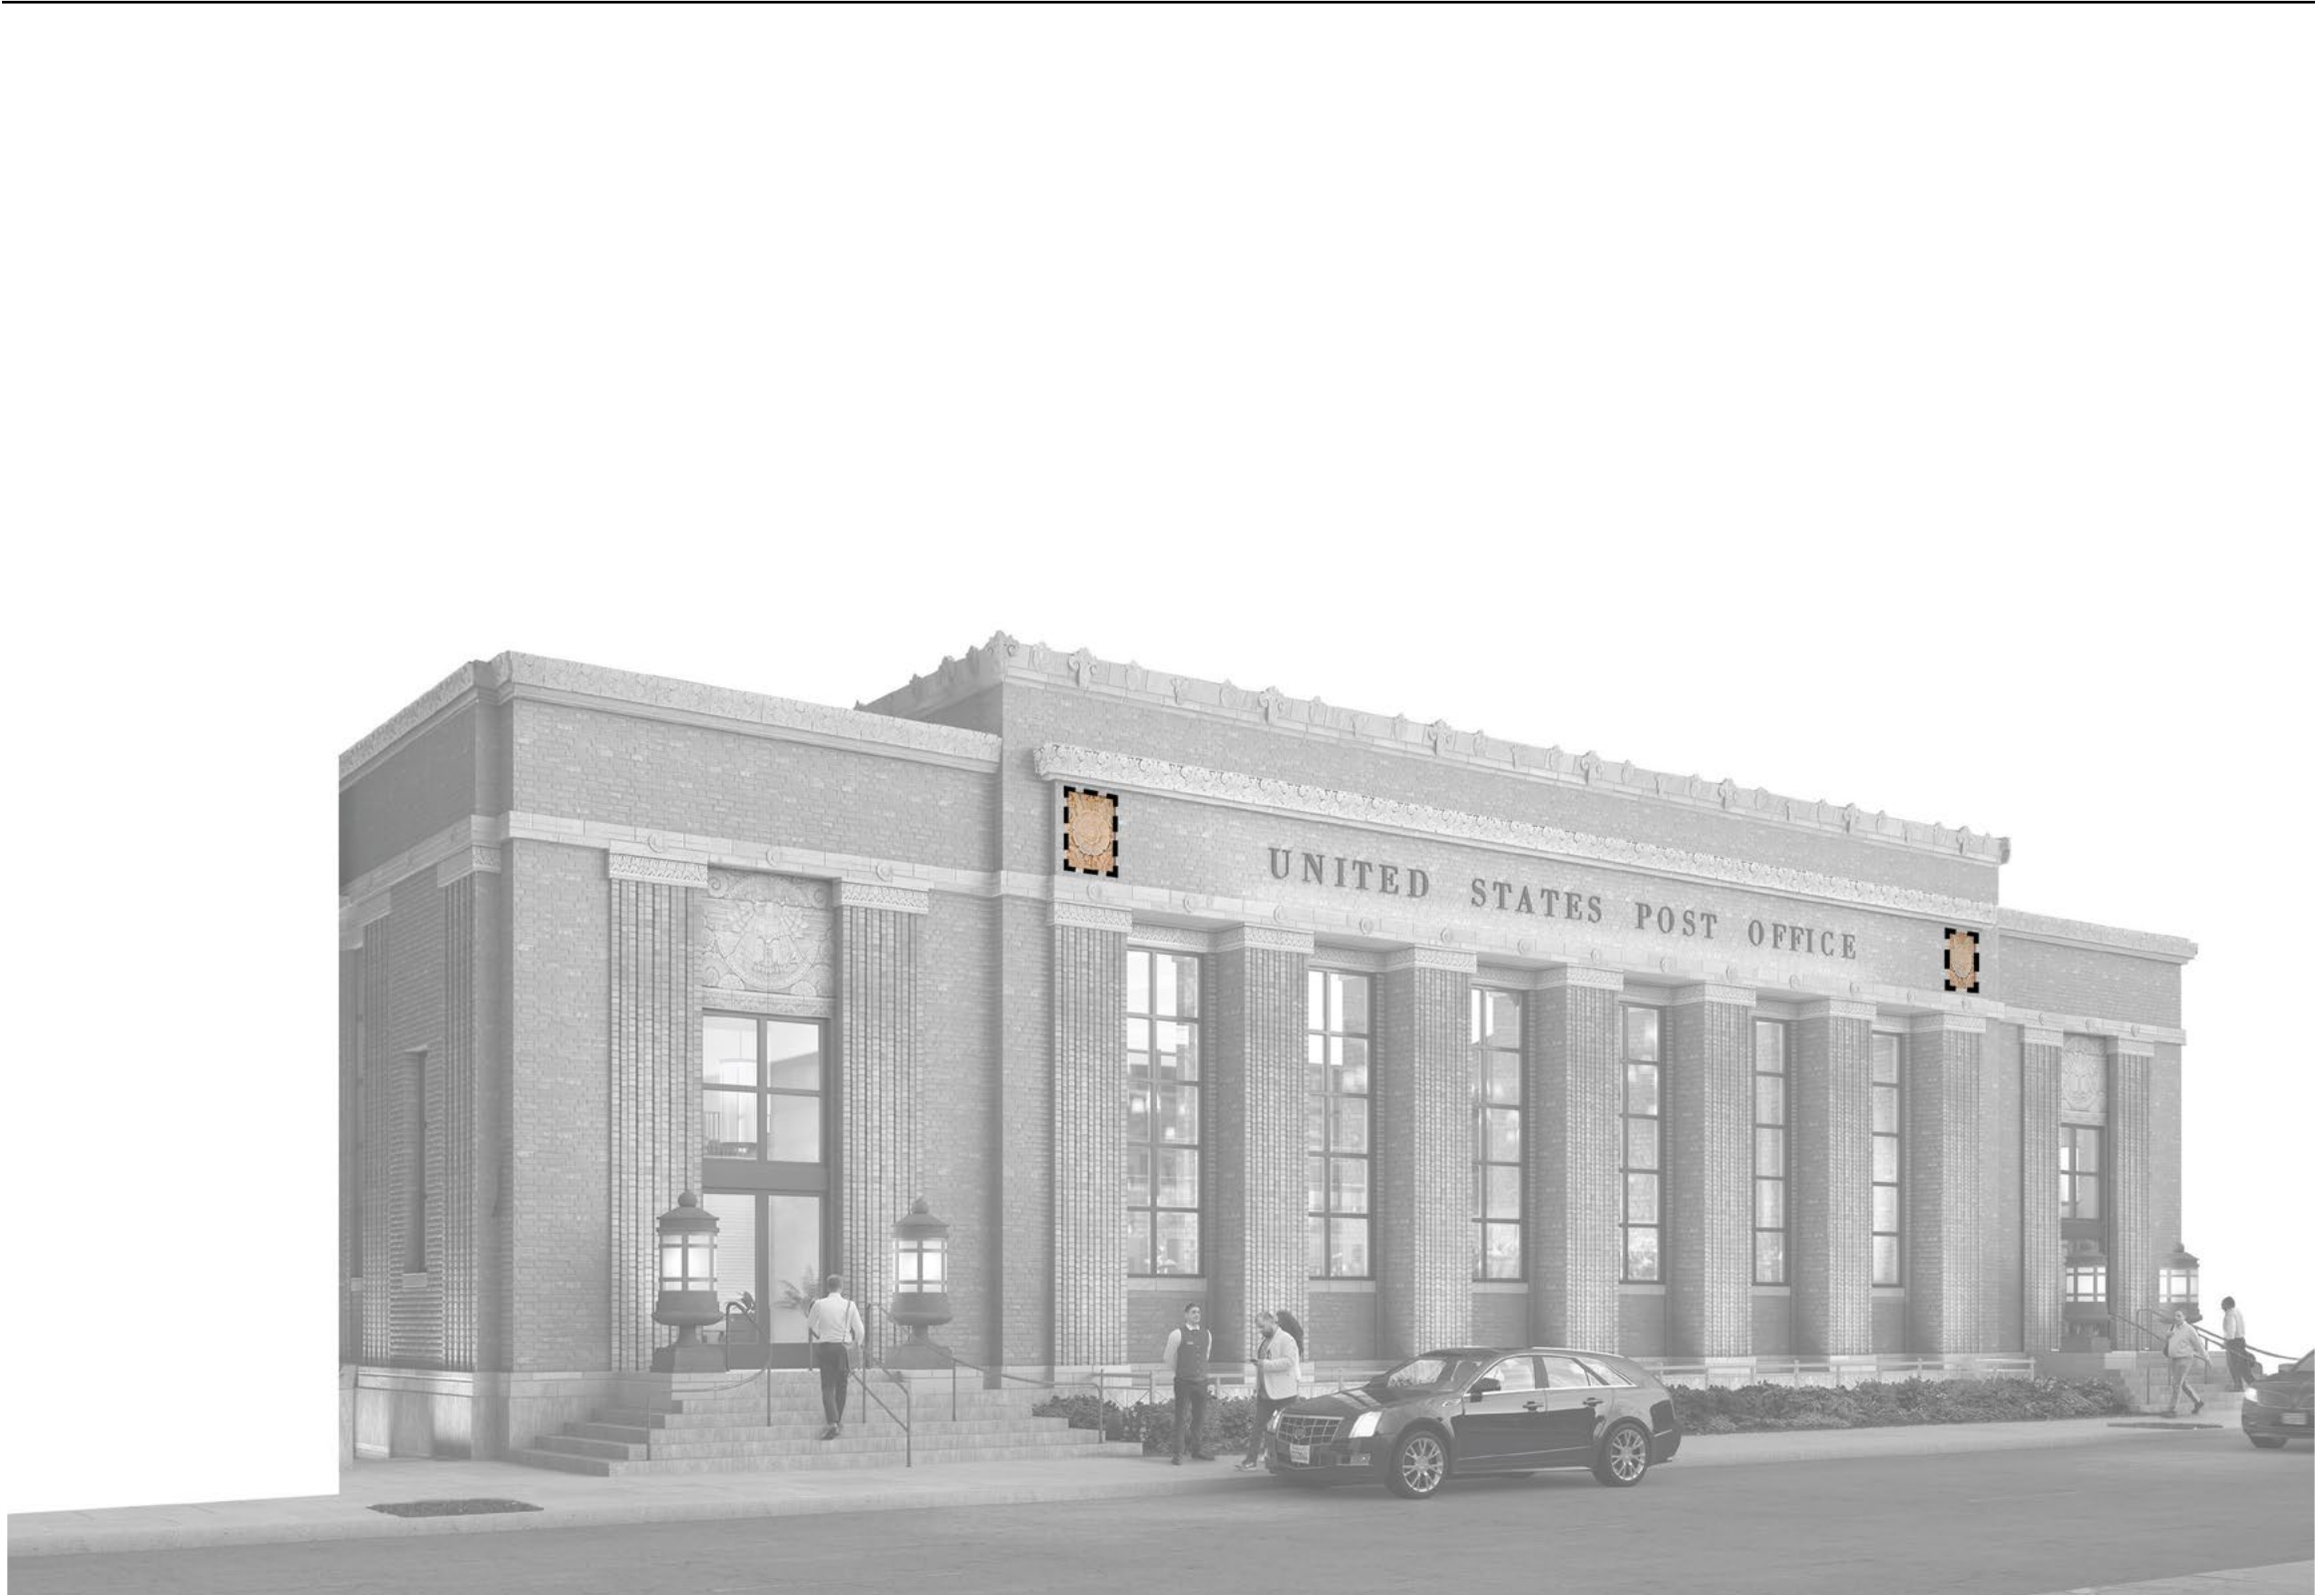
FEATURE 05

Ornament that consists of decorative brickwork and terracotta panels in a geometric motif.

The designated motifs and brickwork remain unchanged, any restoration of the brickwork will be repaired in a manner satisfactory to the historic guidelines.

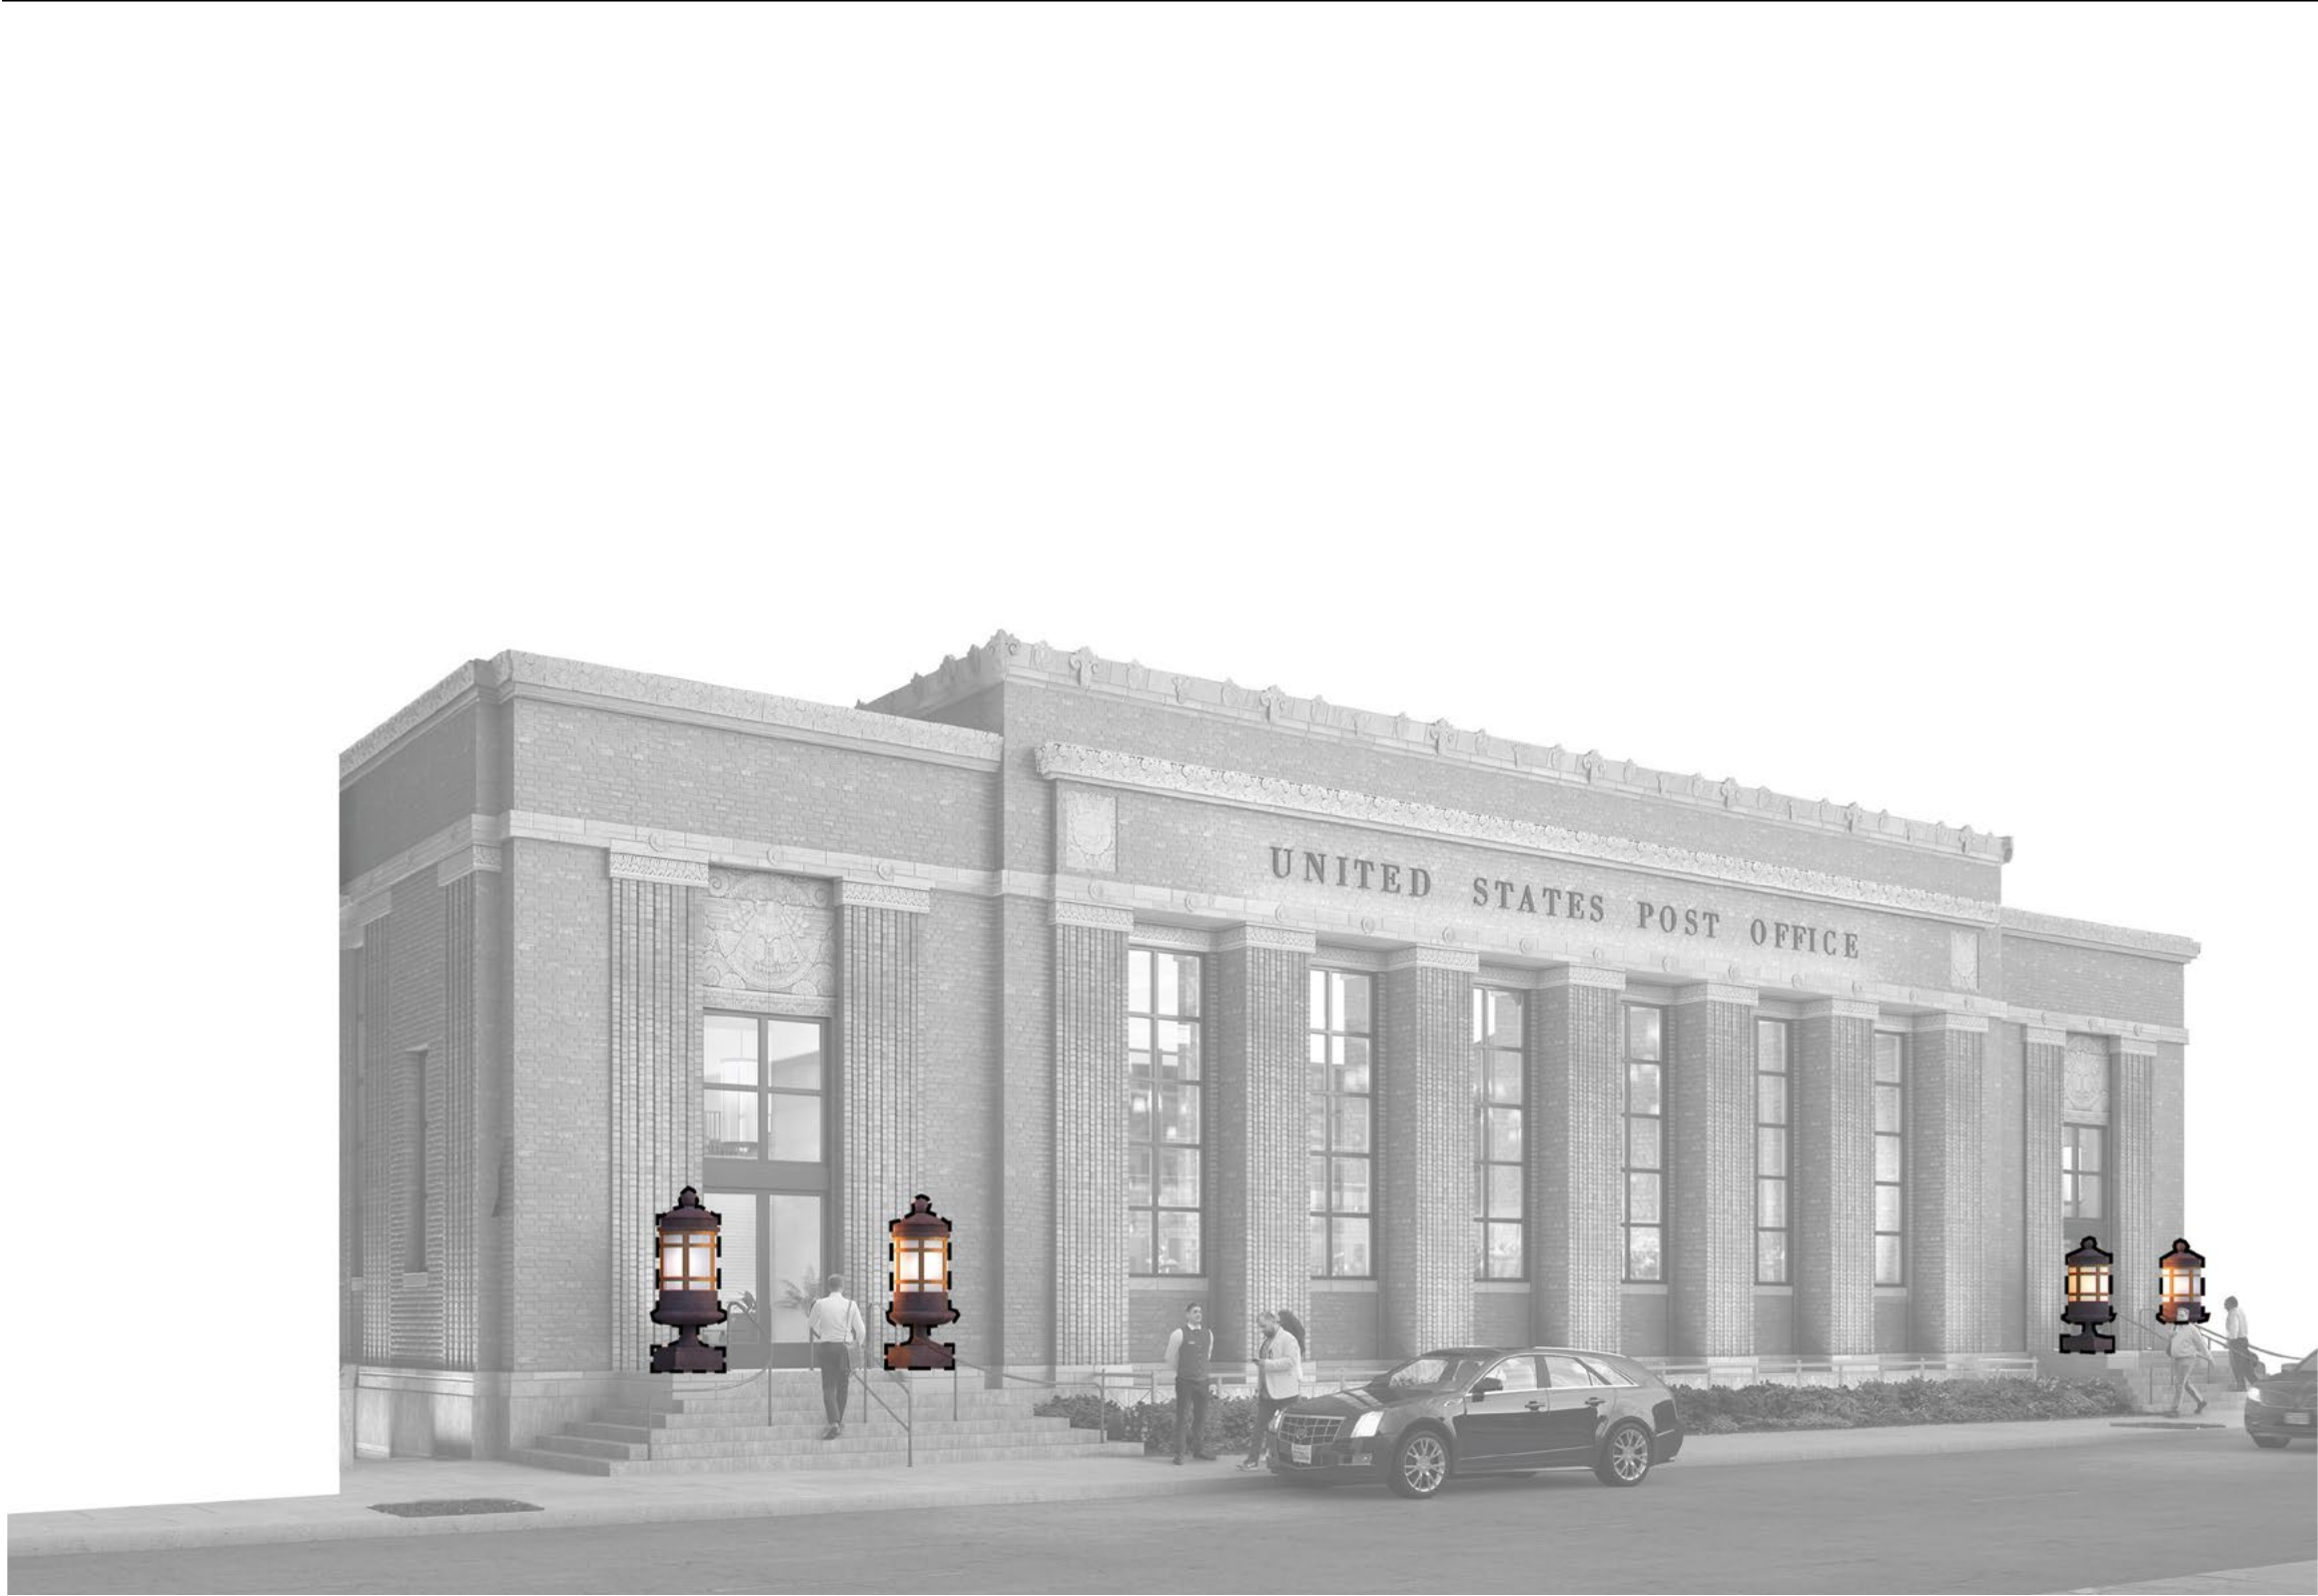
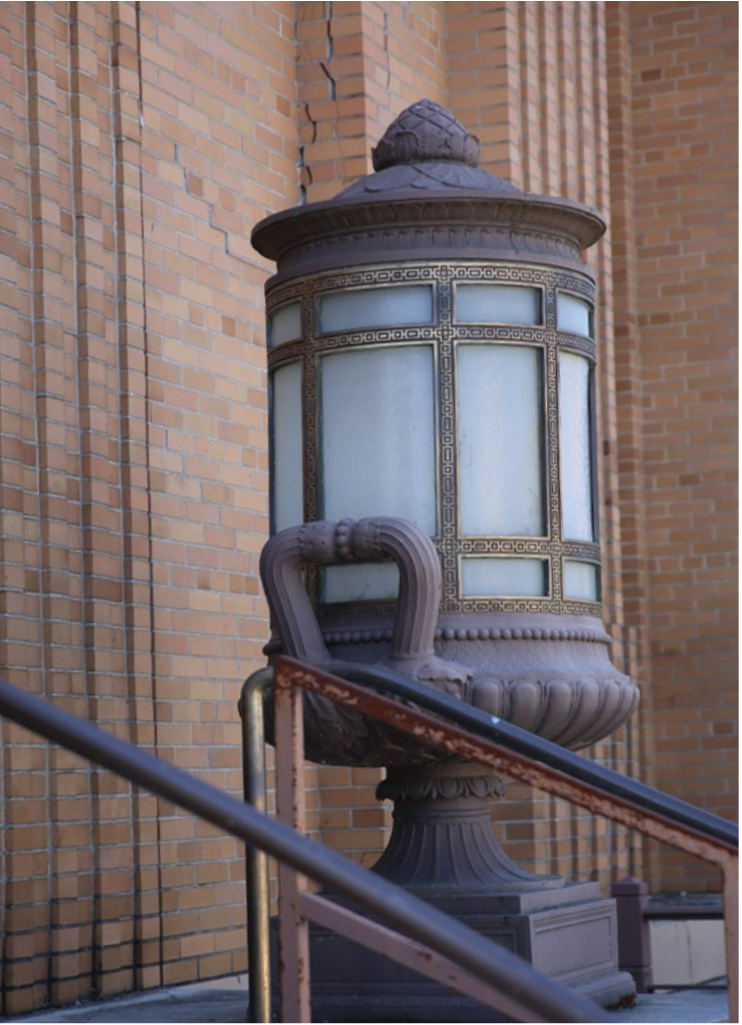
FEATURE 06

Bronze and milk glass urn-shaped light fixtures adjacent to the entryways.

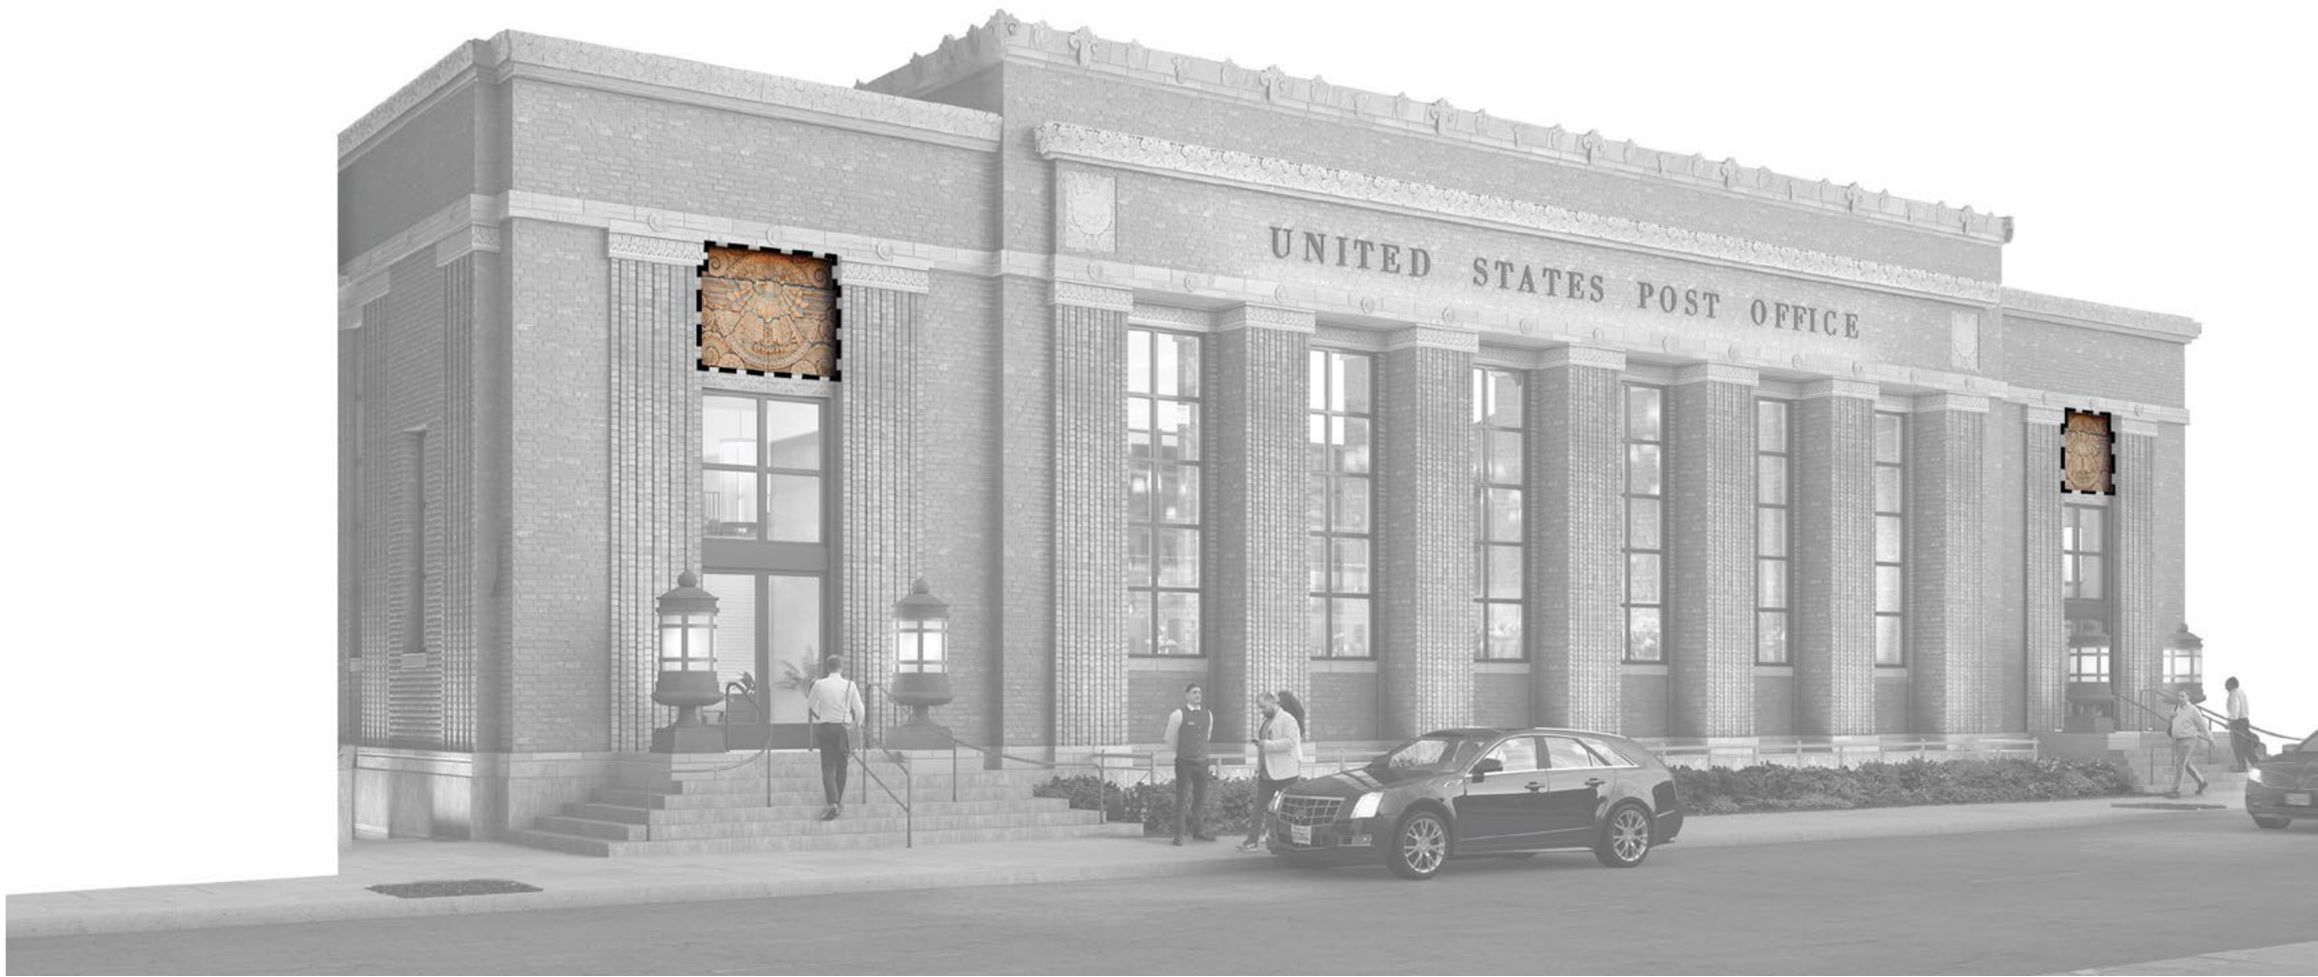
FEATURE 07

Large terracotta panel containing the Art Deco eagle above each door.

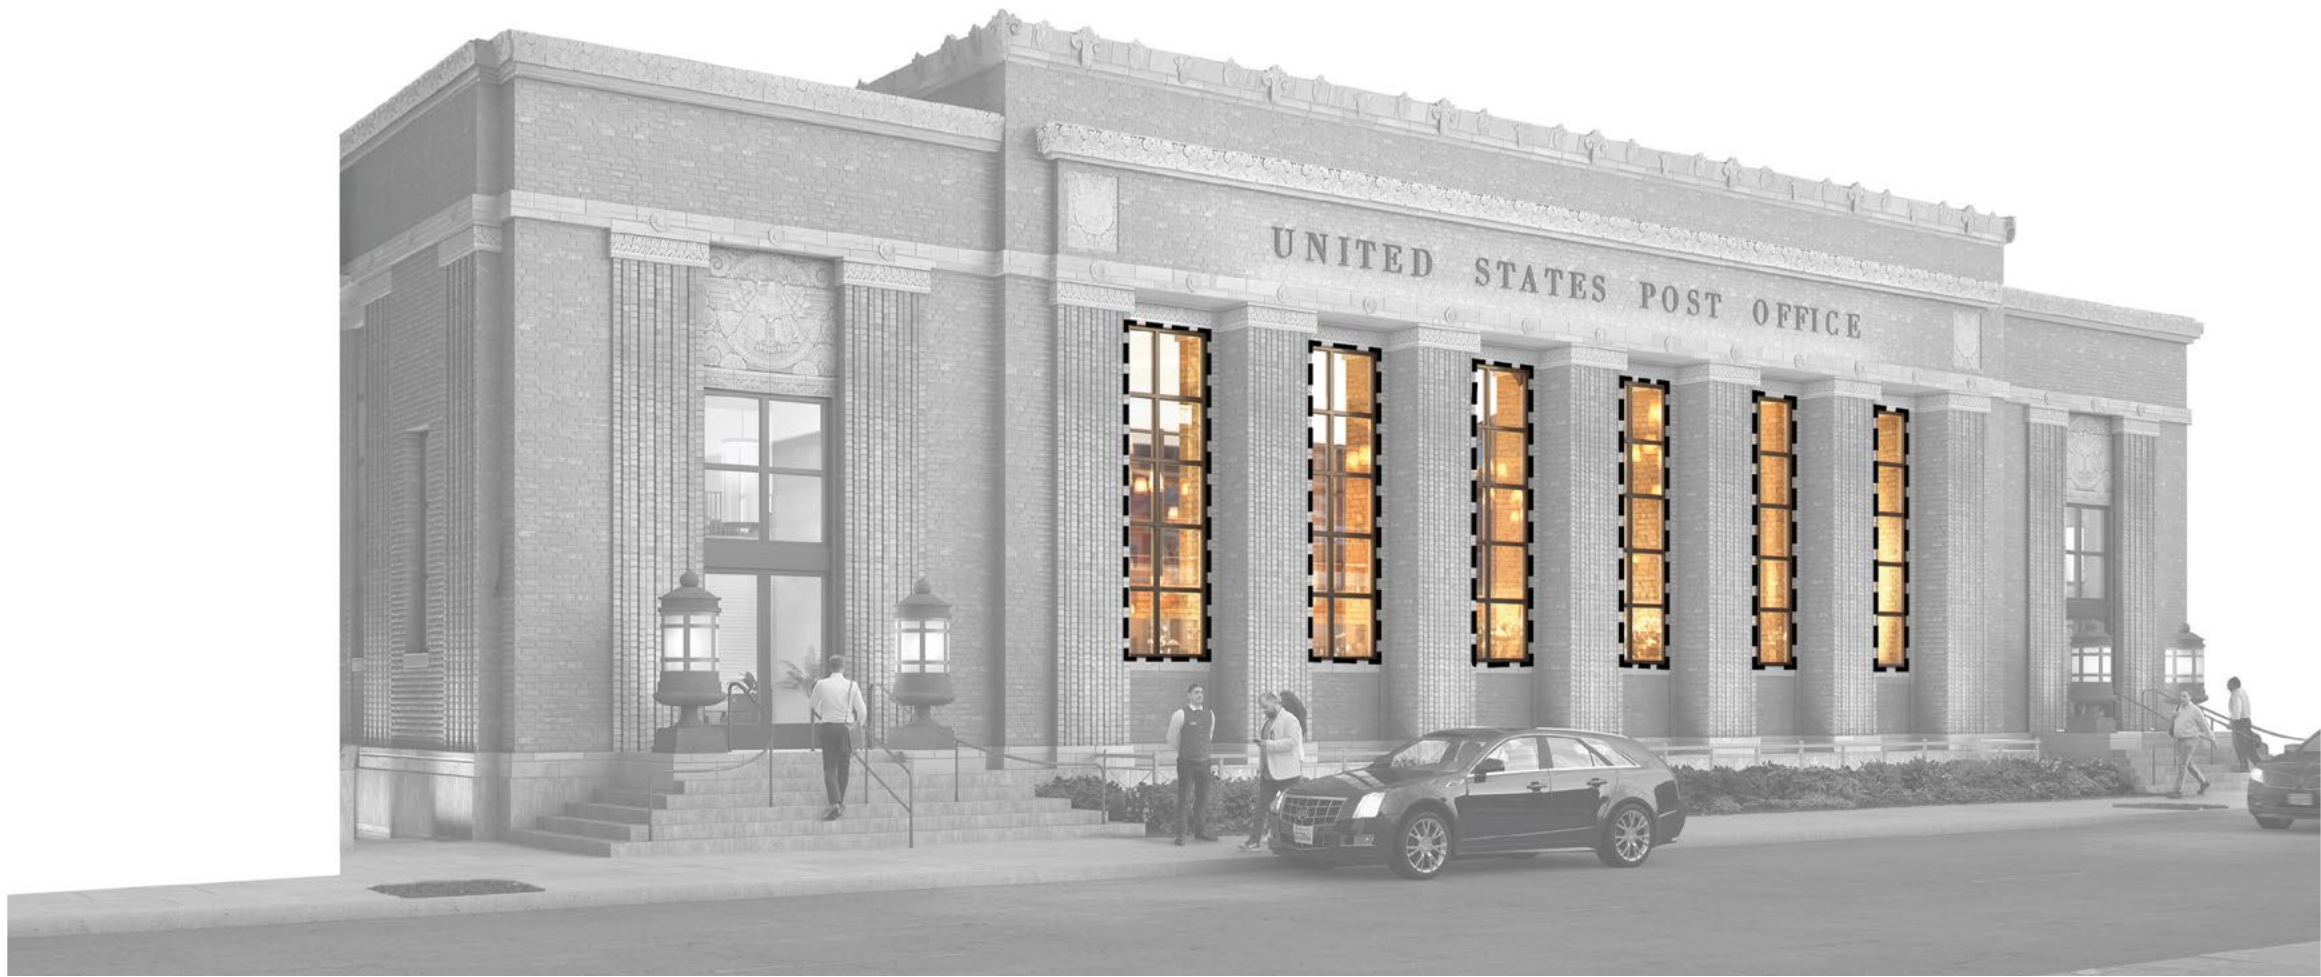
FEATURE 08

Monolithic windows on the main facade.

Windows along 2nd street will be repaired and replaced per the historic guidelines.

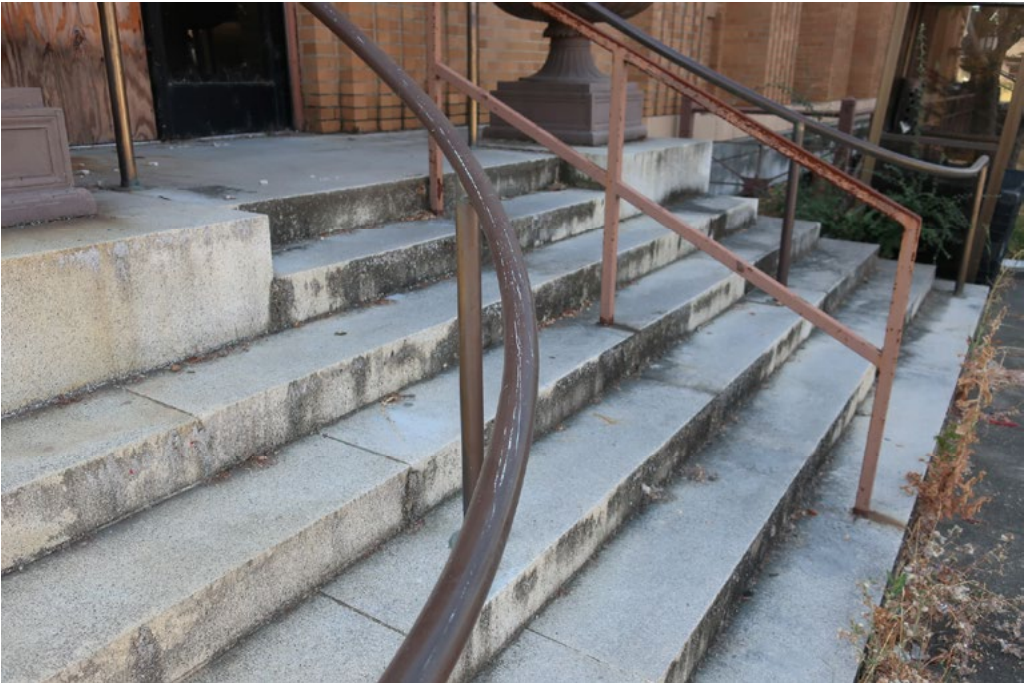
Fig.1 – Granite steps

- E1. Granite work (figs.1-4) – Sierra white granite wall base and steps, including carved cornerstone:
- a. Partial removal, salvage and reinstallation
  - b. Partial removal and in-kind replacement associated with rehab work
  - c. Overall cleaning following completion of granite rehab work
- E2. Masonry work (figs.5-10) - Roman face brick exterior walls and pilasters, smooth textured, buff colored; and Terra Cotta with smooth finish and buff color to match face brick:
- a. Partial removal, salvage and reconstruction of damaged brick and terra cotta masonry, including substrate repairs and substructural anchorage;

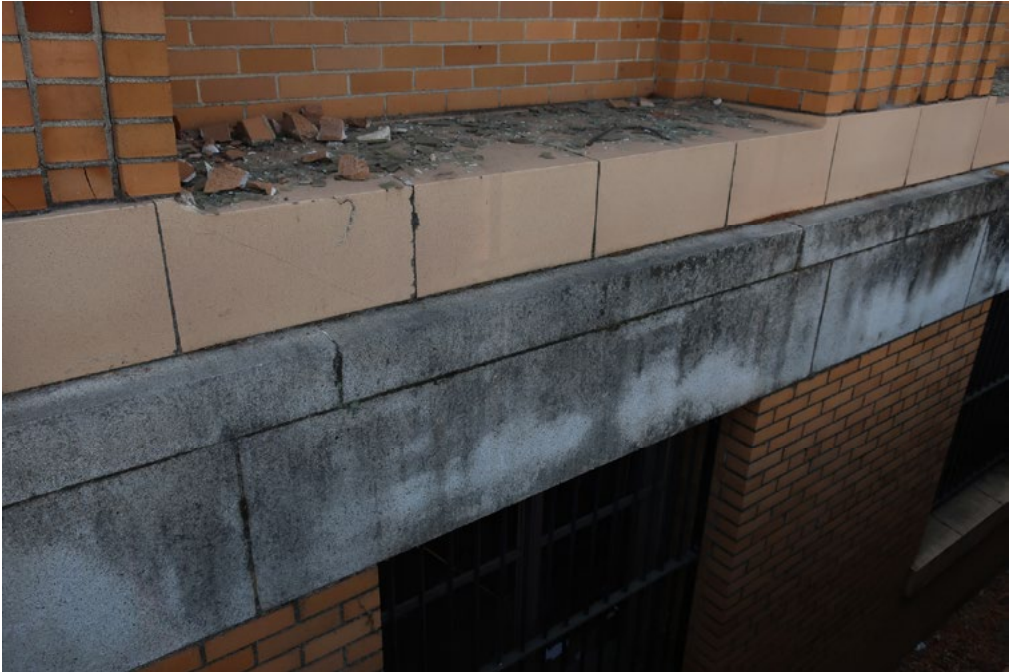
Fig.3 – Granite (and terra cotta) wall base
