## **Certificate of Appropriateness**

# FRANKLIN STATION

CERTIFICATE OF APPROPRIATENESS | AUGUST 28, 2025

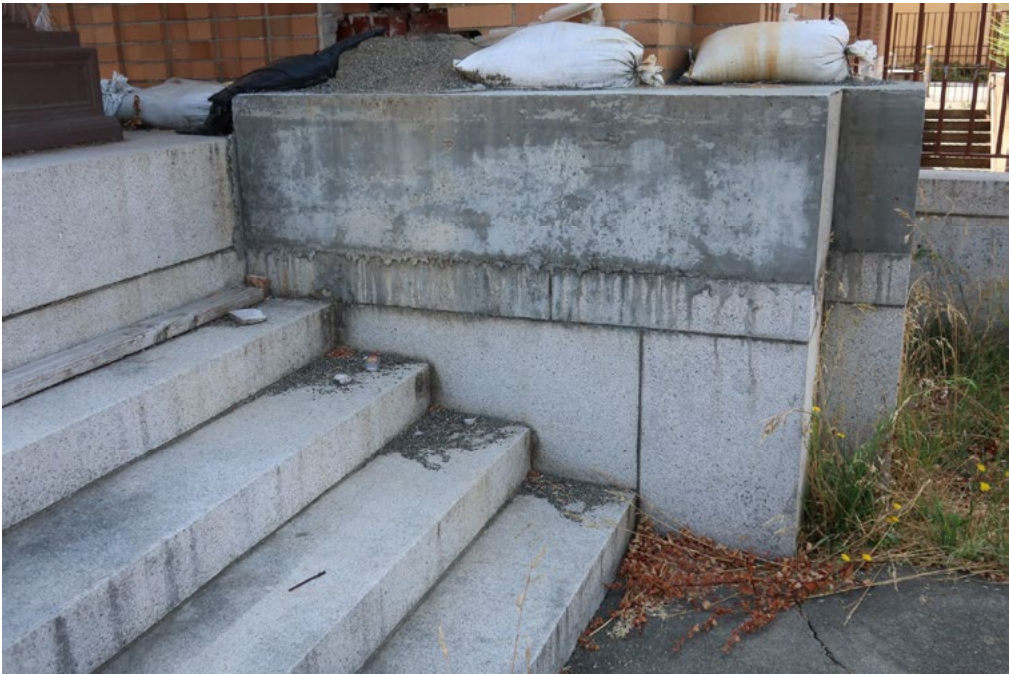
Fig.4 – Granite steps with added concrete abutment

- E1. Granite work (figs.1-4) – Sierra white granite wall base and steps, including carved cornerstone:
- a. Partial removal, salvage and reinstallation
  - b. Partial removal and in-kind replacement associated with rehab work
  - c. Overall cleaning following completion of granite rehab work
- E2. Masonry work (figs.5-10) - Roman face brick exterior walls and pilasters, smooth textured, buff colored; and Terra Cotta with smooth finish and buff color to match face brick:
- a. Partial removal, salvage and reconstruction of damaged brick and terra cotta masonry, including substrate repairs and substructural anchorage;

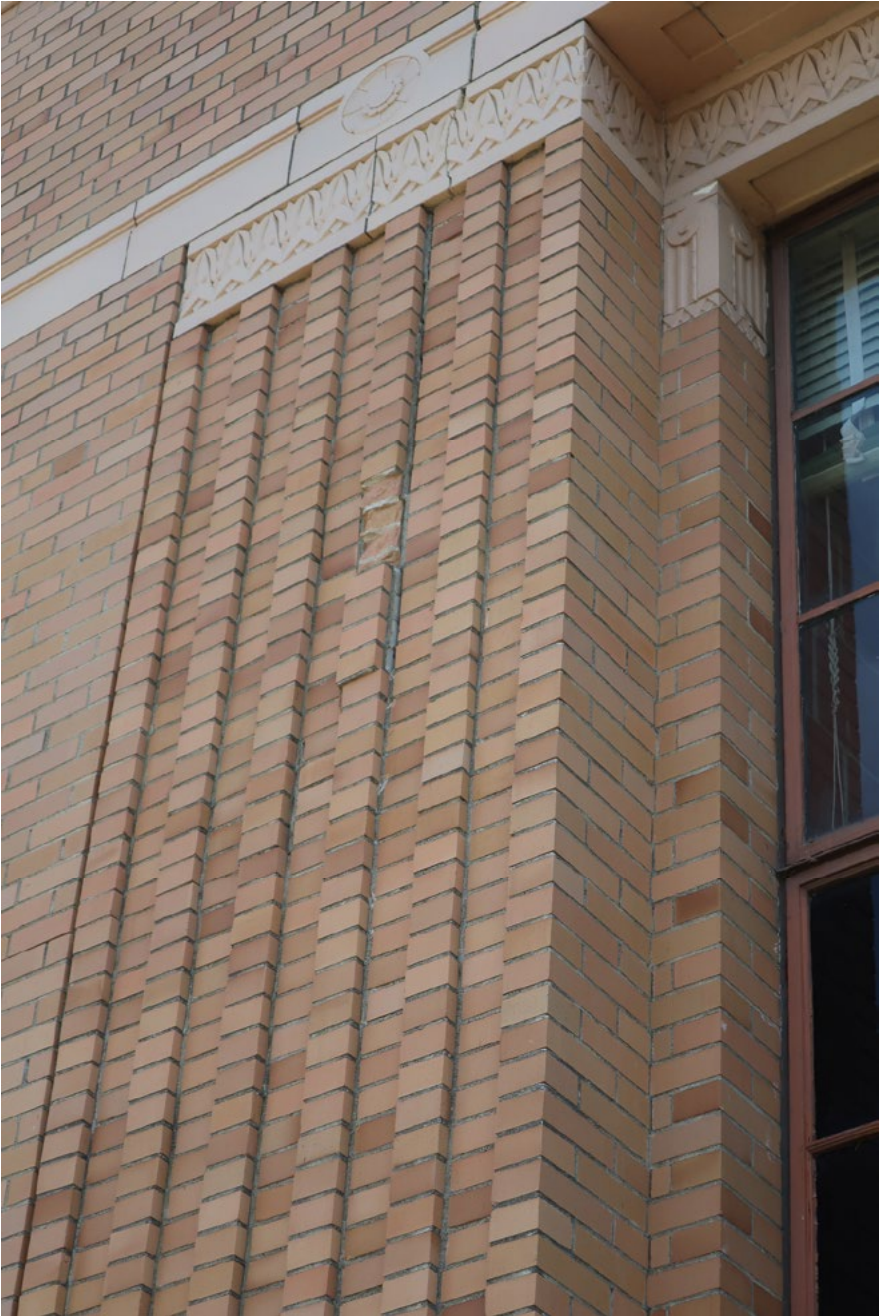
Fig.5 – Brick and terra cotta masonry

- b. Replacement materials must match existing finishes, colors, textures and sizes – preferably reuse salvaged face bricks from existing building, potentially reuse salvaged terra cotta;

- c. Patch and coat minor to moderately damaged (spalled and cracked) terra cotta units;
  - d. Repoint all reconstructed masonry and repoint all existing deteriorated masonry joints with pointing mortars to match the (cleaned) existing

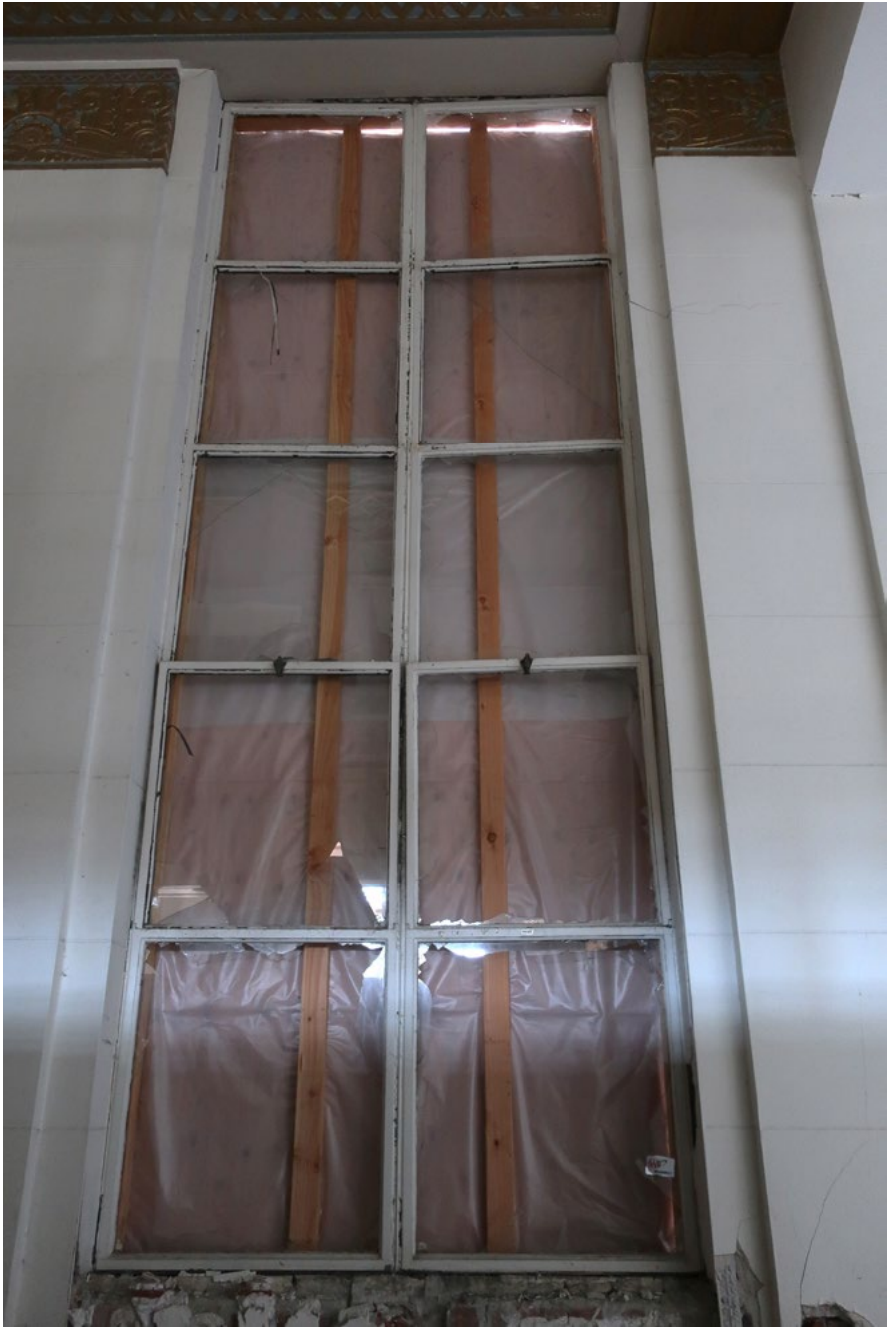
Fig.11 – Steel sash window (at interior)

- e. Following completion of reconstruction and repairs, clean masonry walls
- E3. Steel sash windows (fig.11) – painted and clear glazed:
  - a. Remove window units for shop restoration

- b. Remove glazing, strip coatings from steel, retain samples for identification of paint colors;
  - c. Repair damaged (bent, broken, missing) steel parts; replace elements to match existing where irreparable or missing;

- d. Repair operating hardware or replace to match existing where irreparable or missing;
  - e. Prime and paint (powder coat) steel sash to match original paint color;

- f. Reglaze with clear, tempered glass;
  - g. Reinstall repaired window units, including requisite setting hardware, sealants, etc.;
  - h. Install protections for duration of construction;

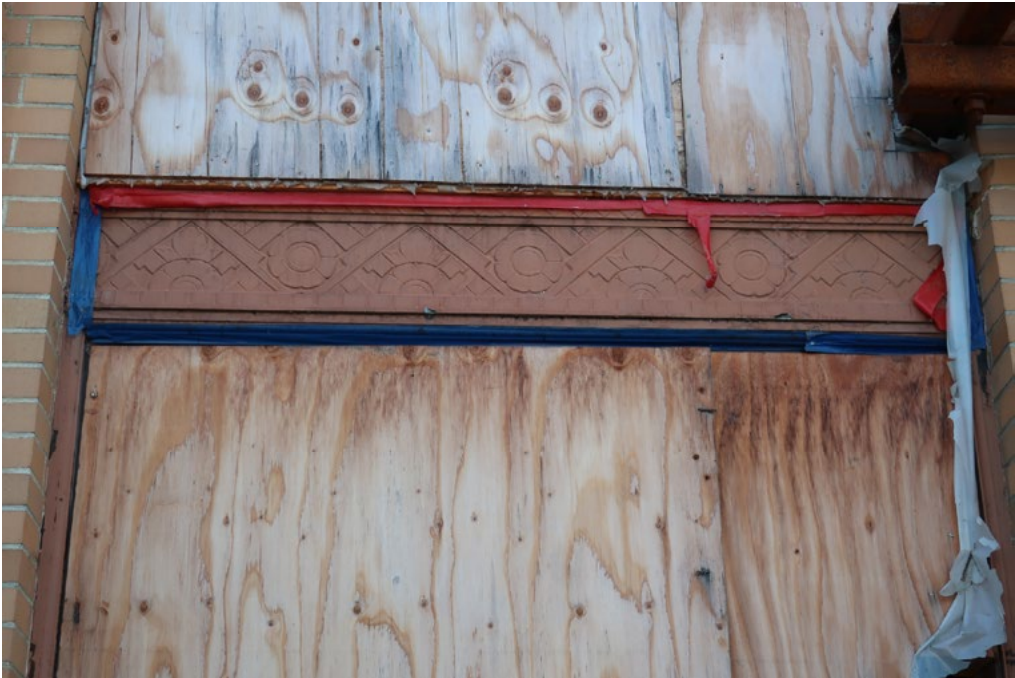
Fig.12 – Cast iron door lintel (and frame)

- a. Remove and salvage for repair, refinishing and reinstallation;
  - b. Strip coatings, retain samples for identification of paint colors;
  - c. Repair damaged (bent, broken, missing) iron parts; replace elements to match existing where irreparable or missing;

- d. Prime and repaint (powder coat) iron work to match original paint color;
  - e. Reinstall repaired and refinished cast iron elements, including requisite setting hardware, sealants, etc.

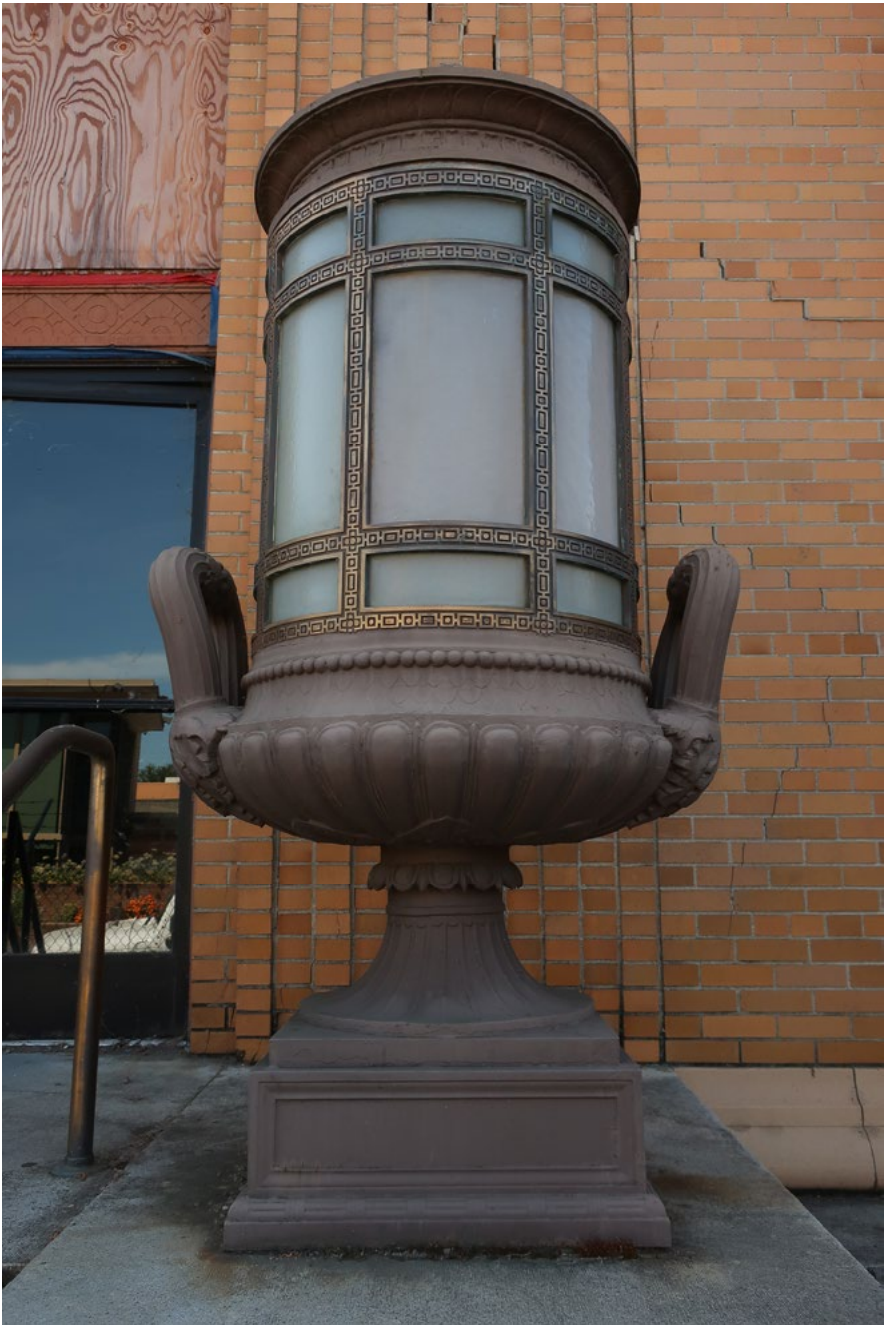
Fig.14 – Cast iron, bronze and glass lantern

- a. Remove and salvage for repair, refinishing and reinstallation;
  - b. Remove and salvage glass;
  - c. Strip coatings from iron, retain samples for identification of paint colors;

- d. Repair damaged (bent, broken, missing) parts; replace elements to match existing where irreparable or missing;
  - e. Rewire and relamp fixtures;

- f. Prime and repaint (powder coat) iron work to match original paint color;
  - g. Clean and seal bronze elements;
  - h. Clean and reinstall glass; replace to match where irreparable or missing;

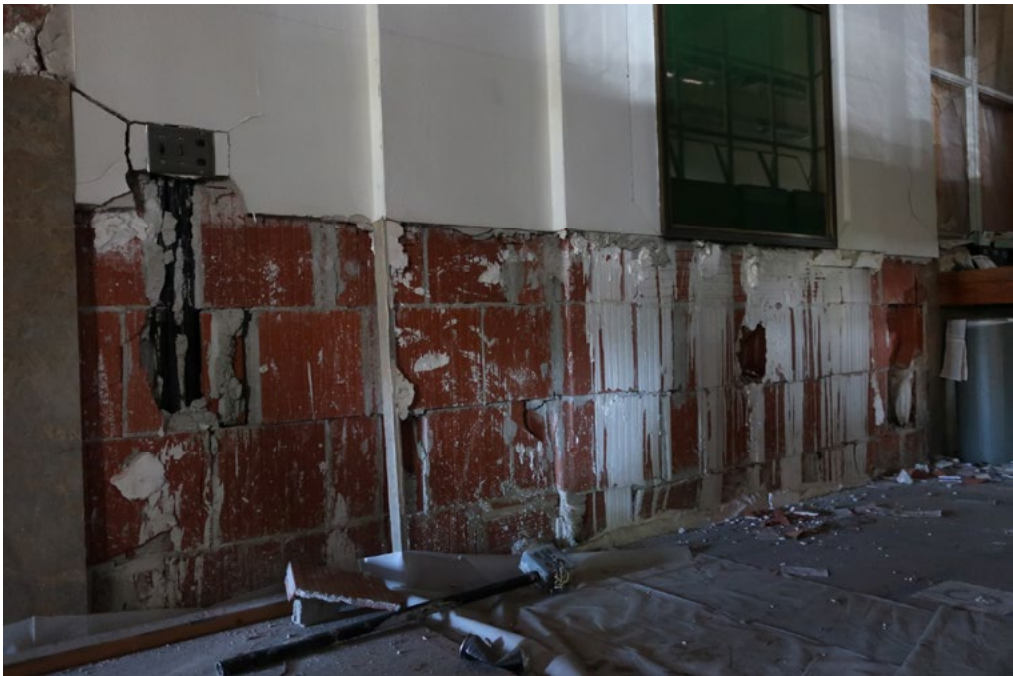
Fig.19 – Marble wainscoting

- a. Retain and protect marble flooring;
  - b. Remove and replace damaged and irreparable flooring material with new to match existing;
  - c. Remove and salvage marble wainscoting and door surrounds for repair, refinishing and reinstallation;

- d. Clean retained and salvaged marble with restoration cleaners;
  - e. Repair damaged (breaks, cracks, holes and spalls) marble with stone dutchmen, crack and hole repair mortars to match clean marble;

- f. Replace irreparable and missing marble with new to match cleaned existing;
  - g. Reinstall marble wainscoting and door surrounds, including required anchorage hardware, setting and pointing mortars, grouts and sealants.

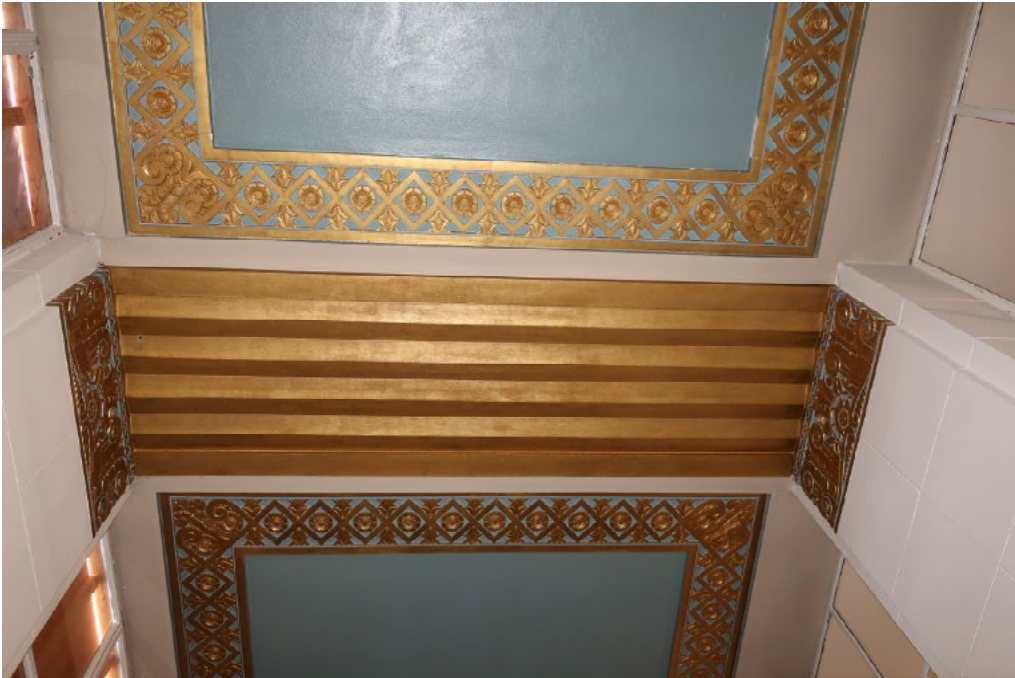
Fig.21 – Plaster ceilings

- a. Retain and protect in place or selectively remove and salvage for repair, strengthening and reinstallation (based on structural investigations);

- b. Investigate, repair and strengthen ceiling support structure;
  - c. Repair damaged and replace irreparable and missing plaster with new plaster to match cleaned existing surfaces and profiles;

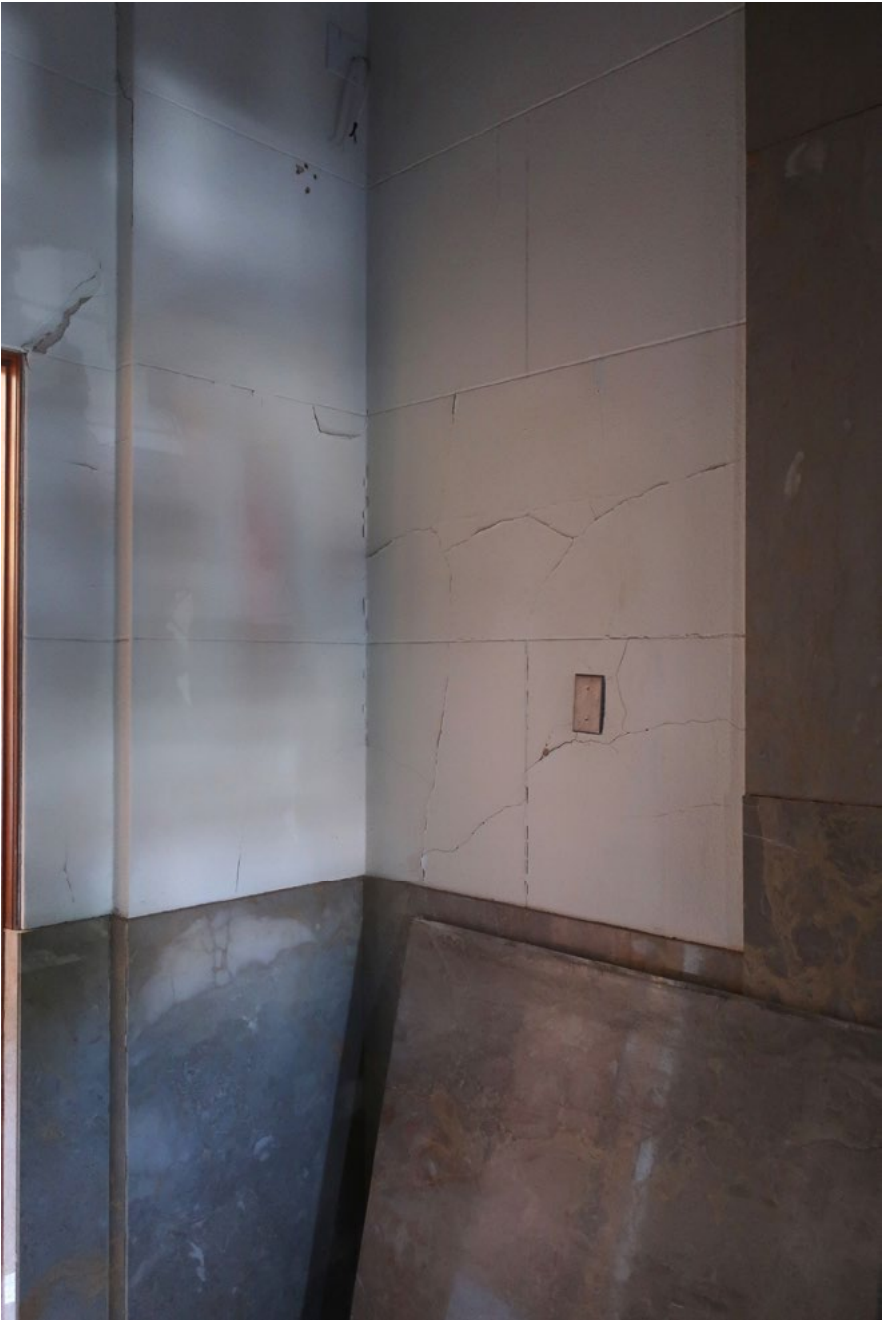
Fig.23 – Plaster walls

- a. Retain and protect in place and selectively remove where irreparably damaged;
  - b. Remove, salvage cast ornamental lintels, panels and plaques;

- c. Repair damaged and replace irreparable and missing plaster with new plaster to match cleaned existing surfaces and profiles;
  - d. Reinstall removed and repaired/replaced ornamental lintels and panels, including anchorage hardware and setting mortars;

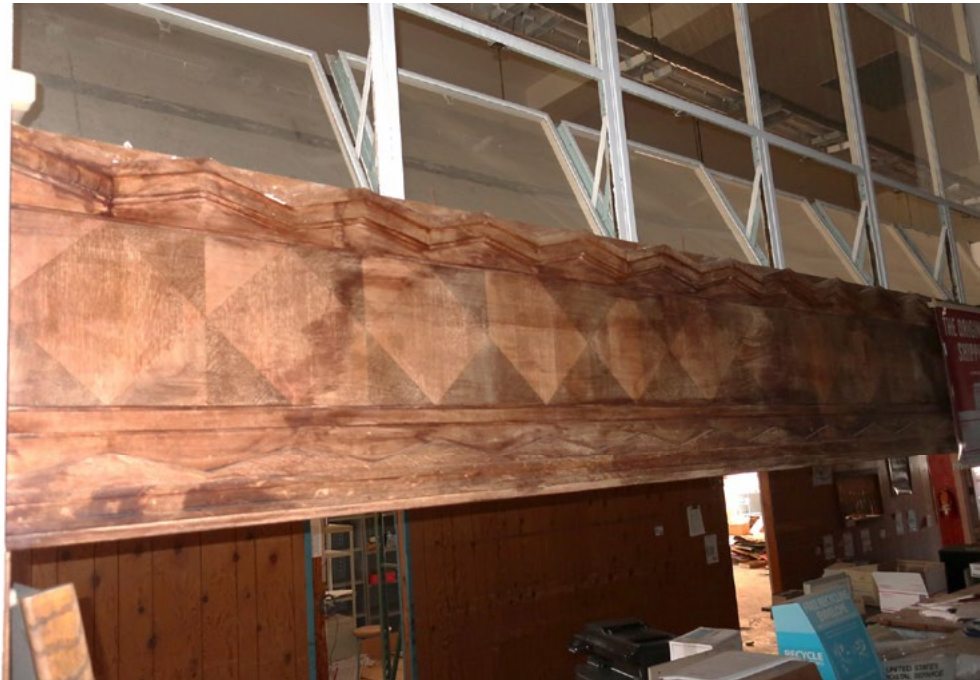
Fig.27 – Wood lintels

- I.5. Wood lintels (fig.27) – Carved (at service counters):
  - a. Retain in place or remove and salvage for reinstallation;
  - b. Repair damaged wood (voids, holes, cracks) with wood Dutchman and fillers to match the existing wood;

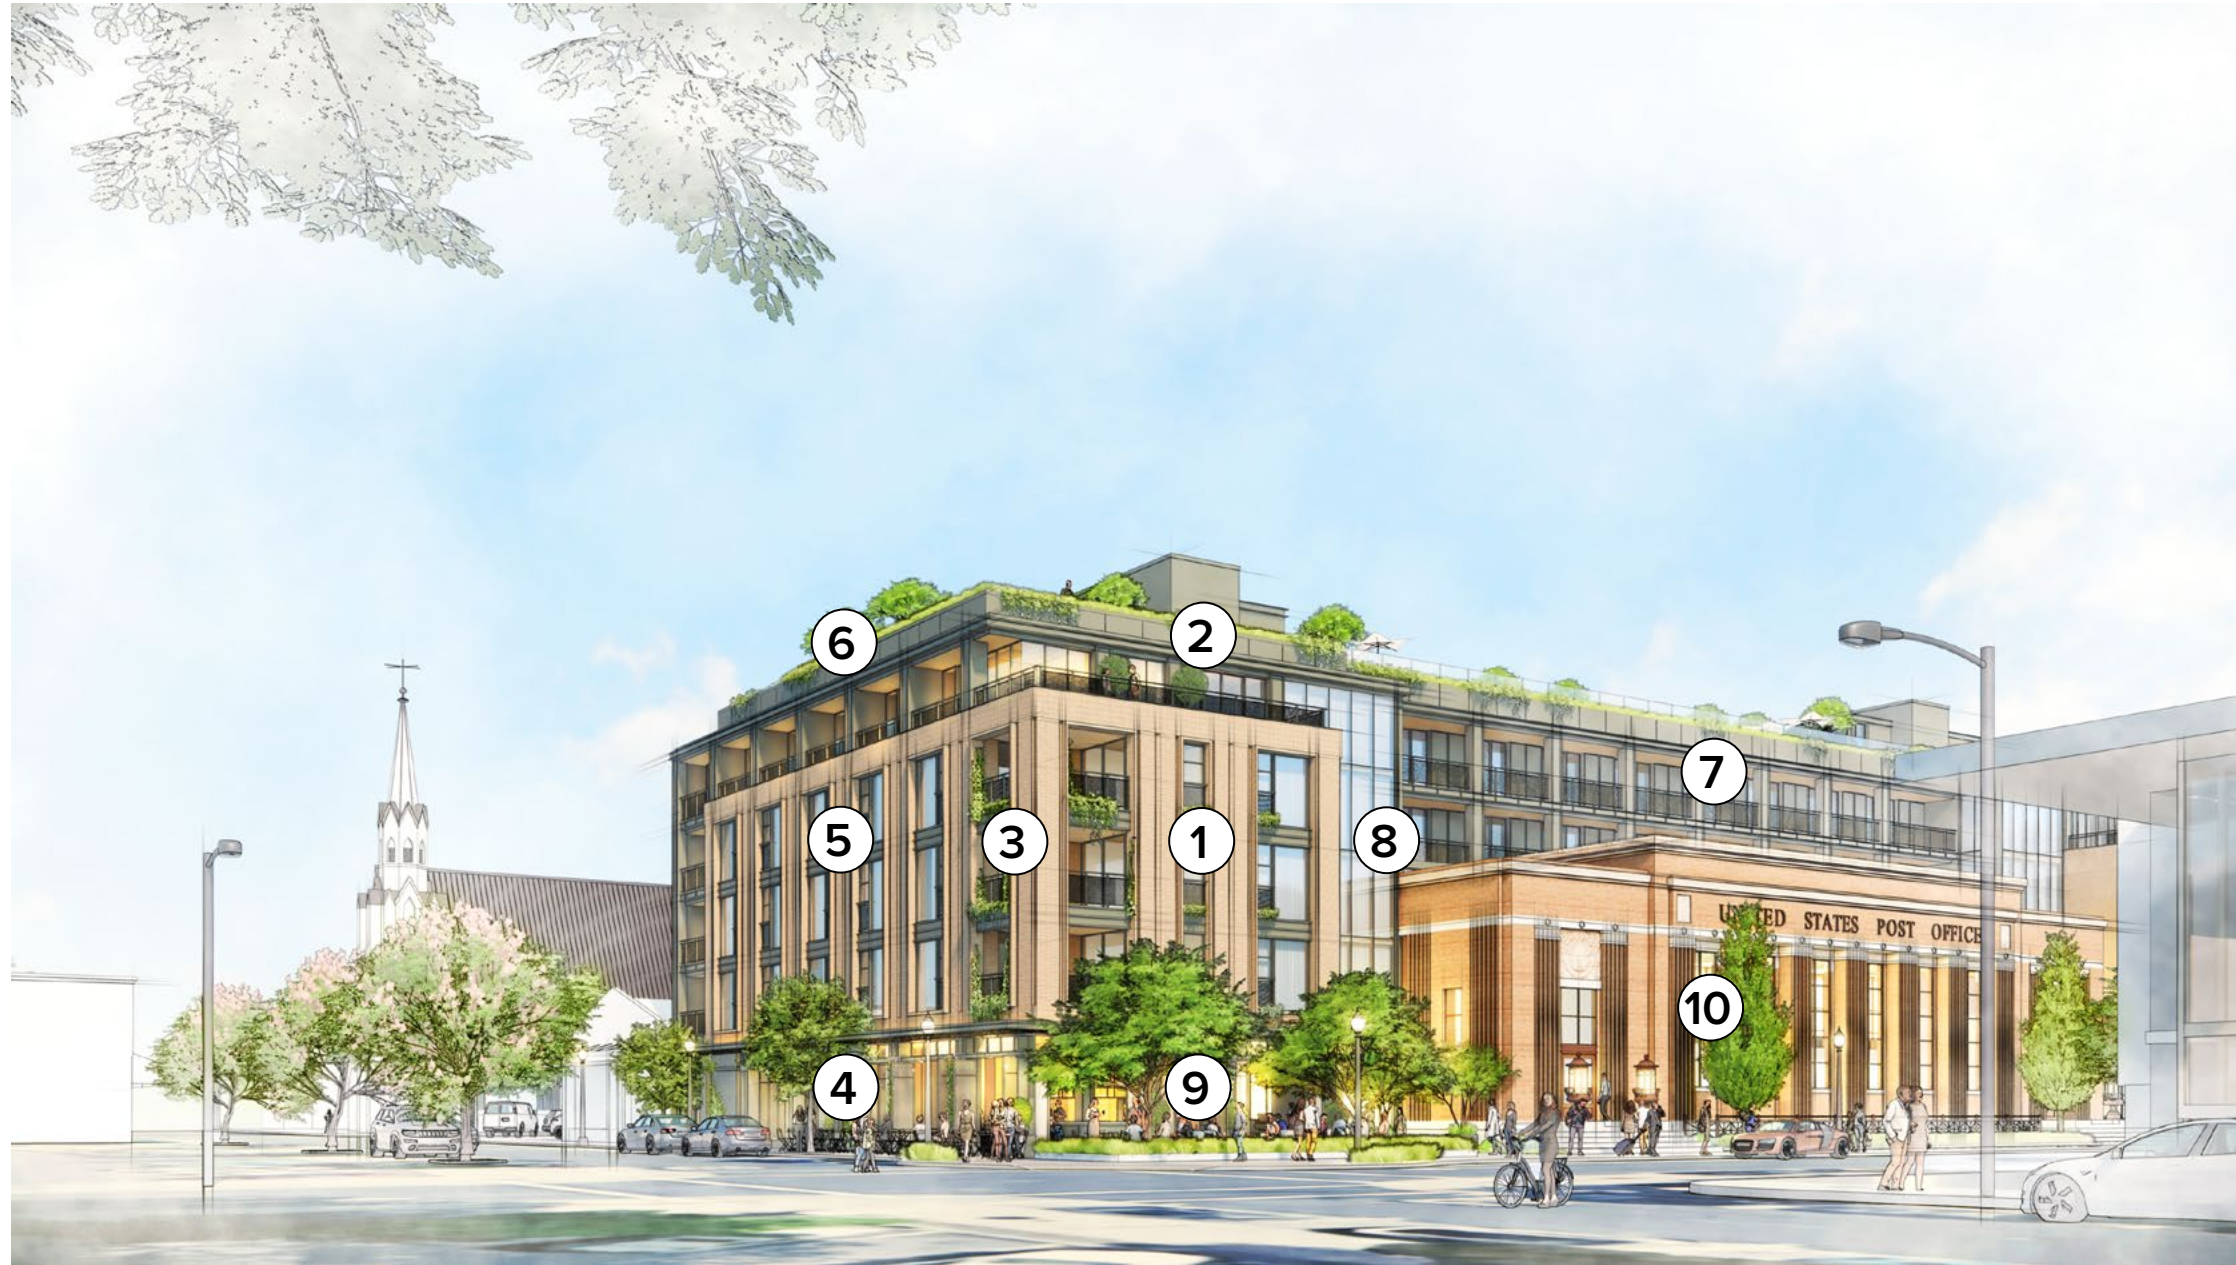
## REVERENCE AND RESPECT FOR THE HISTORIC POST OFFICE : 10 STRATEGIES

- 1 MASSING: PULL FACE BACK SO POST OFFICE SITS PROUD OF BUILDING
- 2 MASSING: STEP TOP STORIES BACK TO REDUCE AP- PARENT MASS OF BUILDING
- 3 MASSING: SYMMETRICAL 'DUMBBELL' SCHEME CEN- TERED ON POST OFFICE
- 4 MASSING: 'LIFT' BUILDING OFF GROUND TO EMPHA- SIZE MASS/'GROUNDED' P.O.
- 5 MATERIALITY: UTILIZE BRICK AS PRIMARY BUILDING MATERIAL, FLANKING P.O.
- 6 MATERIALITY: UTILIZE BRONZE METAL, RECALLING TRIM AND DETAILING ON P.O.
- 7 MATERIALITY: DARK BUILDING DIRECTLY BEHIND P.O. TO RECEDE FROM VIEW
- 8 DETAILING: POST OFFICE FACADE SET INTO SIMPLE GLAZED WALLS ON EITHER SIDE
- 9 LANDSCAPE: INVITING PUBLIC PLAZA AT CORNER OF 2ND AND RANDOLPH
- 10 FRONT DOOR: EXPERIENCE ENTERING HOTEL IS THRU P.O. 'ARRIVAL GALLERY'
