MEMORANDUM

Subject: Certificate of Appropriateness, The Crescent, 2344 Old Sonoma Road

CERTIFICATE OF APPROPRIATENESS
DEC 15, 2022

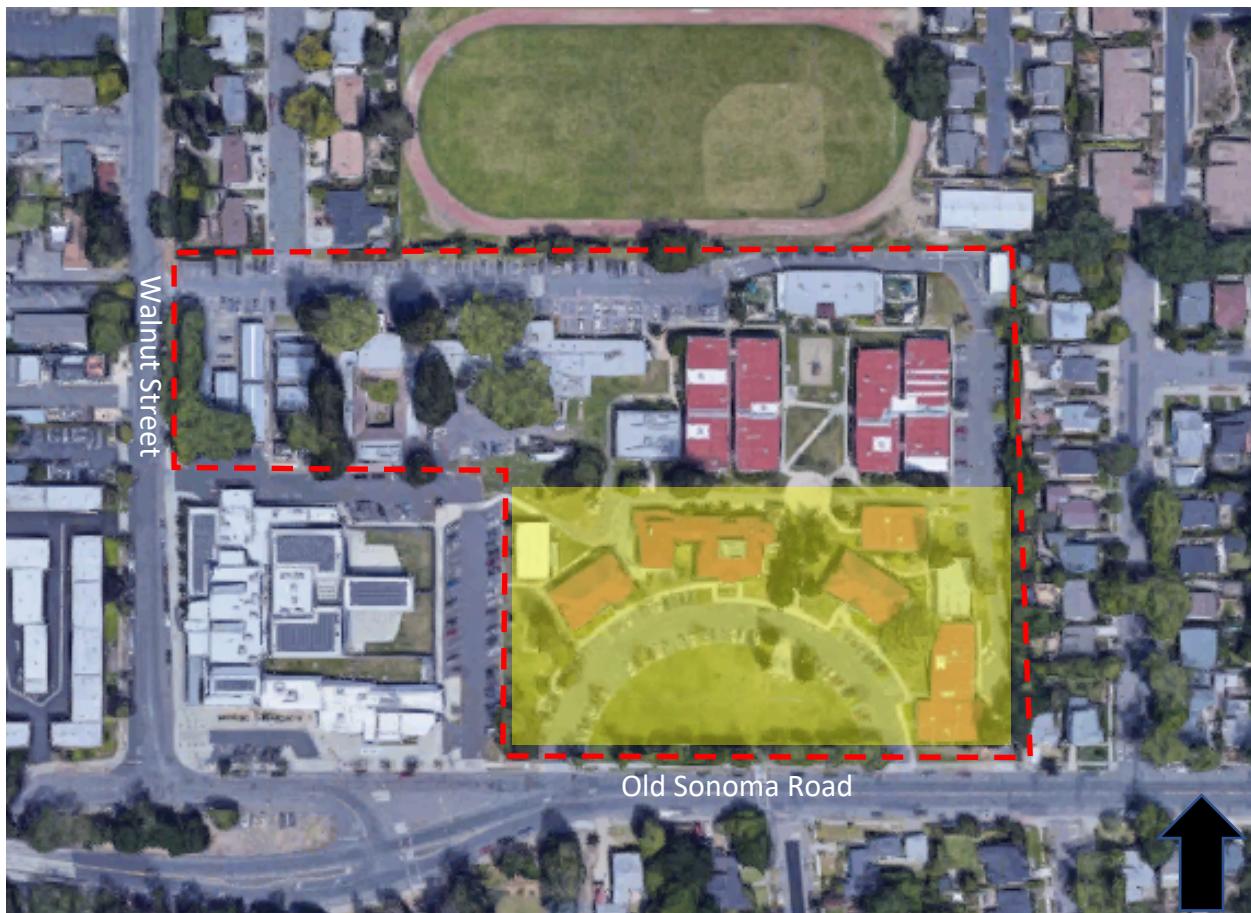
Figure 2: Location of Project Site dashed in red and National Register District boundary highlighted in yellow (Google Earth, 2022)

The southeastern portion of the Project Site contains the remaining buildings of the Napa County Infirmary and was listed in the National Register of Historic Places (National Register) on June 4, 2018 (see **Figures 2 and 3**). Properties listed in the National Register are automatically included in the California Register of Historical Resources (California Register) and defined as mandatory historical resources by the California Environmental Quality Act (CEQA). Changes to the property are regulated by Municipal Code Section 15.52, which states the alteration, demolition, or relocation of any listed historical resource requires a Certificate of Appropriateness. The findings required for the approval of a Certificate of Appropriateness include compliance with the Secretary of the Interior's Standards (Standards). This memorandum was prepared for the Certificate of Appropriateness application for The Crescent Project proposed by the Napa Community Real Estate Fund, LP (Applicant).

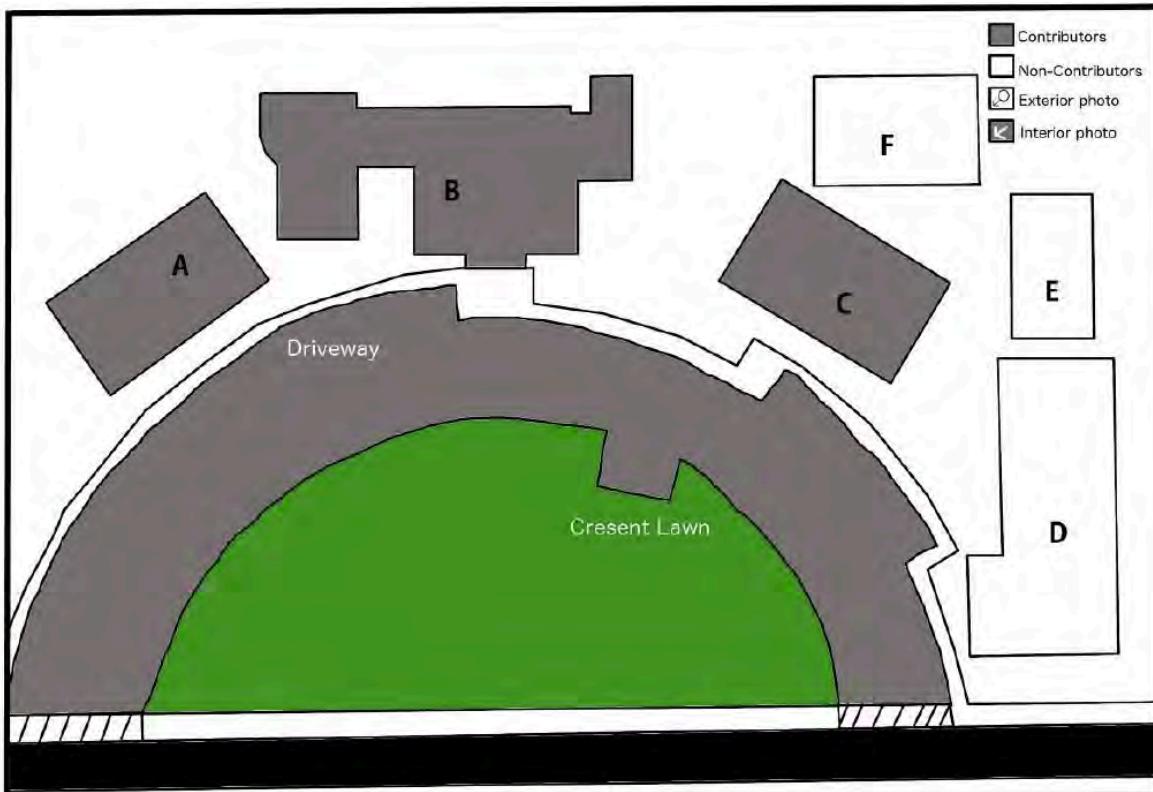
*Figure 3: Boundary map from National Register Form (2017)*

The property was listed in the National Register in 2018 as a district under Criterion A and Criterion C. The district boundary is generally rectangular in shape and includes the 1897/1934 hospital/infirmiry building (Building B) as well as the 1912 men's and women's dormitory buildings (Buildings A and C), which are oriented around the crescent shaped driveway and lawn. In addition to these three contributing buildings and one contributing feature, the district includes three non-contributing buildings (Buildings D, E, and F) that were added in the 2000s. The northern portion of the property was not included in the district boundary. It historically included farmland and ancillary buildings that supported the operation of the County Infirmary; however, it was redeveloped by the Health and Human Services Agency from the 1950s through the 2000s and does not retain historic character.

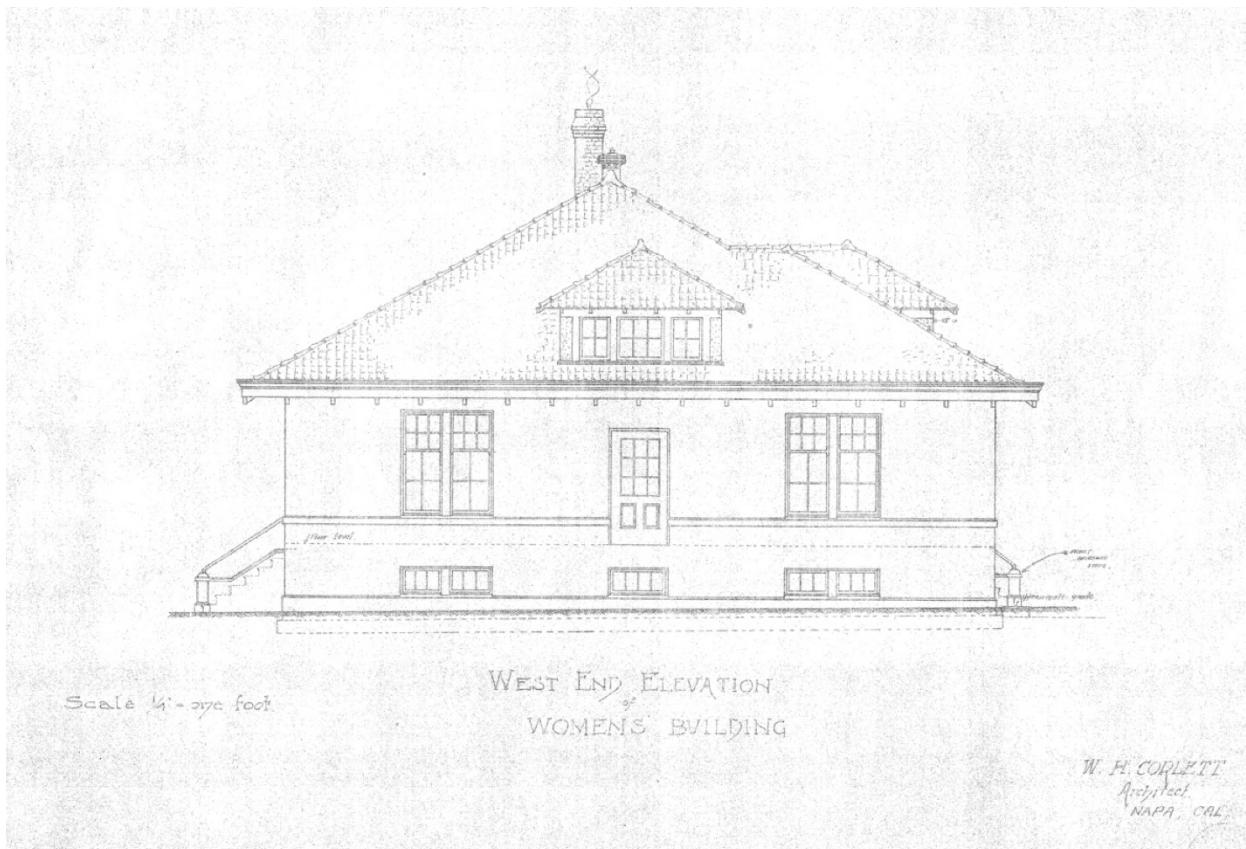
Figure 8: Building C, West Elevation William H. Corlett, 1912.

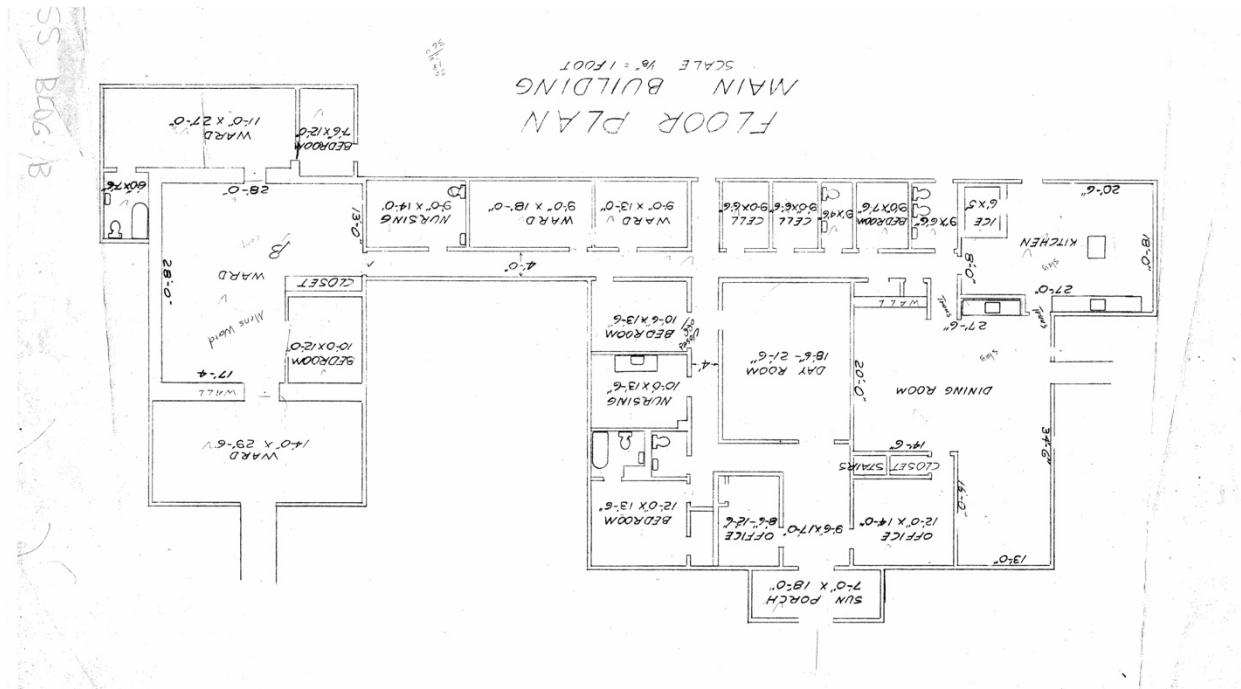
Figure 10: Building B Floor Plan, C.L. Hunt, 1934.

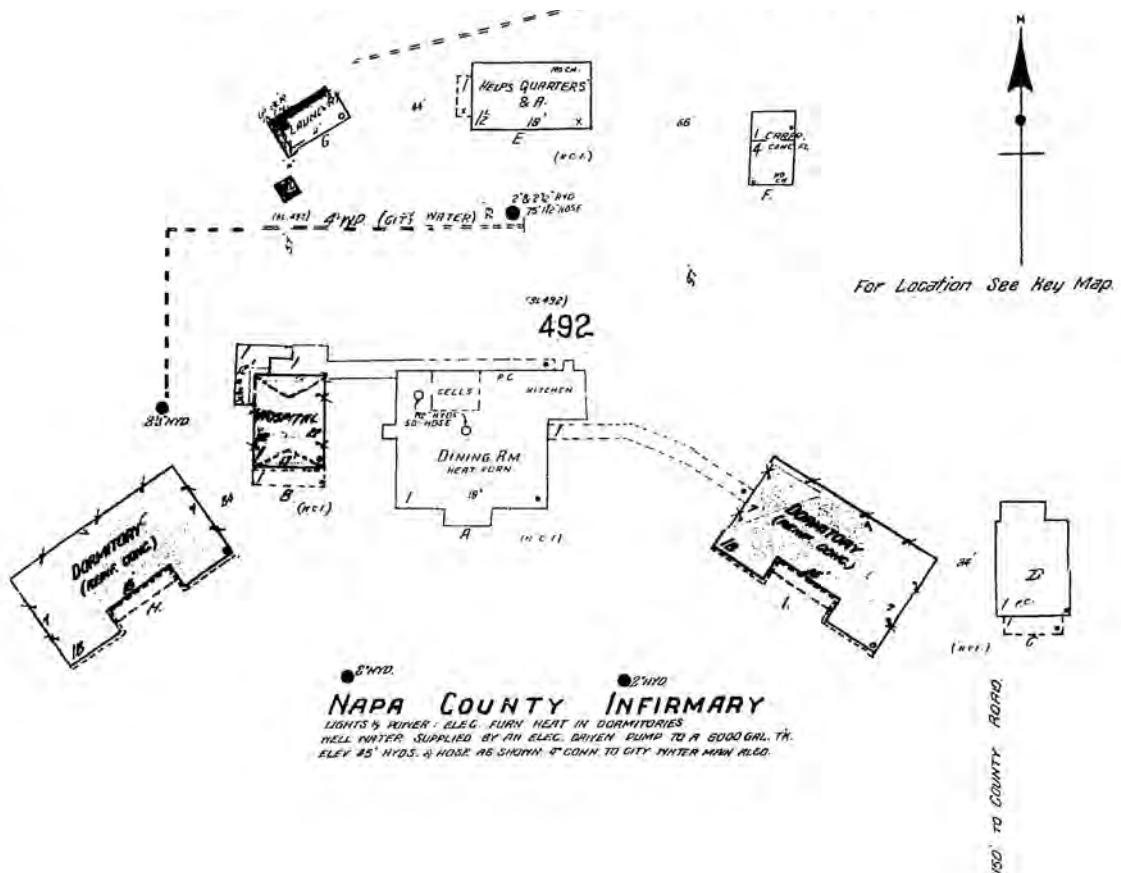
Figure 13: Sanborn Map, Sheet 3, 1949.

Year	Event
	superintendent's cottage is relocated to the east of Building C. The water tower on the north is gone. There are three new ancillary buildings around the hay barn on the north including a laundry (see Figure 9).
1934	The County receives funds from the Civil Works Administration to remodel the two-story center building (Building B) to match Buildings A and C. The 1897 stone hospital building is retained but altered. The front (south) porch is removed and replaced with a 14'0" x 29' x 6" enclosed addition (see Figure 10). The 1869 infirmary building is demolished and replaced with a new building. A colonnade is constructed between Buildings B and C. In addition, the front (south) porches of Buildings B and C are altered (see Figure 11). It appears that some of the 1934 improvements are based upon undated drawings by architect C.L. Hunt (see Figure 12).
1949	The Sanborn Map documents the stone building is preserved, but the remainder is demolished and replaced (Building B). The ancillary buildings include the superintendent's cottage on the east and the three buildings on the north (see Figure 13). The hay barn is now labeled "Helps Quarters."

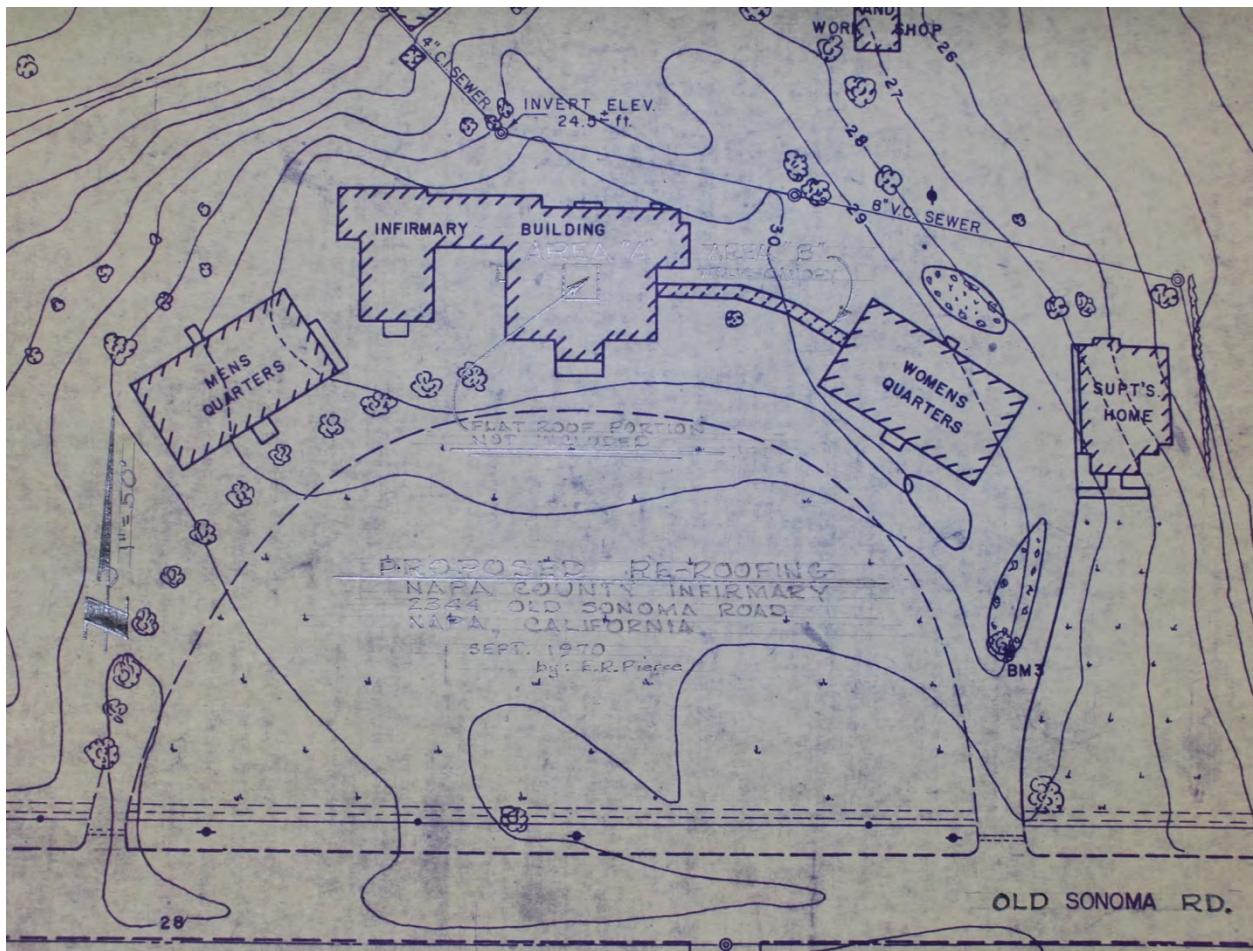
Figure 14: Re-roofing plan, E.R. Pierce, 1970.

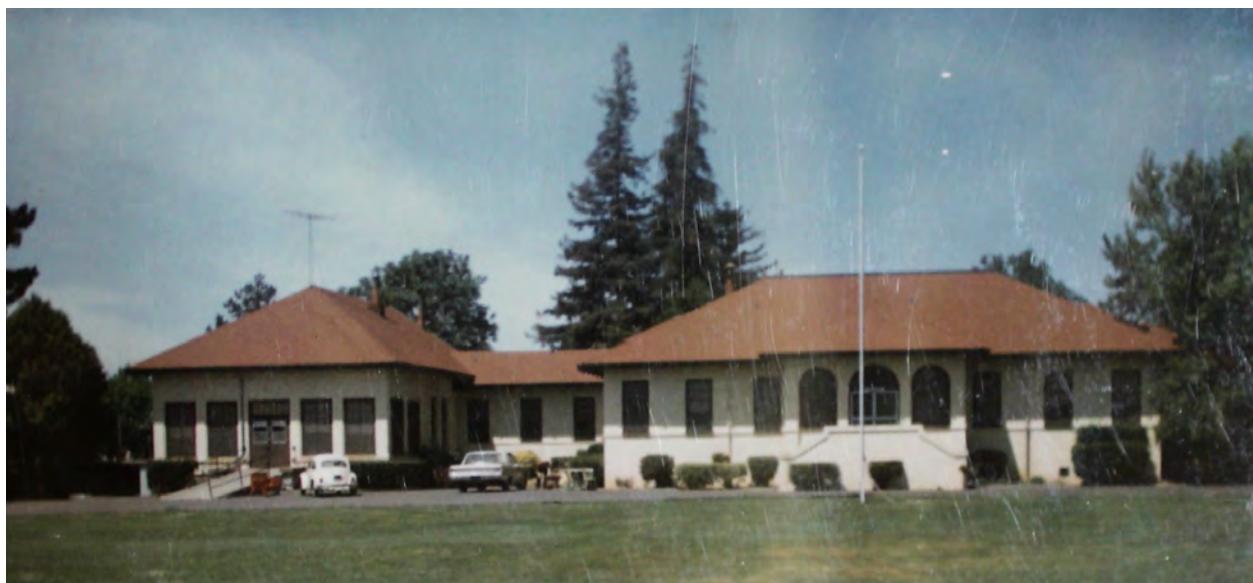
Figure 15: Building B, South Façade, 1973.

1953	The Napa County Social Welfare Department constructs a new building at 2261 Elm Street.
1962	The institution becomes a licensed nursing facility for the elderly. The building interiors are altered to accommodate non-ambulatory patients.
1970	The proposed re-roofing plan indicates clay roof tiles will be replaced with asphalt shingles (see Figure 14).
1973	The institution closes as convalescent home because the buildings no longer meet State code. The County converts the property into an alcohol and mental health services facility and the name changes to Napa County Health and Human Services. Building A becomes a dining room and a crisis center; Building B becomes administrative offices, a conference room, and activity room; and Building C becomes overnight accommodations for male and female patients. Historic photographs show the front porches of Buildings A, B, and C have been enclosed by this time, but original windows remain (see Figures 15 to 16).

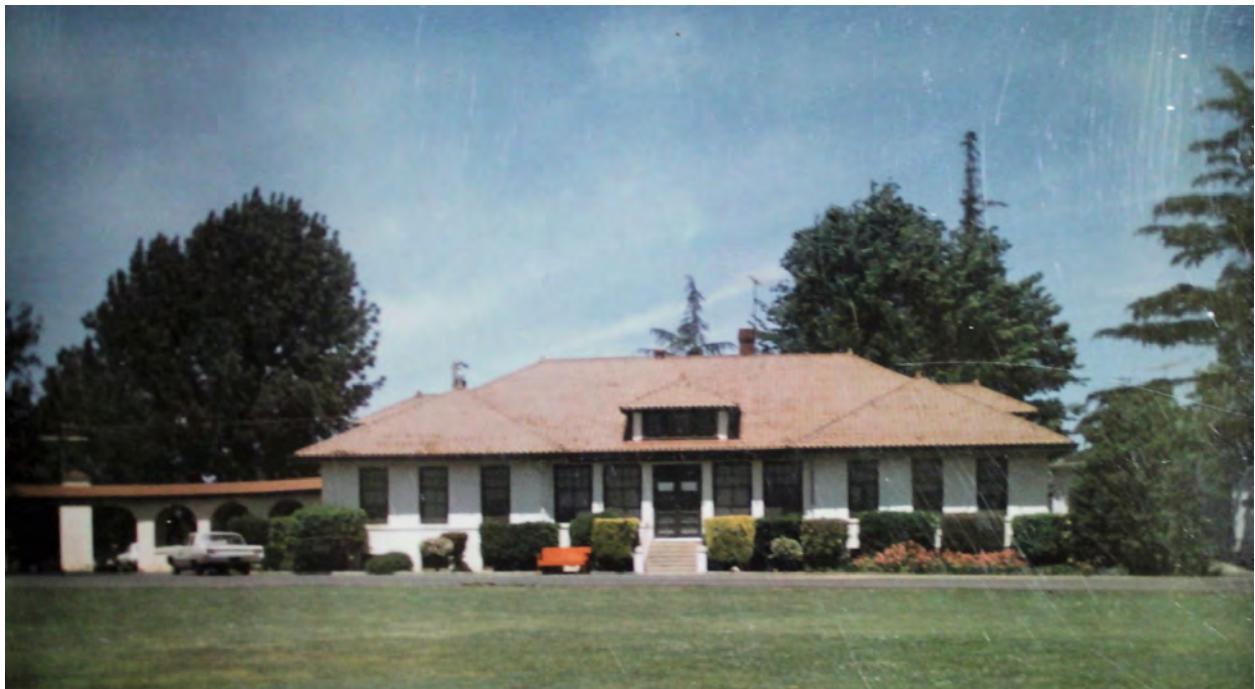
Figure 16: Building C, South Façade, 1973.

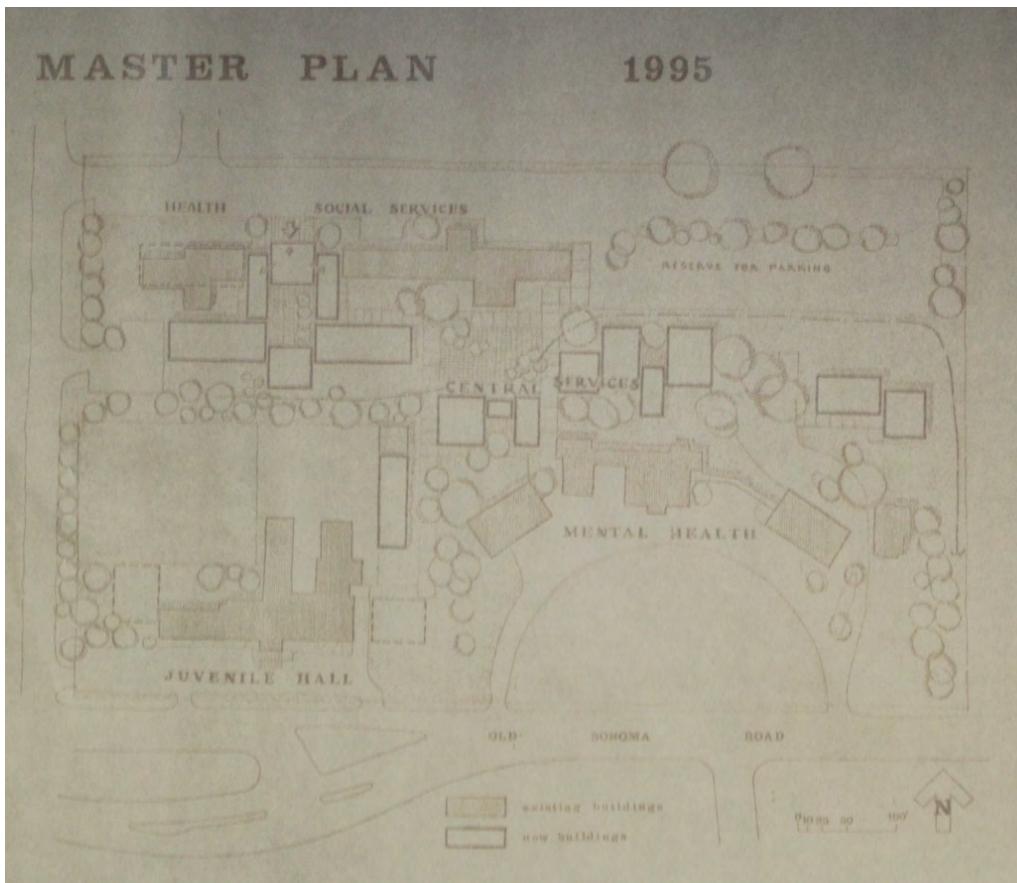
Figure 17: Master Plan, 1995.

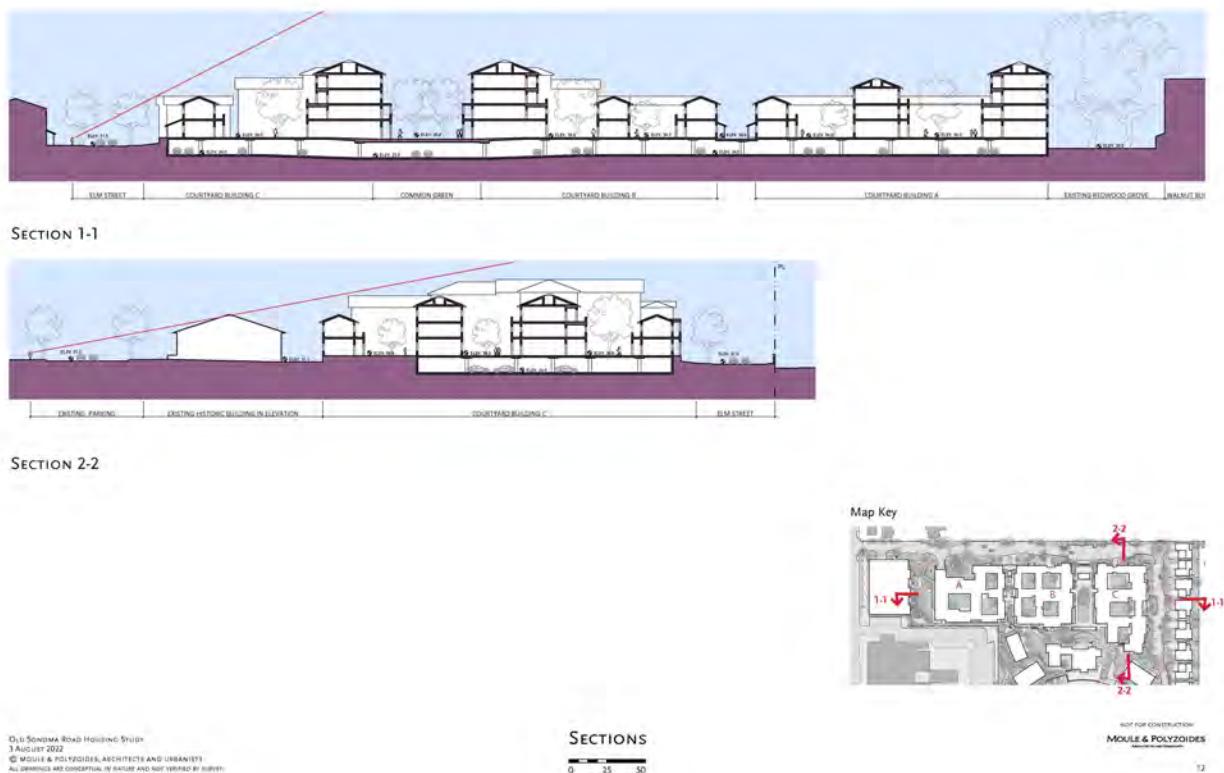
Figure 19: Sight Line Studies, Moule & Polyzoides Architects, 2022.

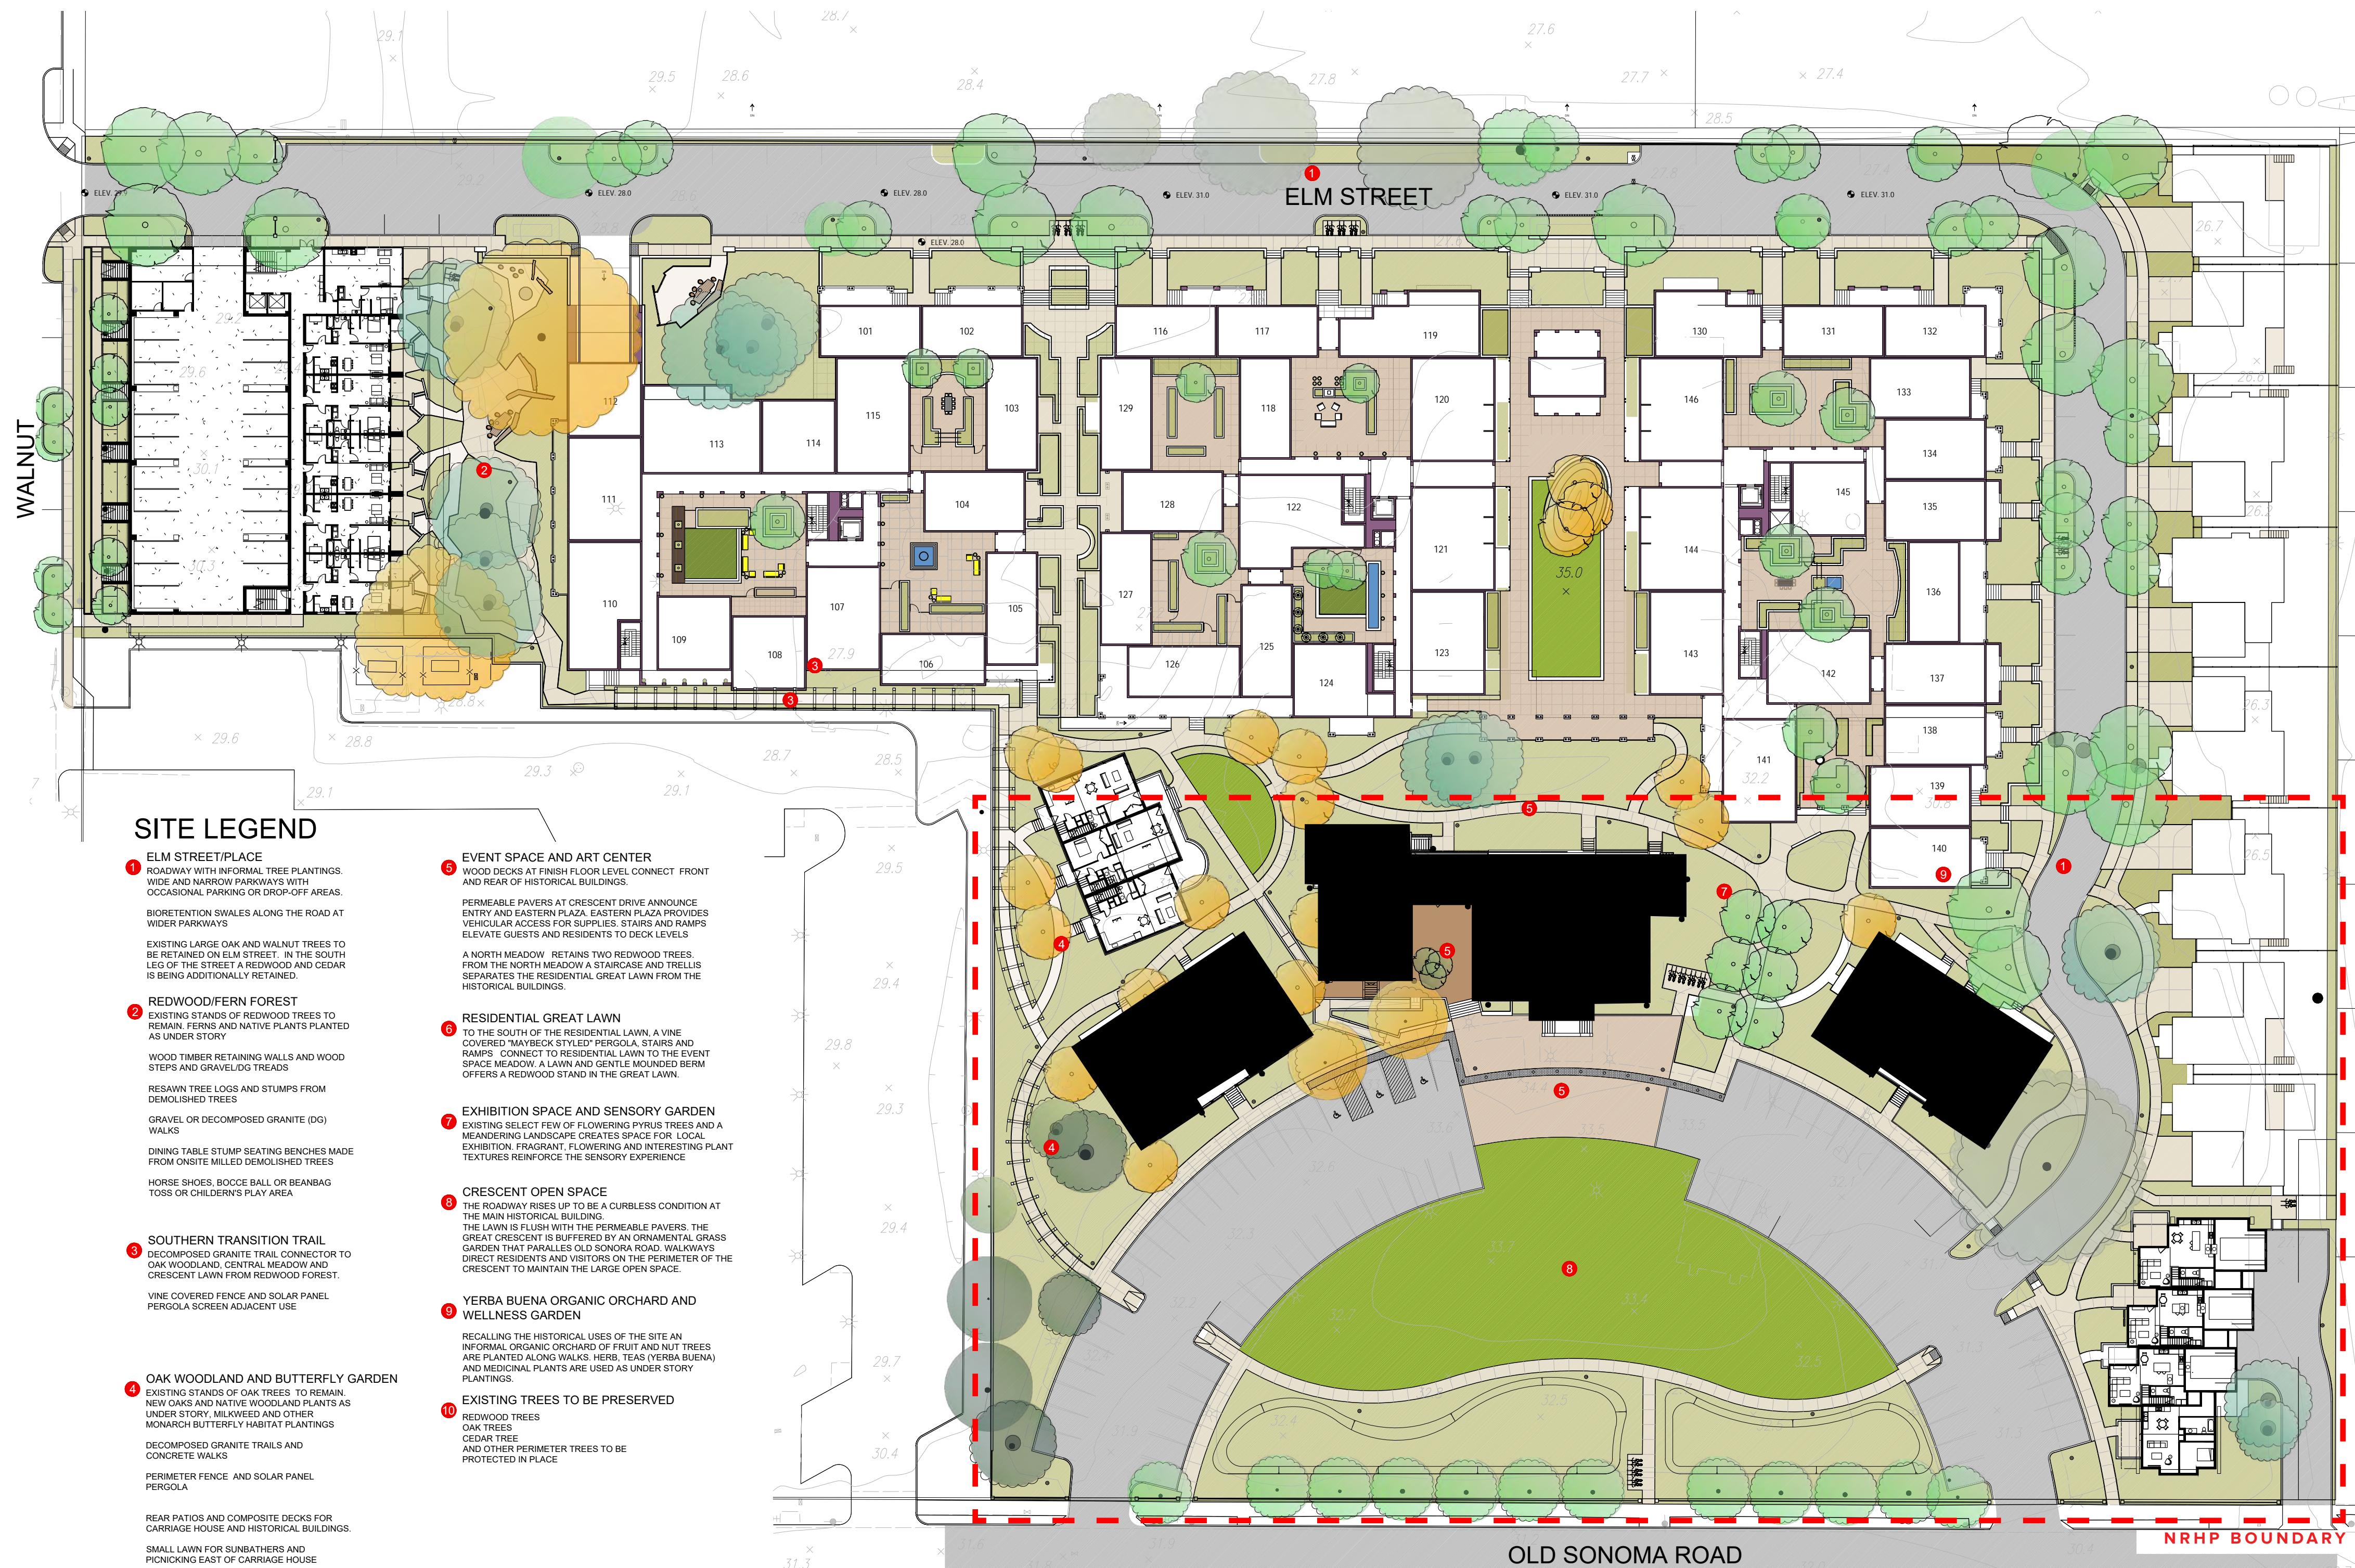
Landscape Plan

- installation of bio-retention and infiltration systems to clean and reduce storm water runoff,
- planting up to 100 additional trees to reduce heat island effect,
- inclusion of solar energy Photovoltaic panels on pergolas,
- installation of low flow drip and smart irrigation, and
- installation of appropriate tree types and placement to reduce energy costs of the buildings.
