MEMORANDUM

Subject: Certificate of Appropriateness, The Crescent, 2344 Old Sonoma Road

CERTIFICATE OF APPROPRIATENESS
DEC 15, 2022

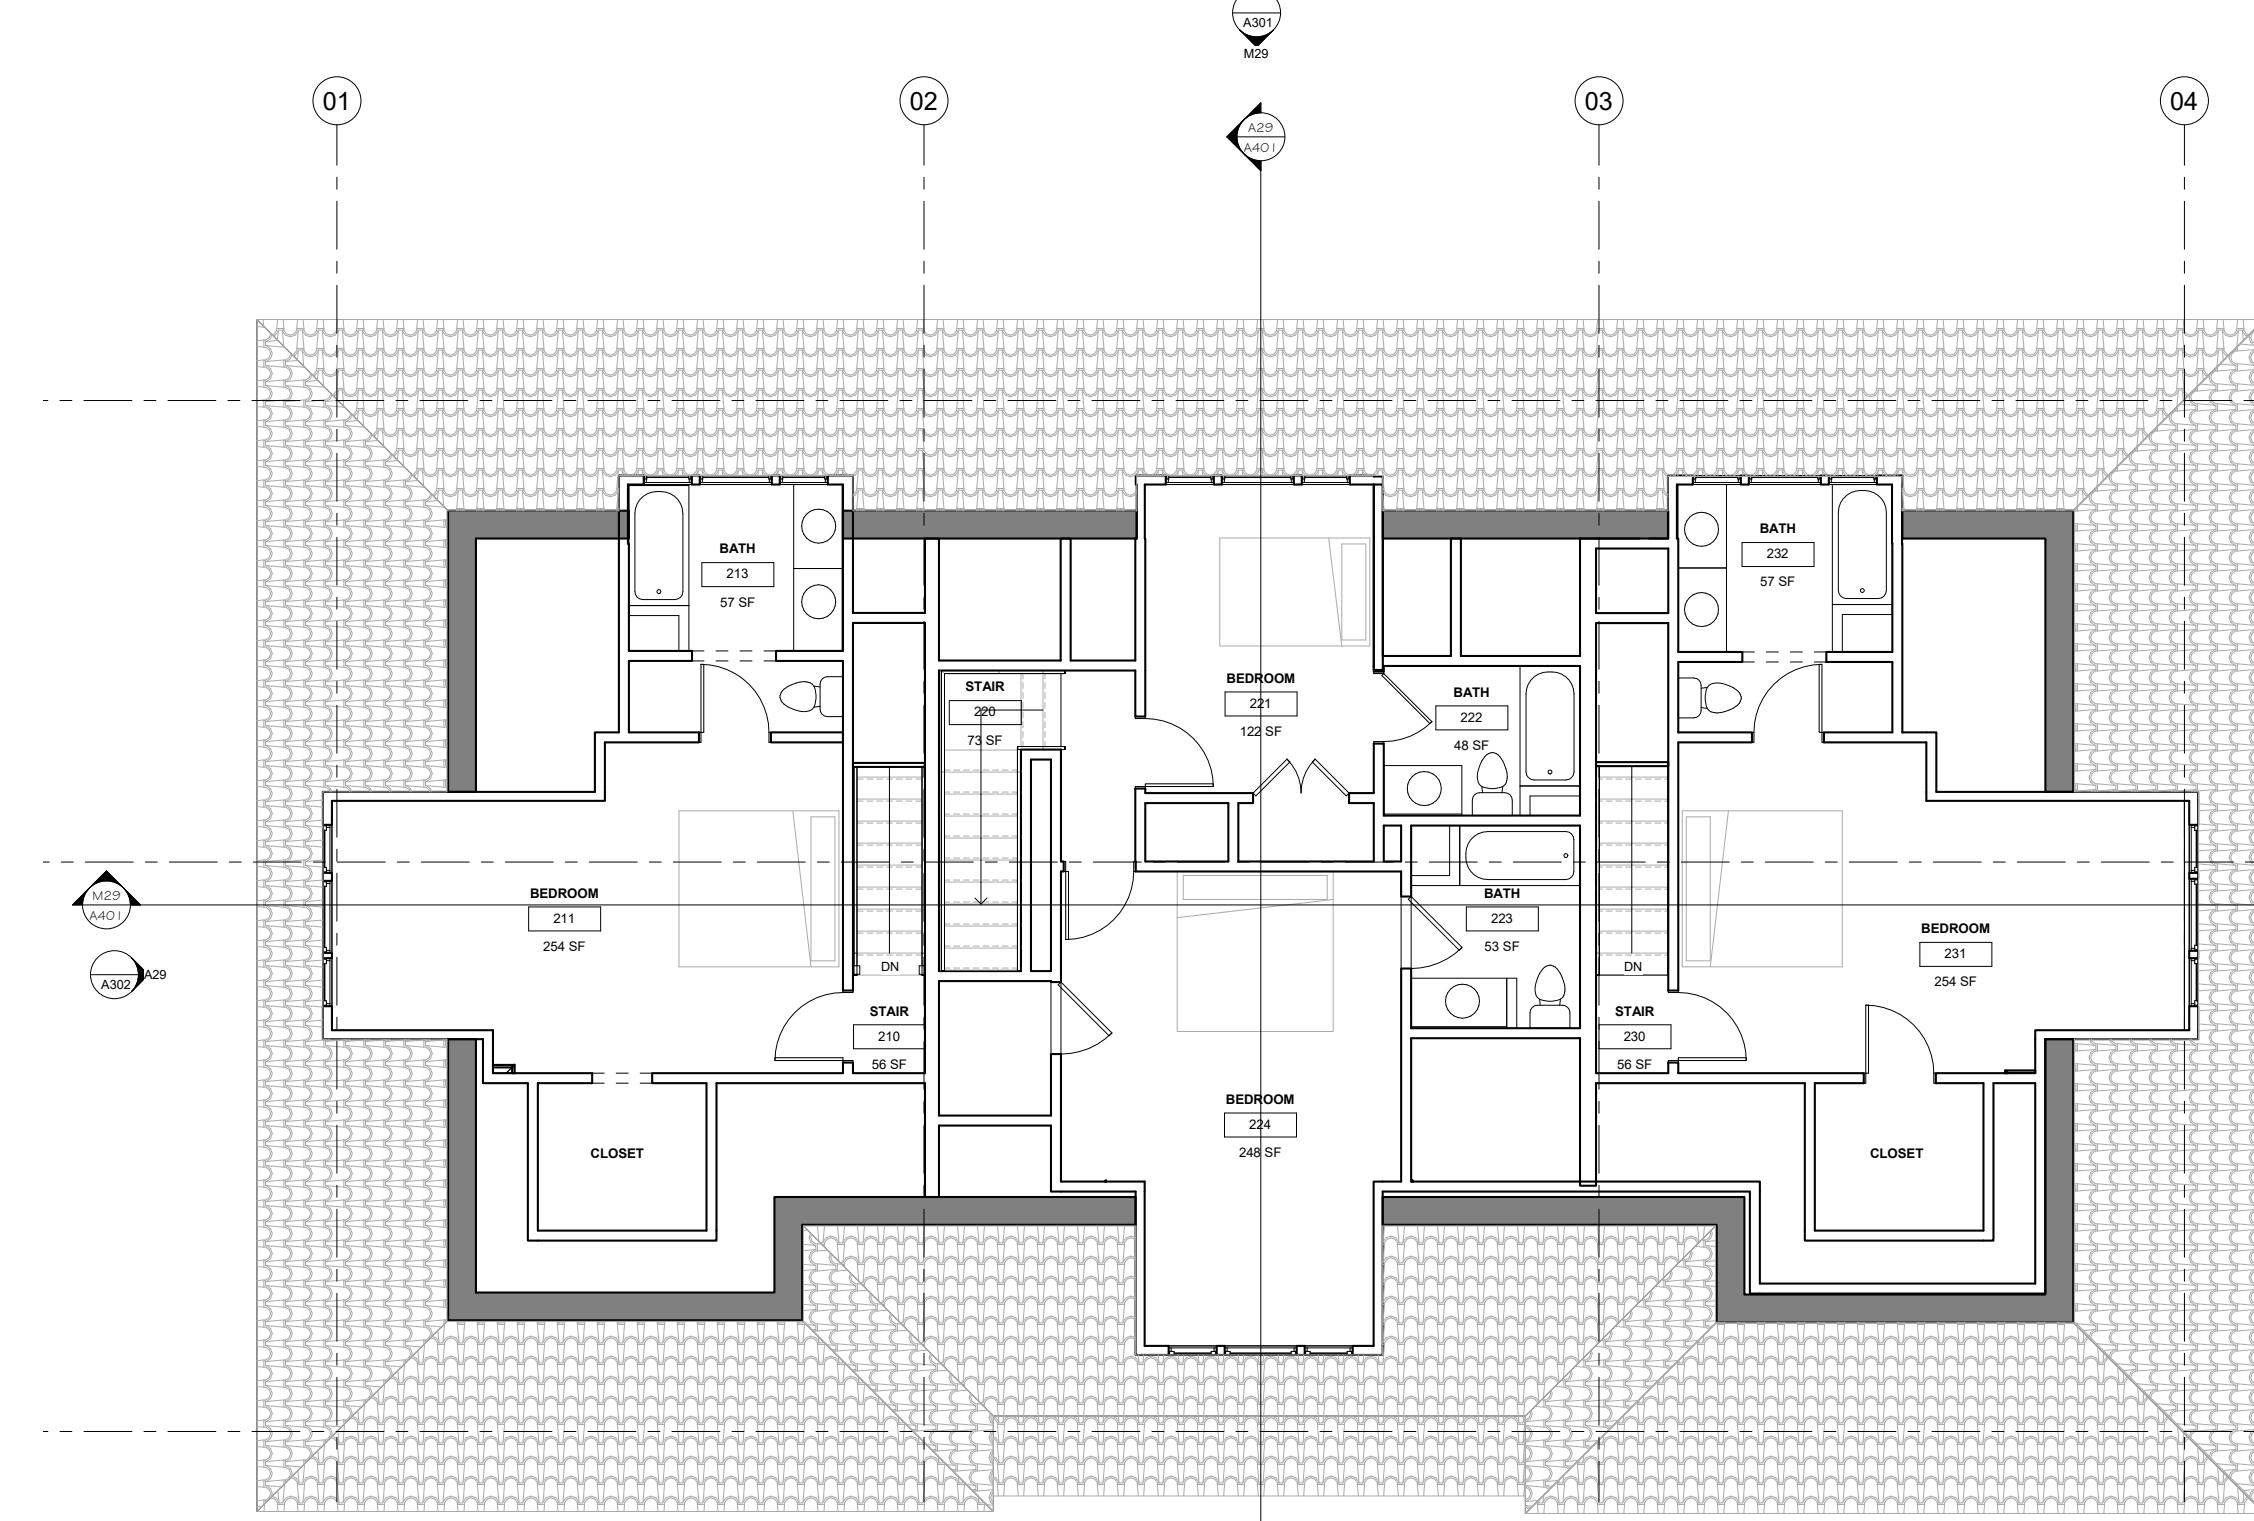
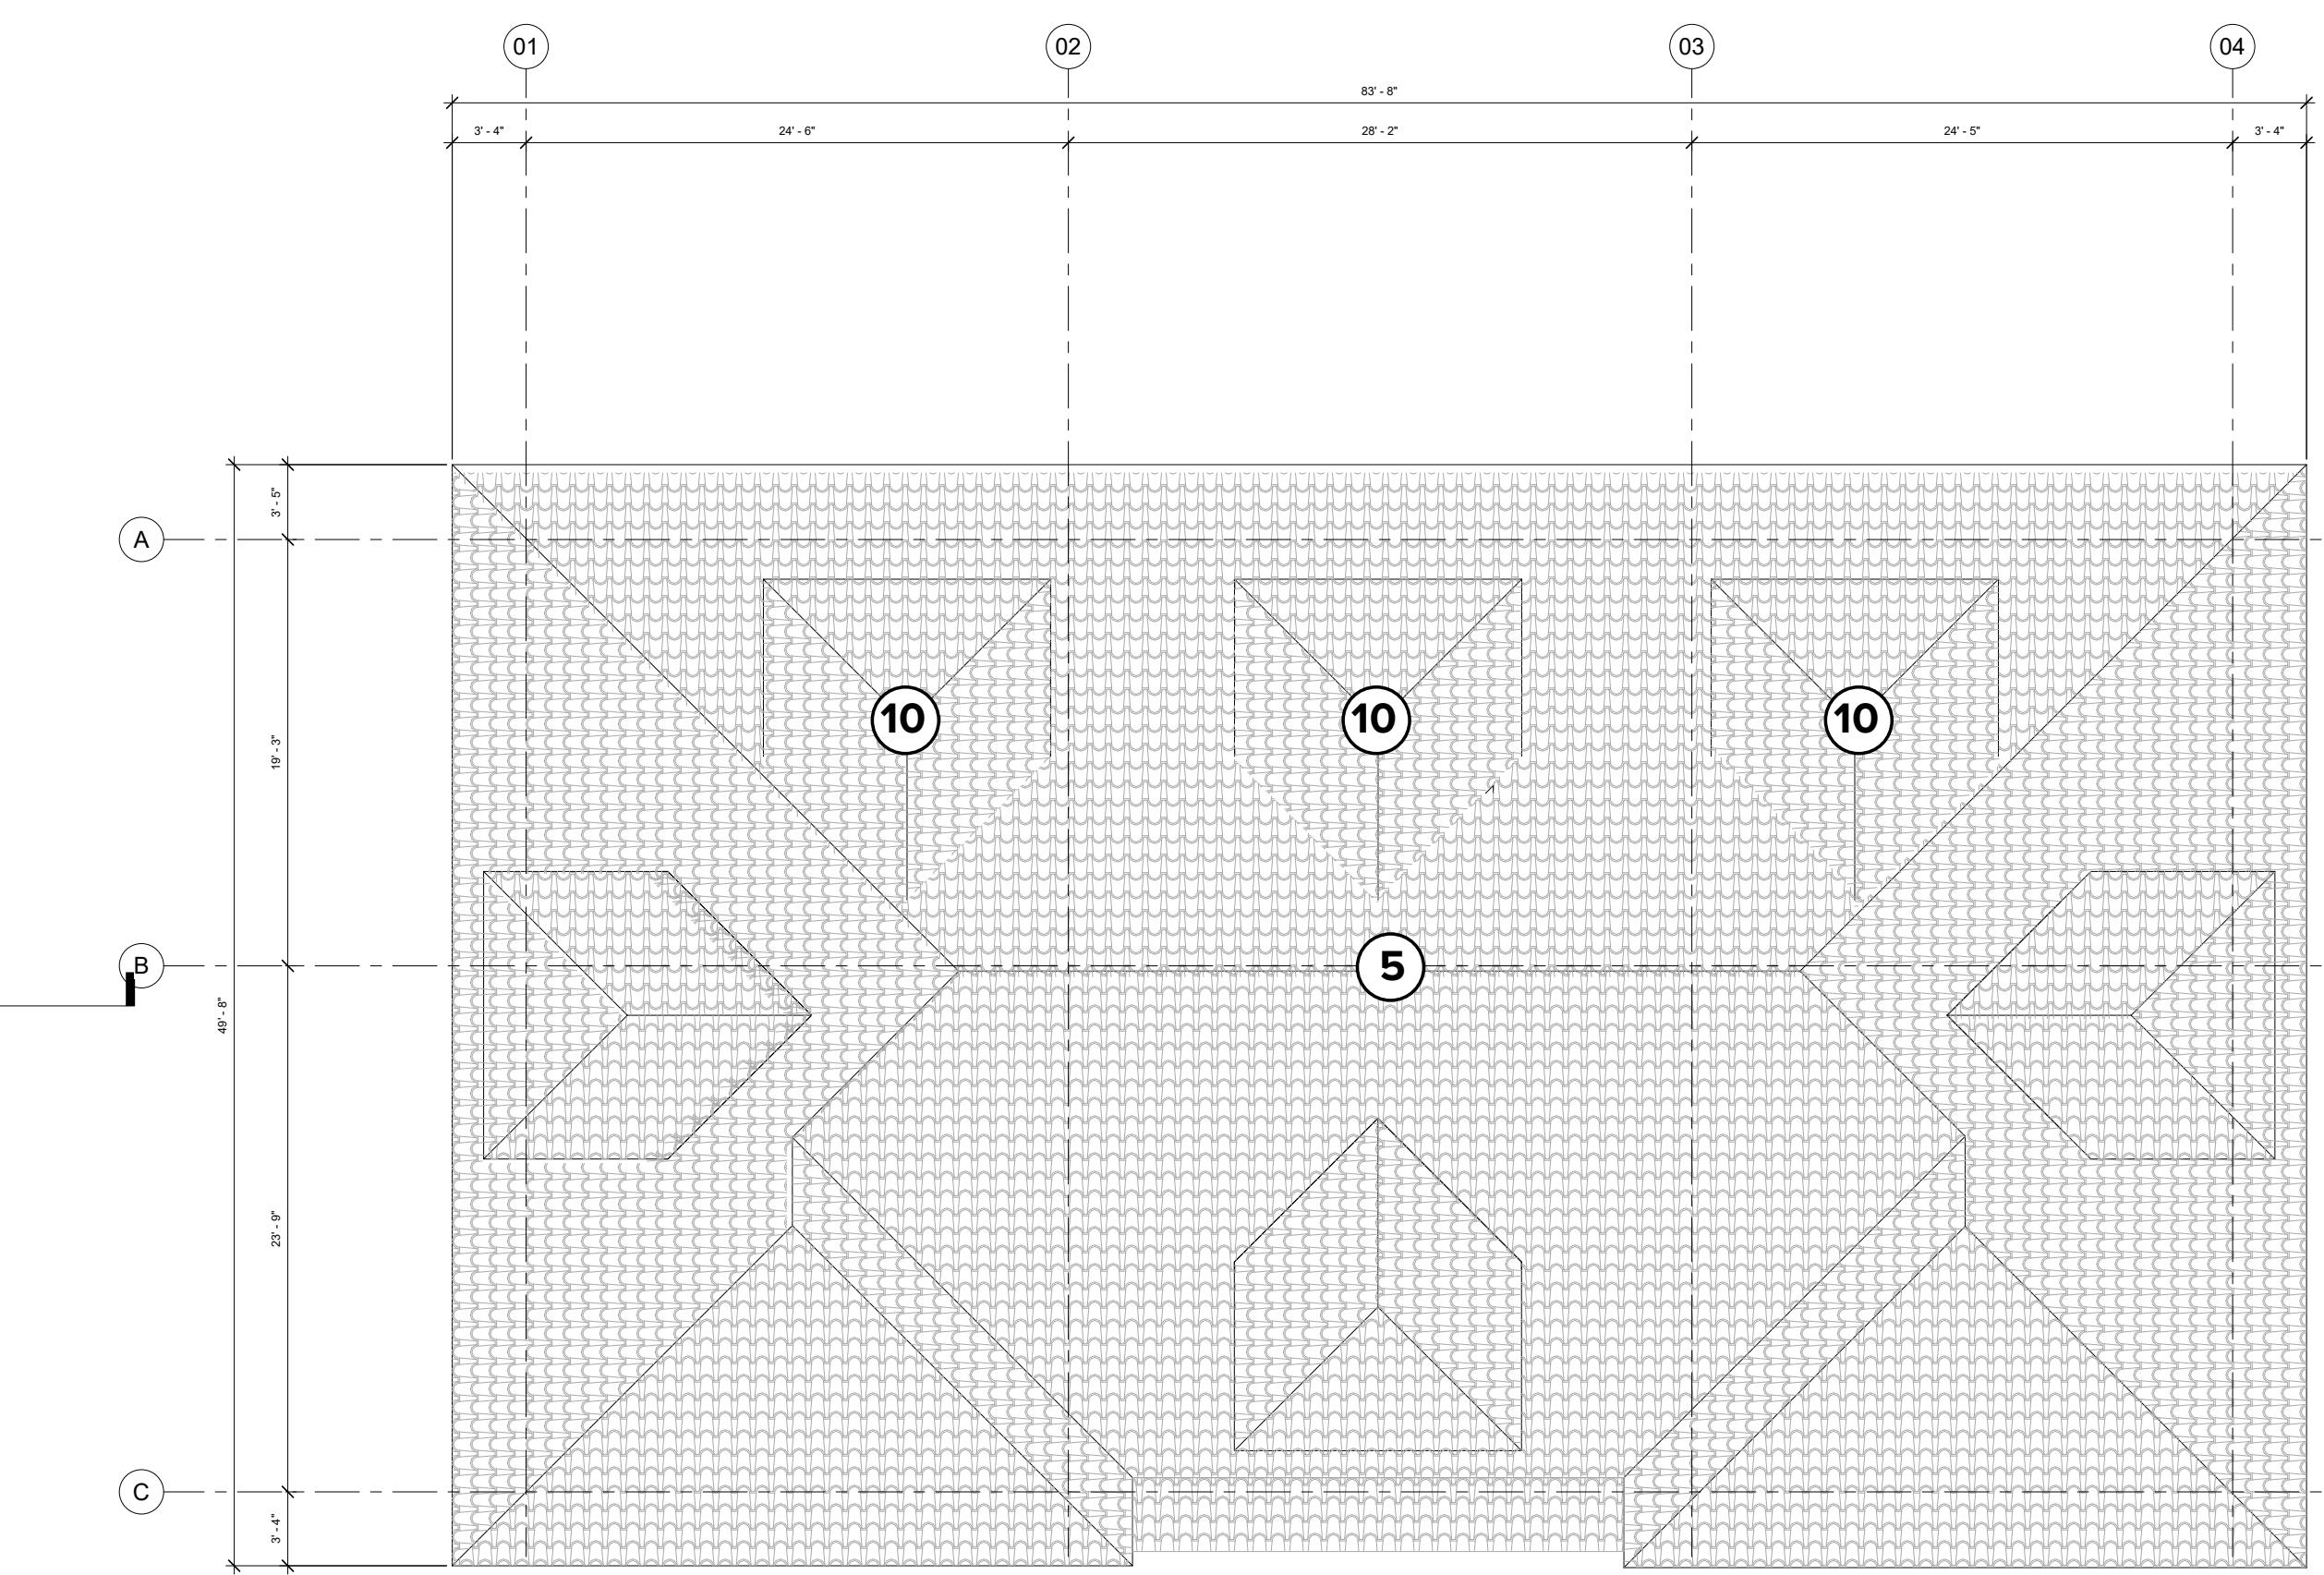
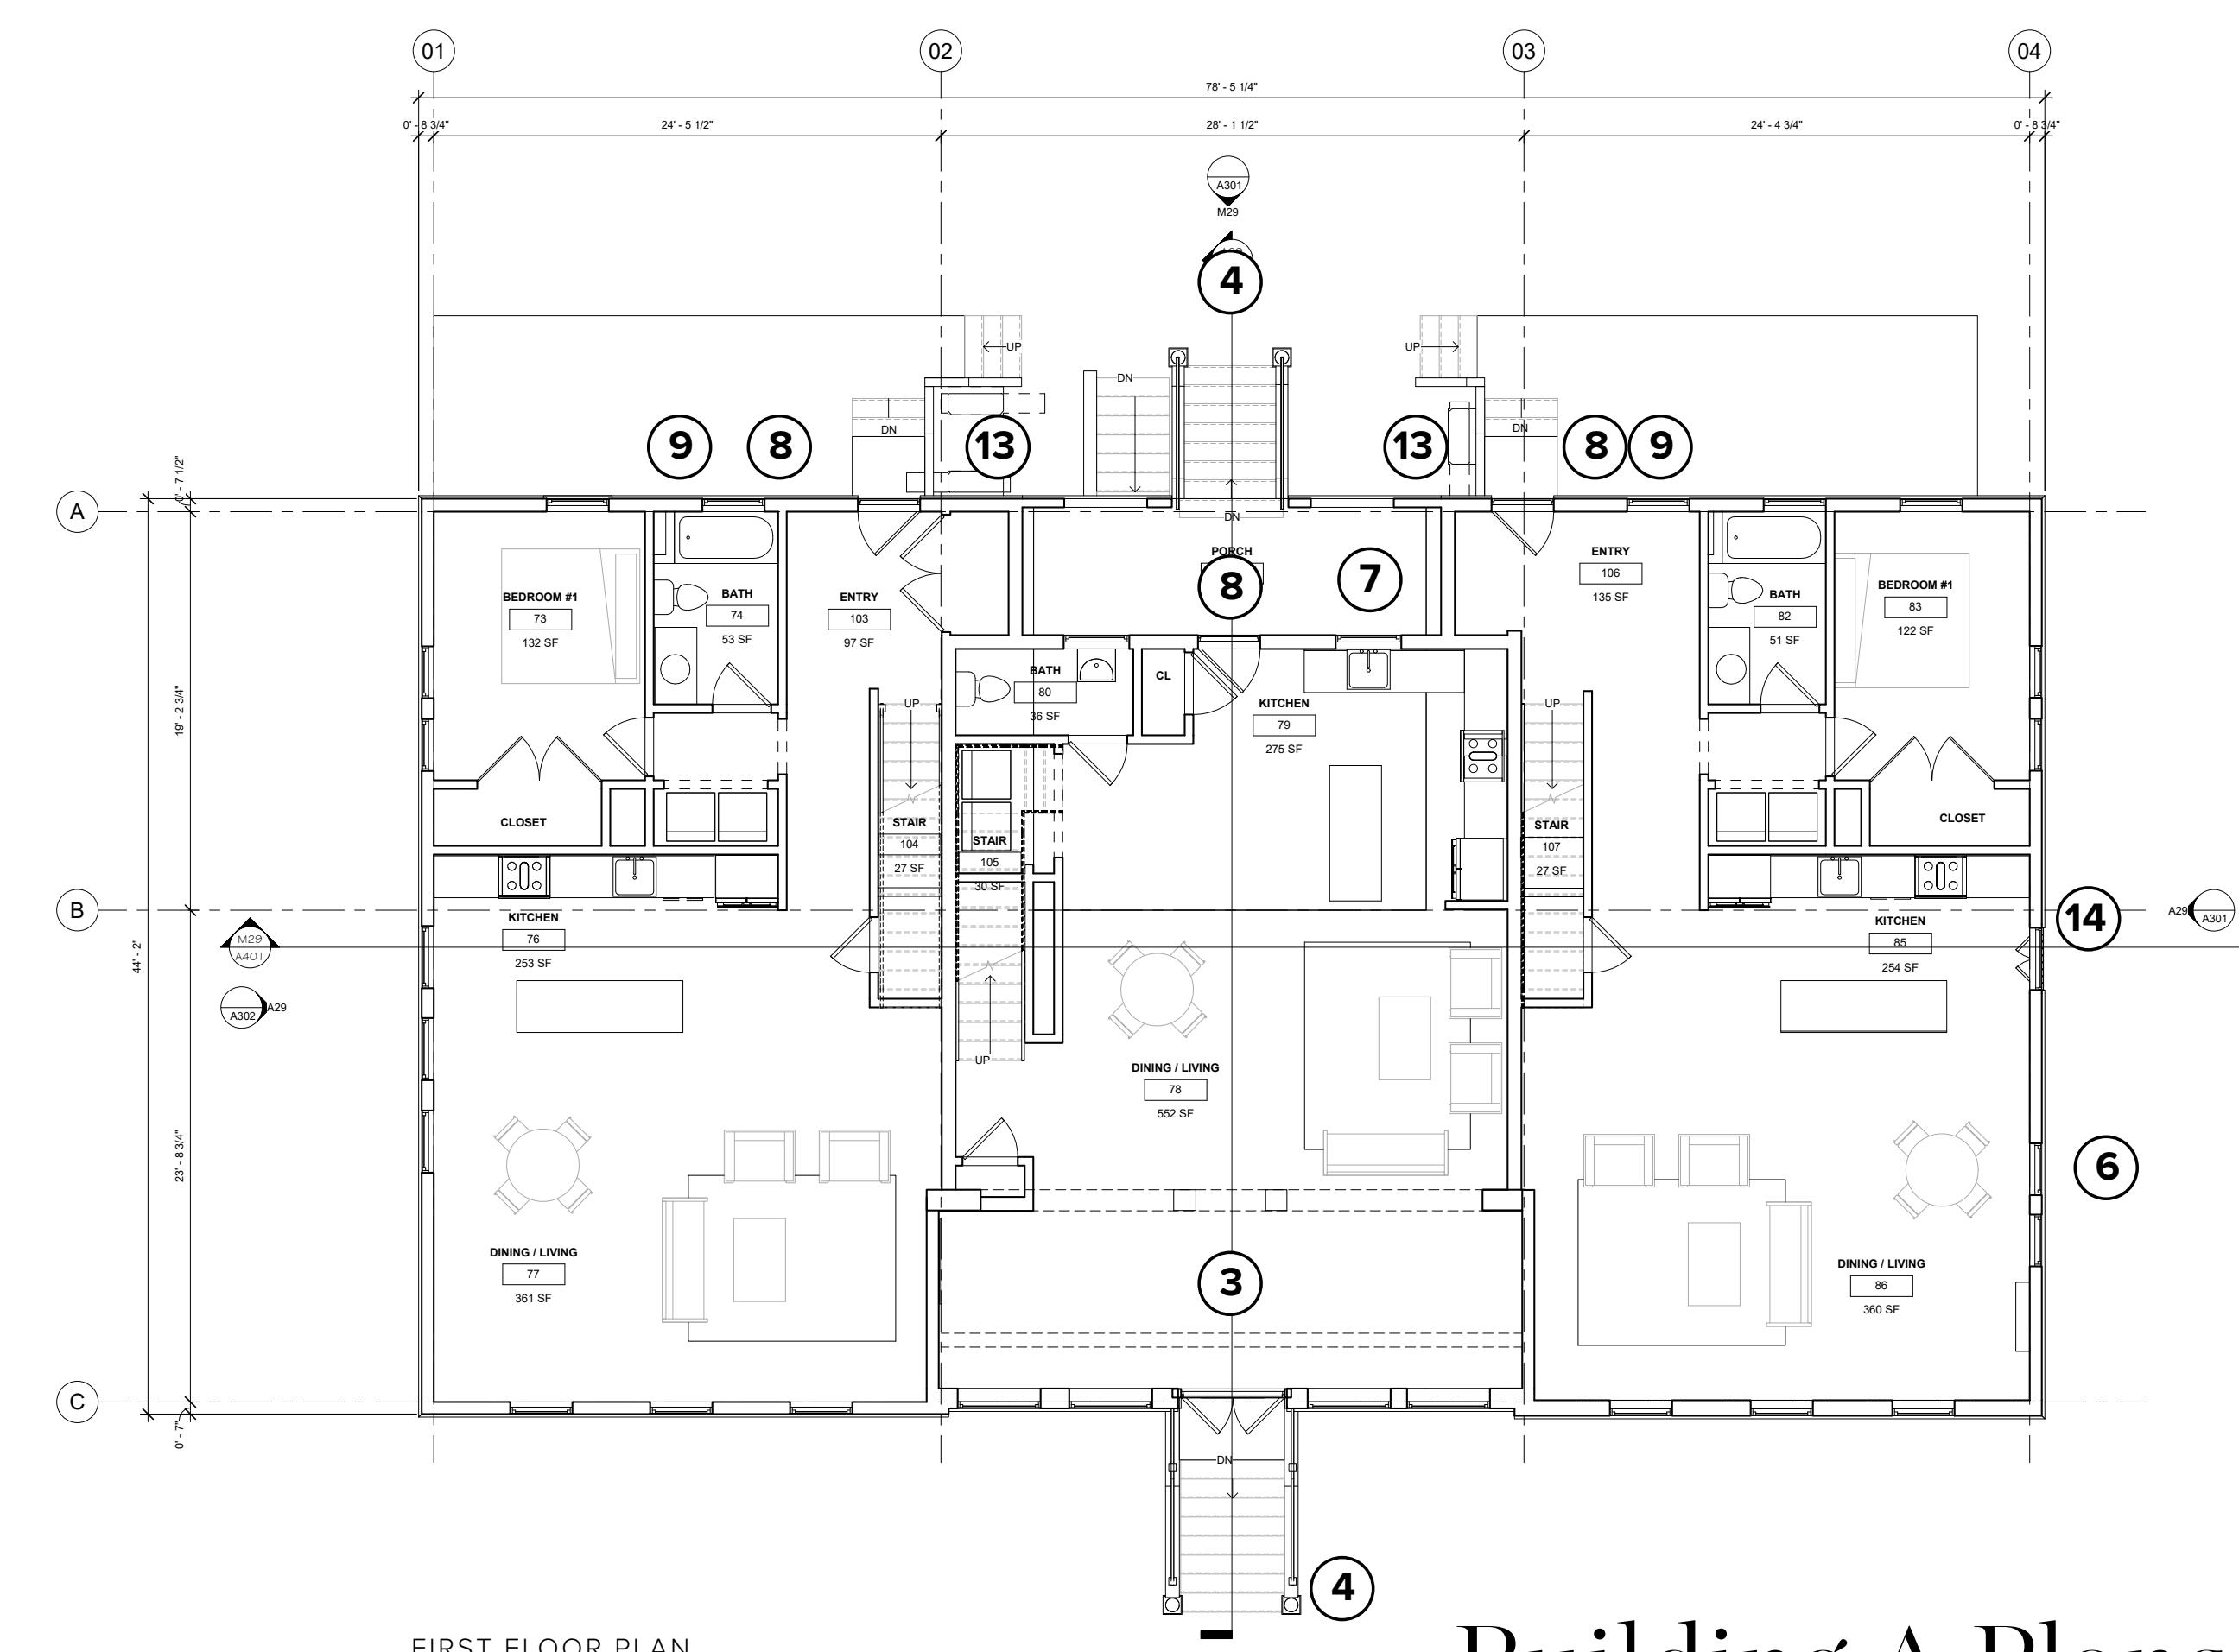
Building A Plans

- 5 REMOVE (E) ASPHALT SHINGLES. RESTORE TILE ROOF PER HISTORIC IMAGES. REPAIR RAFTER TAILS AND INTEGRAL GUTTER AS REQUIRED.
- 6 RESTORE (E) WINDOWS. NEW WOOD WINDOWS TO MATCH (E) DIVIDED LIGHTS, OVERHEAD OPERATION

- 9 PROVIDE NEW STAIR AND RAISED DECK AT EACH UNIT ON THE BACK OF BUILDING
- 10 PROVIDE NEW DORMERS TO MATCH (E) AT EACH UNIT ON THE BACK OF BUILDING
- 11 UNCOVER INFILL WINDOWS WHERE FEASIBLE, PROVIDE NEW WOOD WINDOW TO MATCH (E)

- 12 REPAIR BASEMENT WINDOW VENTS TO MATCH (E)
- 13 LOCATE HVAC EQUIPMENT BELOW DECK
- 14 INFILL JULLIETTE BALCONY AT EXISTING DOOR OPENING

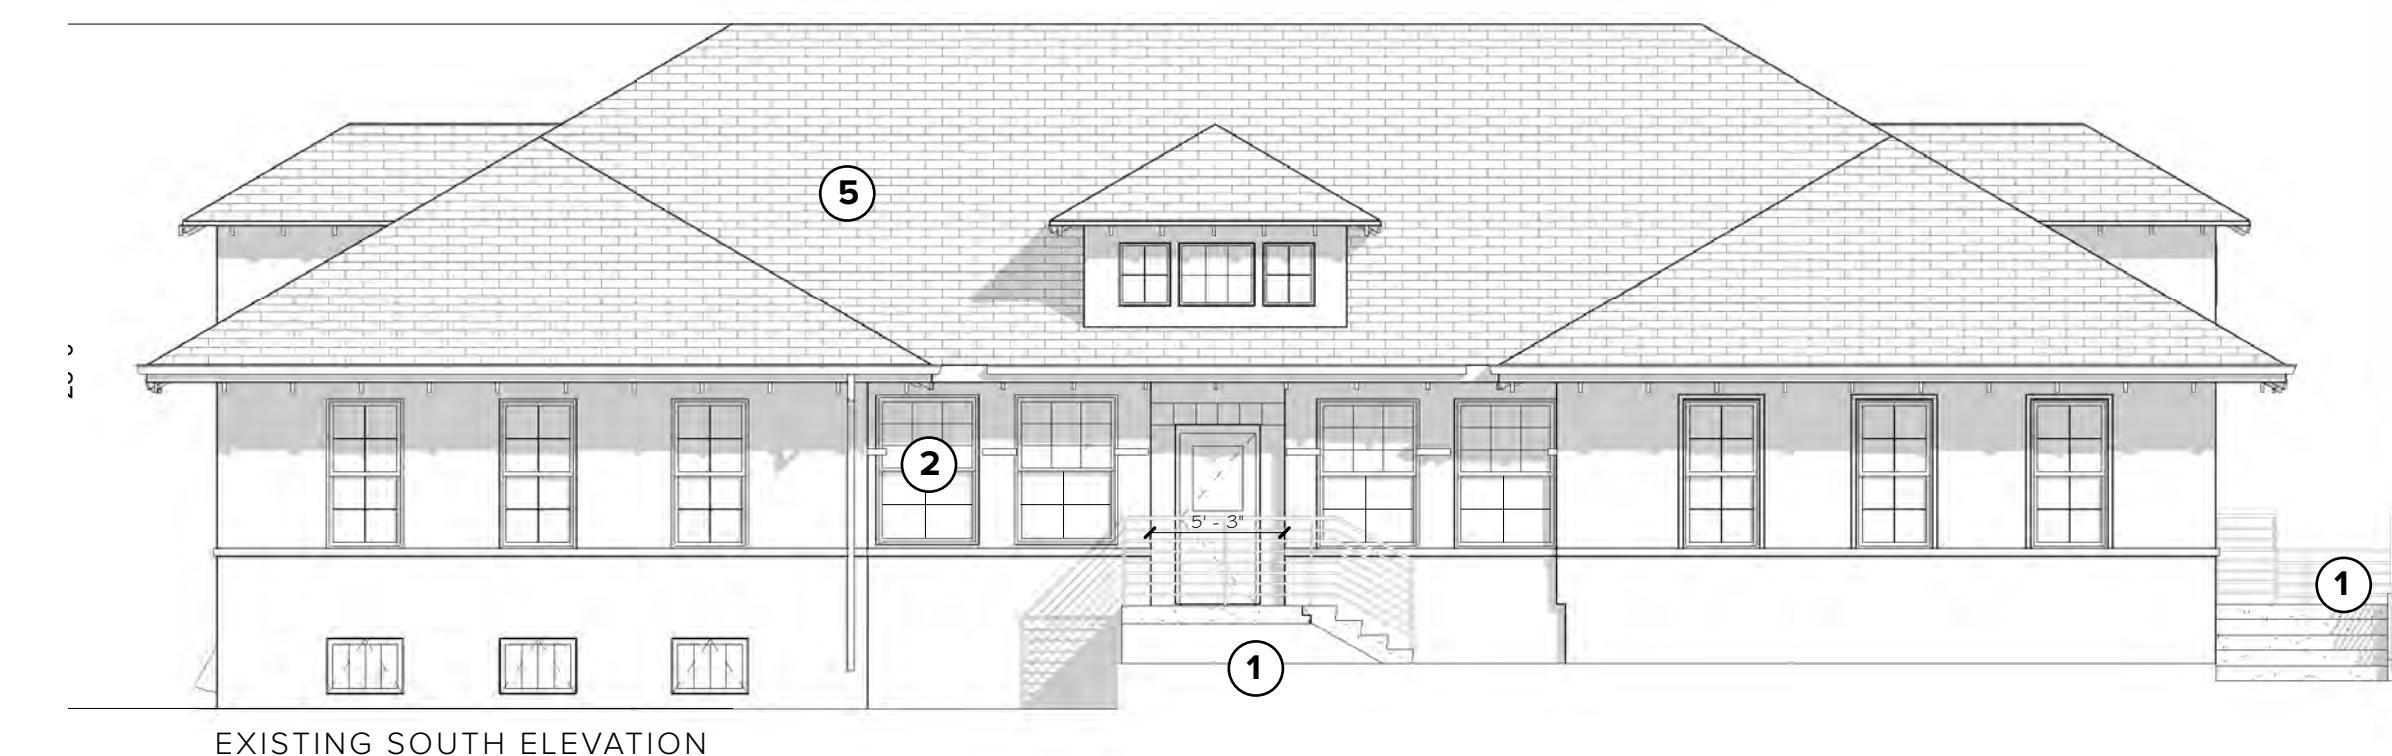
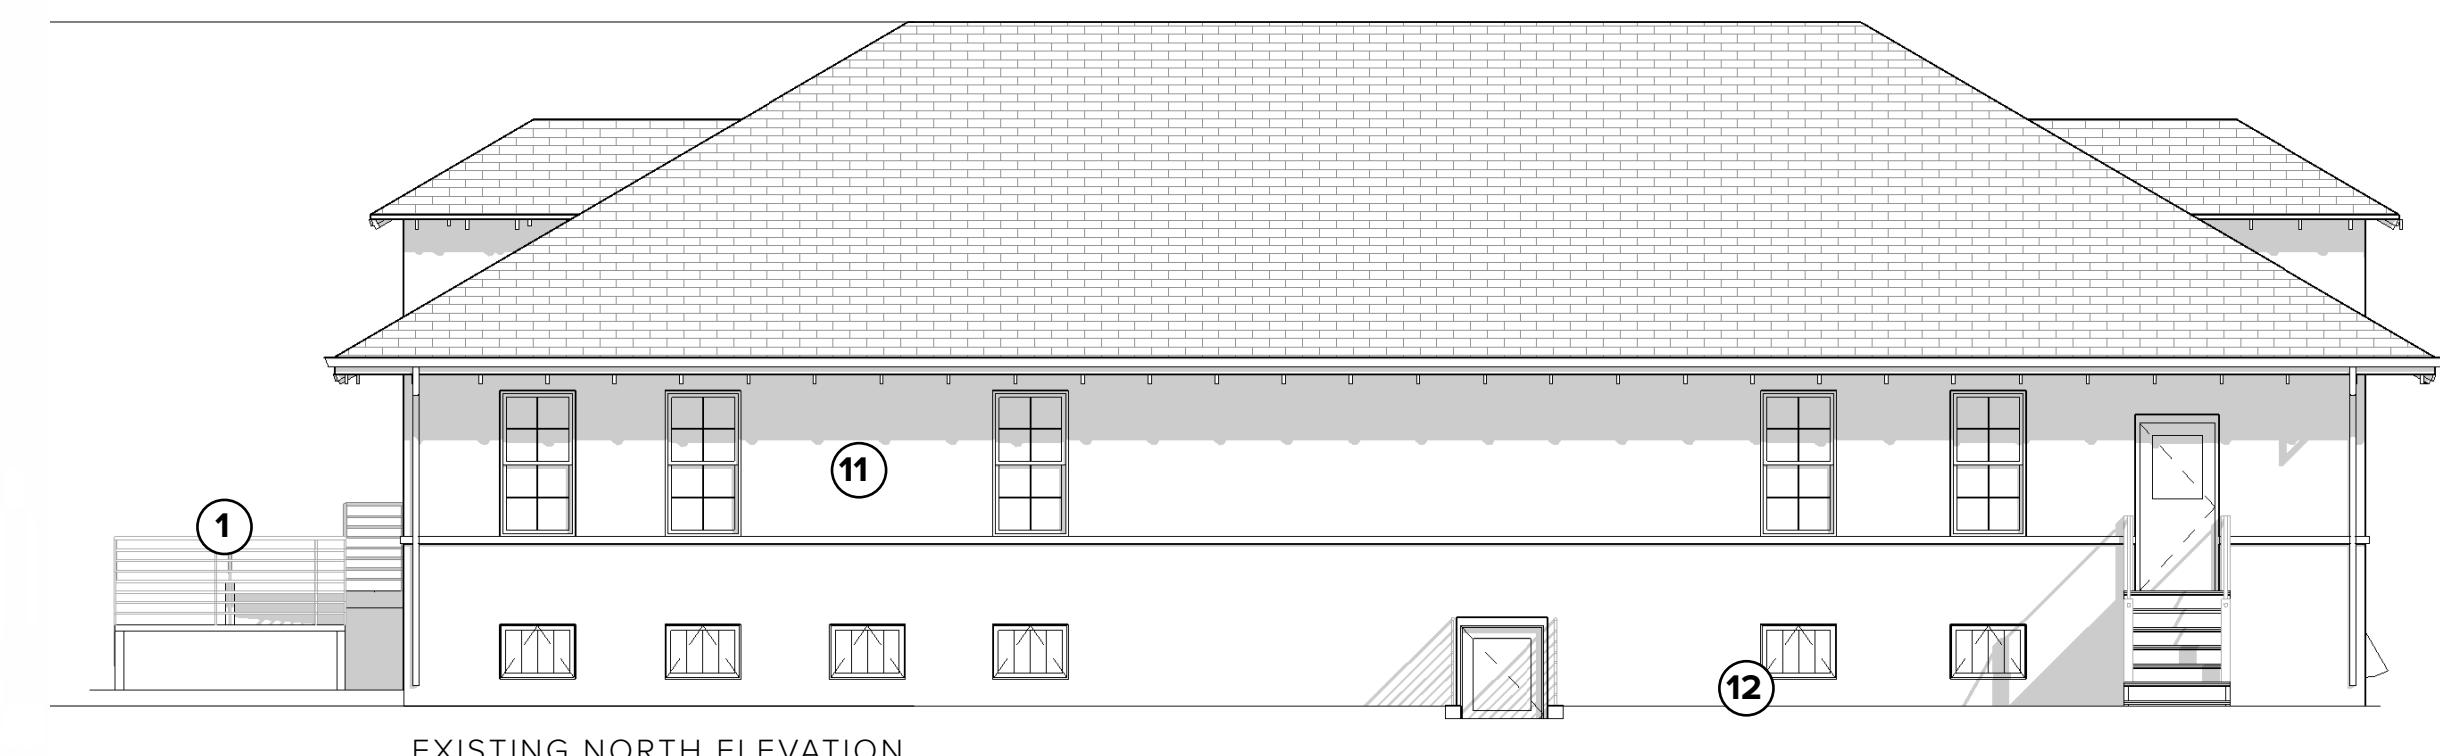
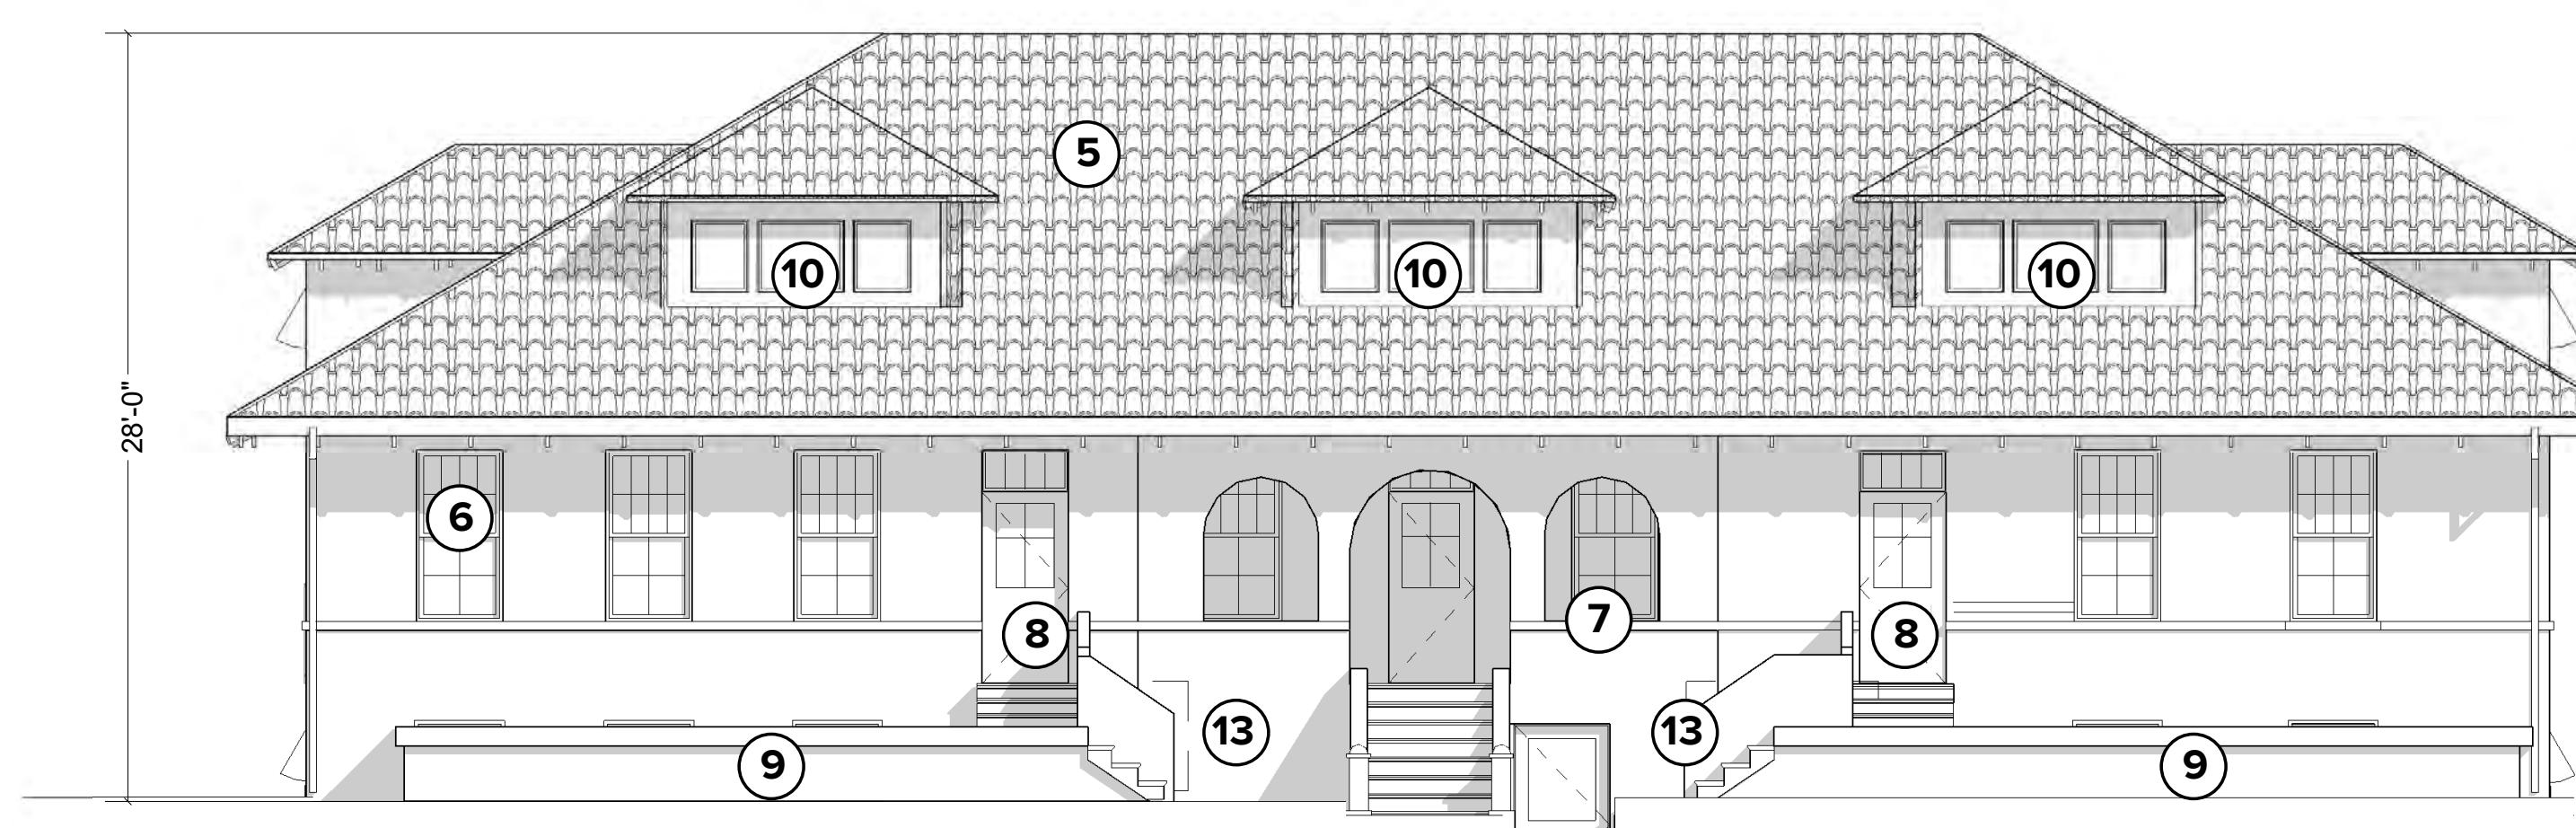
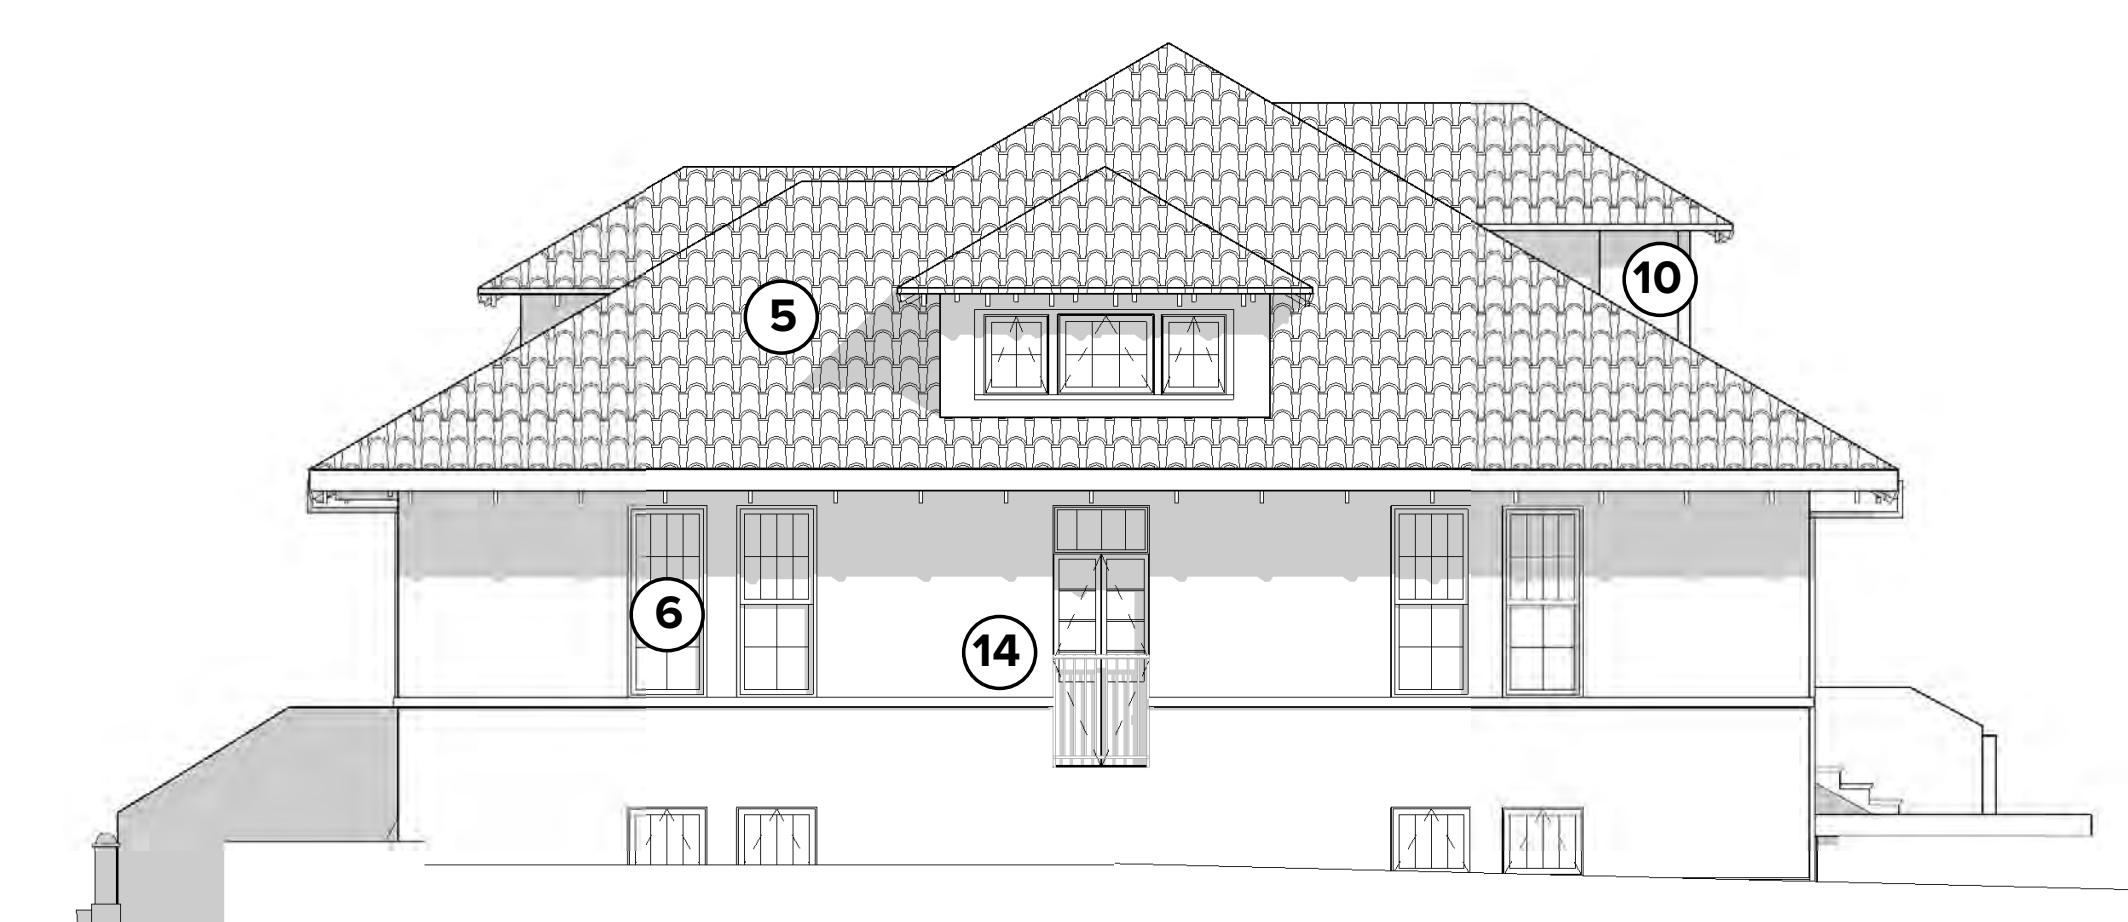
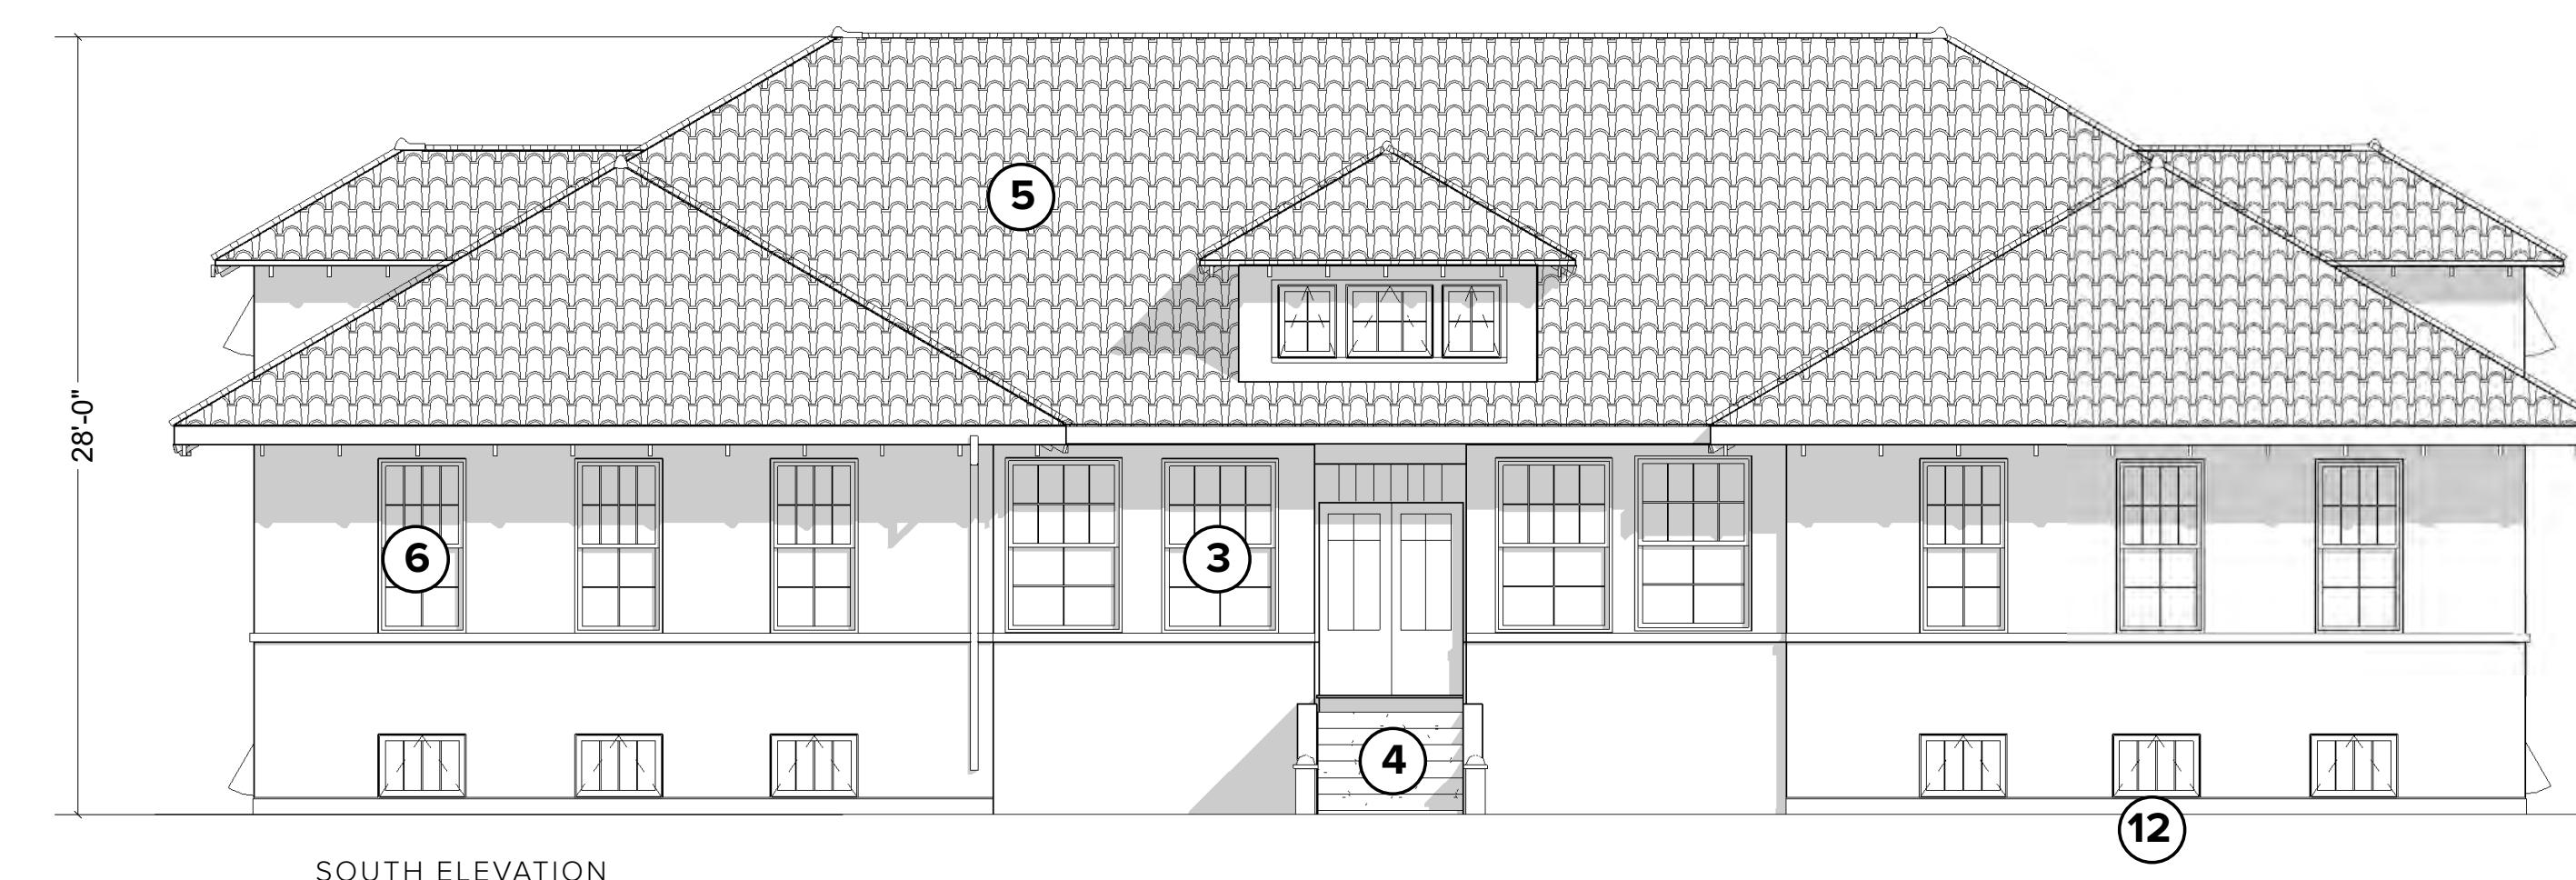
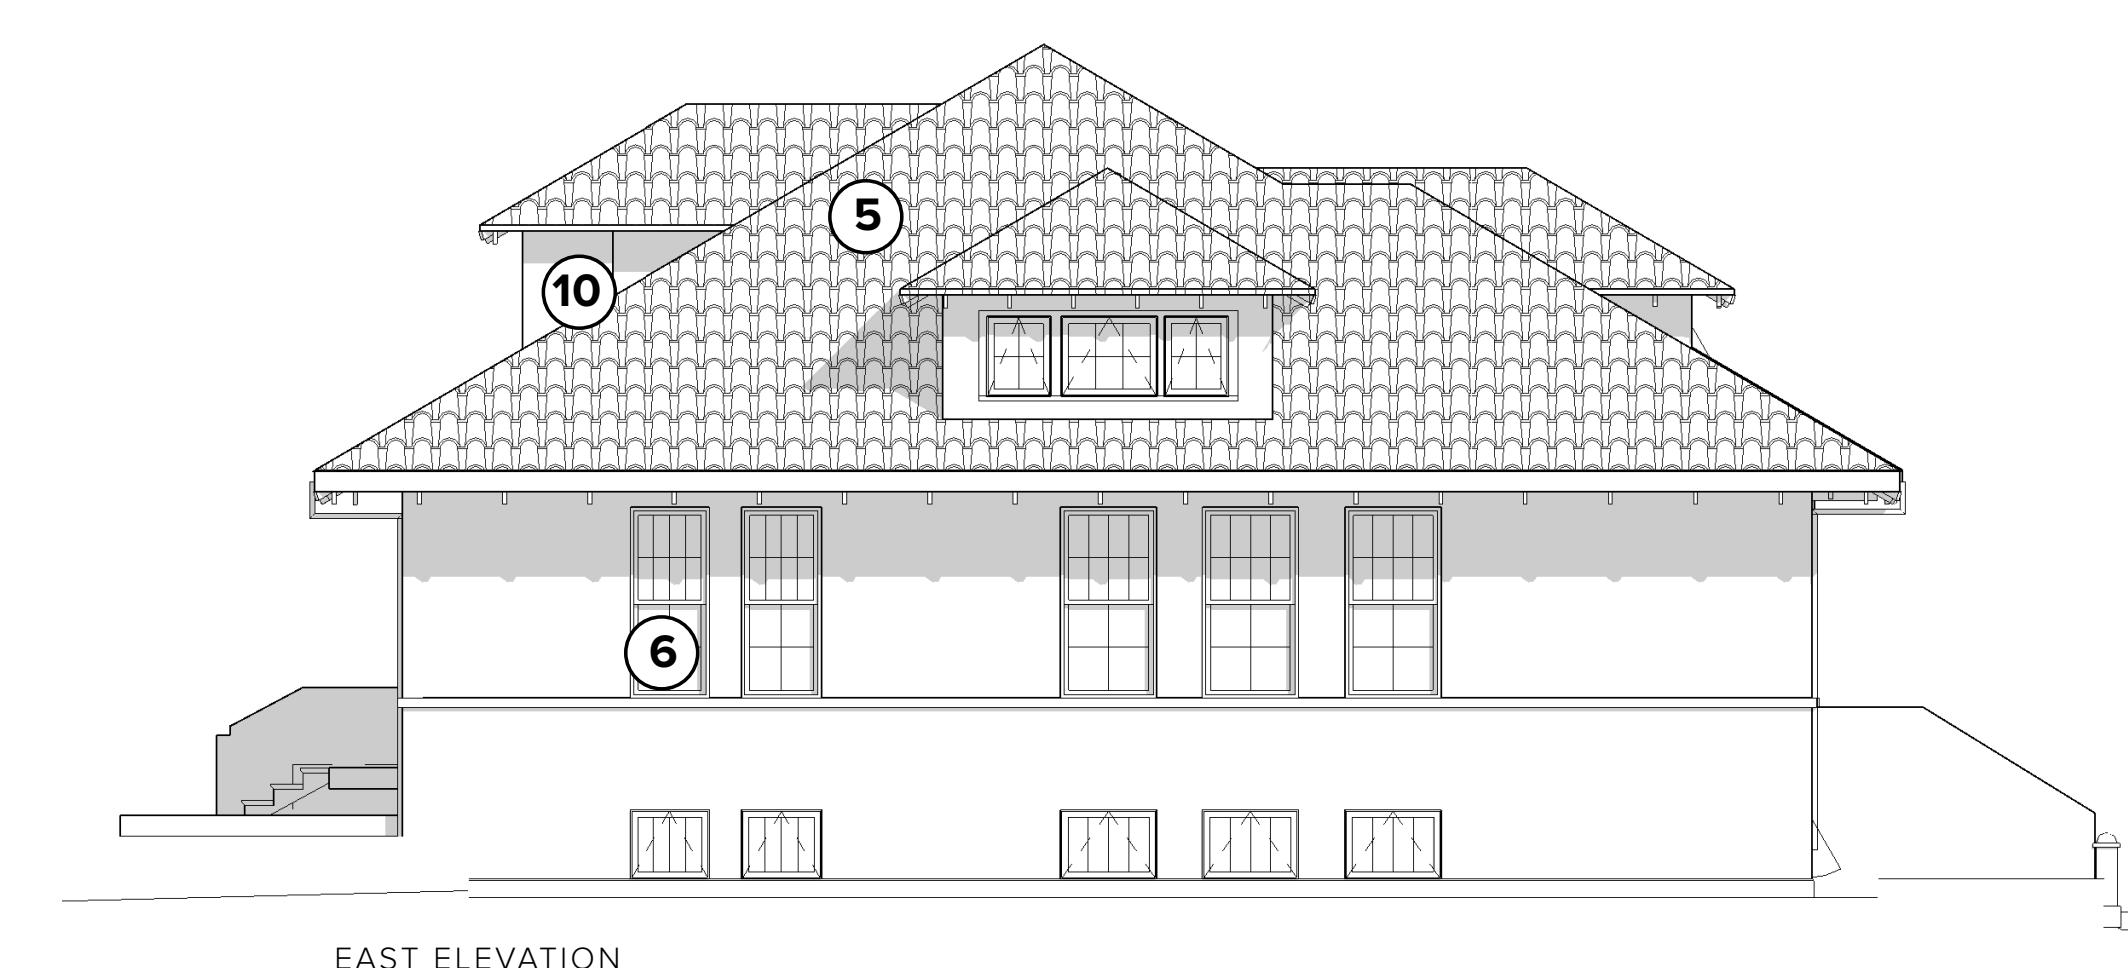
Building A Elevations

- ⑨ PROVIDE NEW STAIR AND RAISED DECK AT EACH UNIT ON THE BACK OF BUILDING
- ⑩ PROVIDE NEW DORMERS TO MATCH (E) AT EACH UNIT ON THE BACK OF BUILDING
- ⑪ UNCOVER INFILL WINDOWS WHERE FEASIBLE, PROVIDE NEW WOOD WINDOW TO MATCH (E)

- ⑫ REPAIR BASEMENT WINDOW VENTS TO MATCH (E)
- ⑬ LOCATE HVAC EQUIPMENT BELOW DECK
- ⑭ INFILL JULLIETTE BALCONY AT EXISTING DOOR OPENING
