MEMORANDUM

Subject: Certificate of Appropriateness, The Crescent, 2344 Old Sonoma Road

CERTIFICATE OF APPROPRIATENESS
DEC 15, 2022

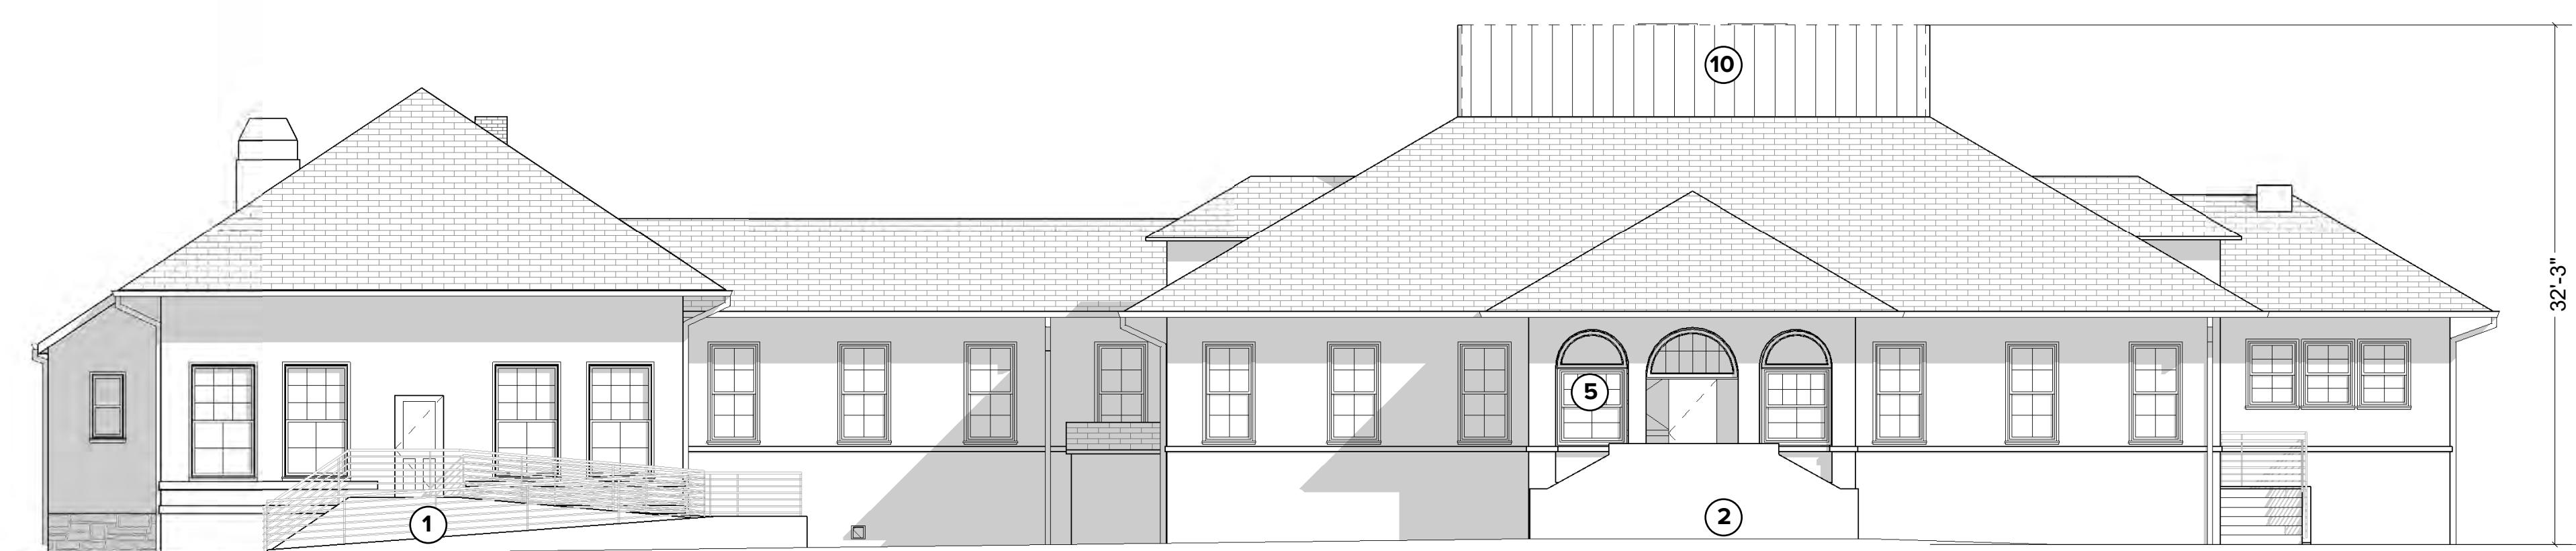
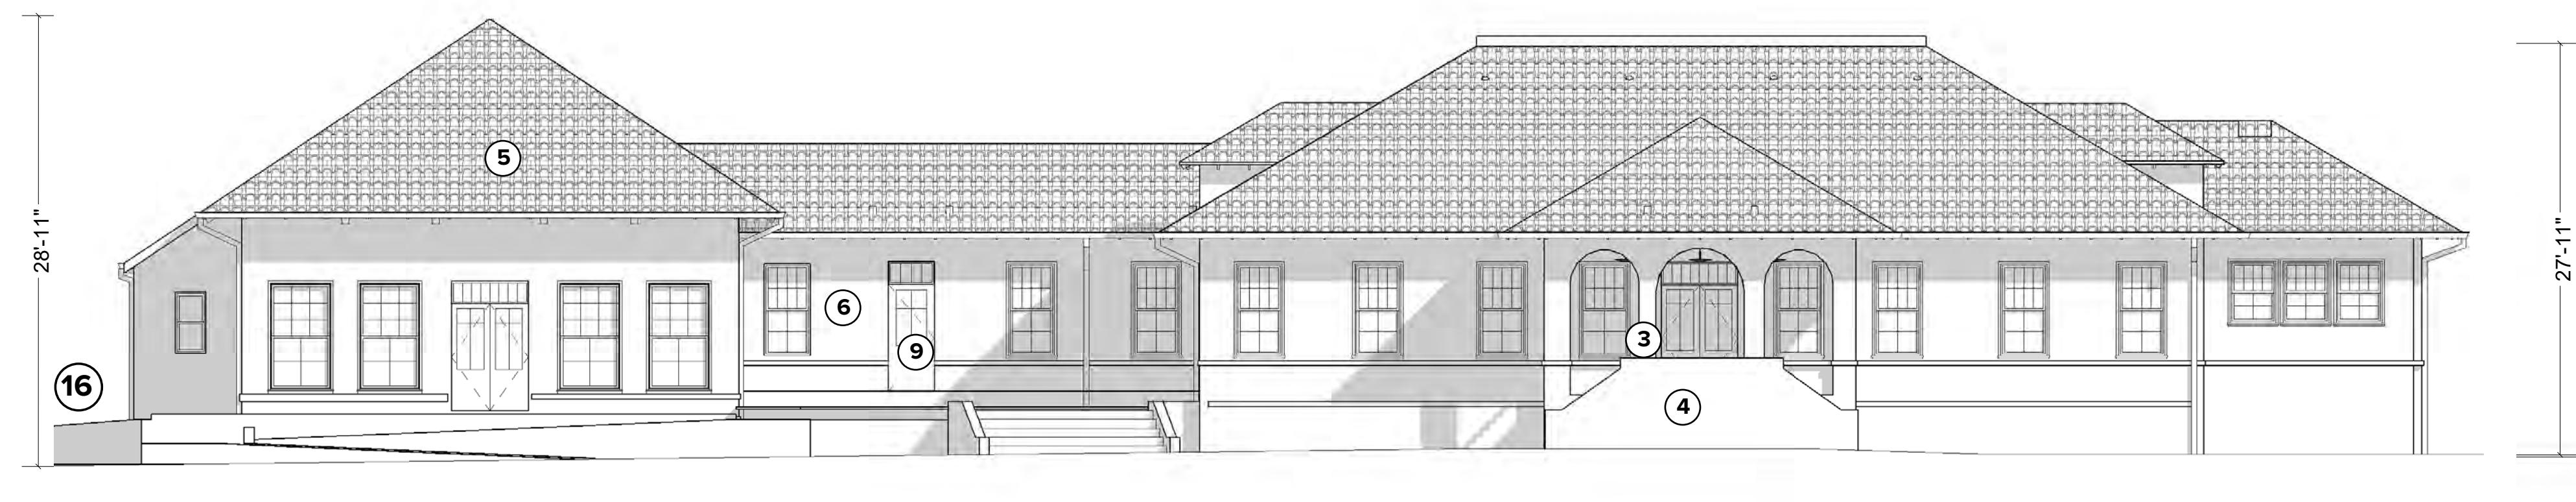
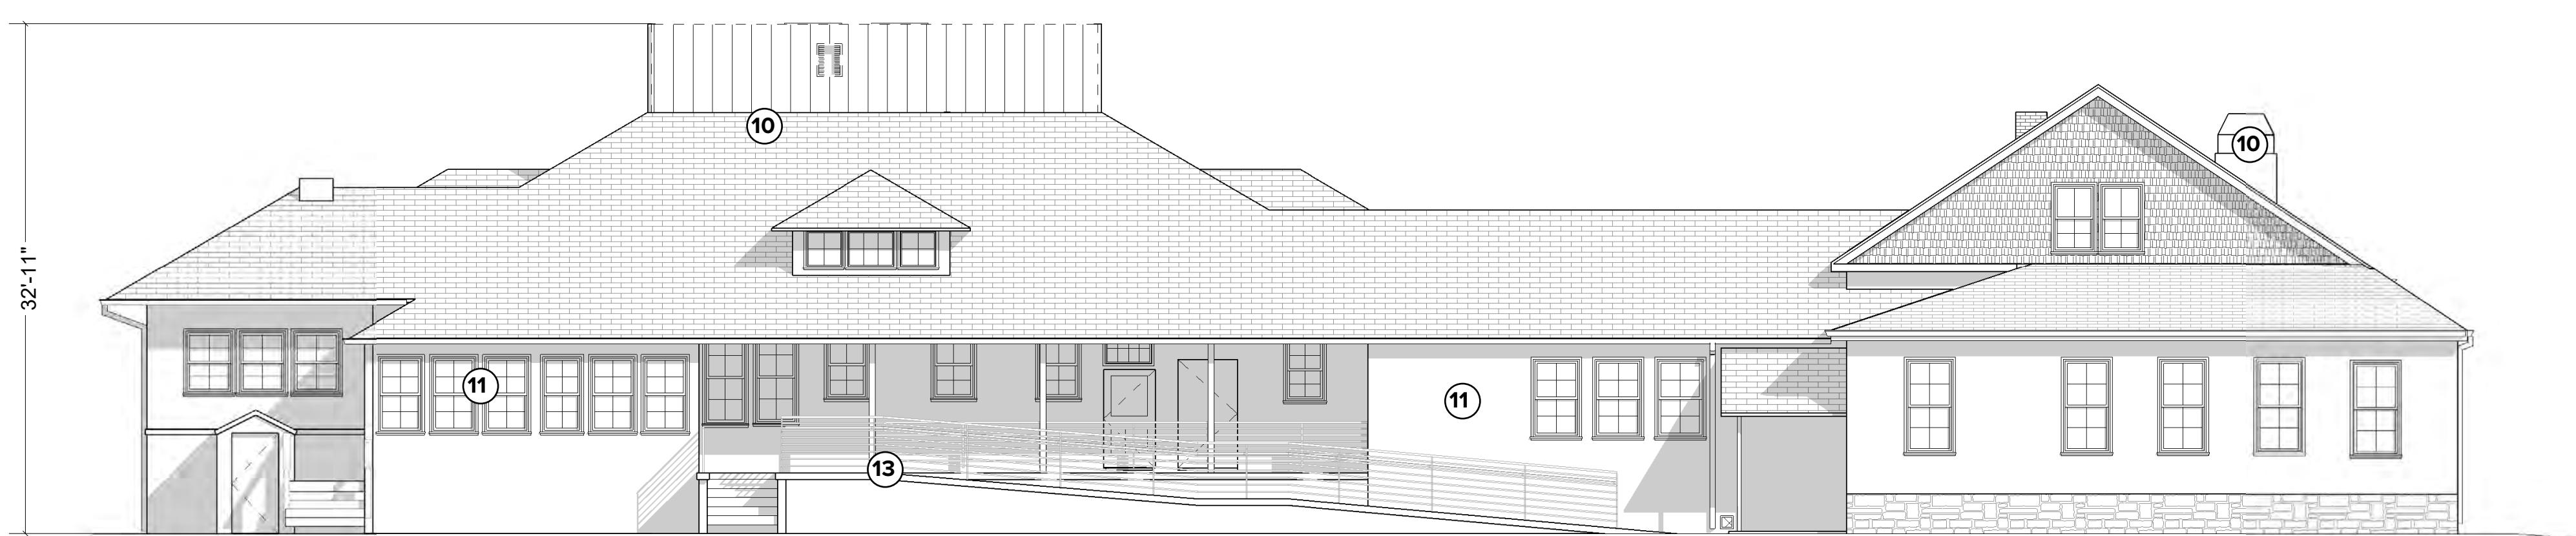
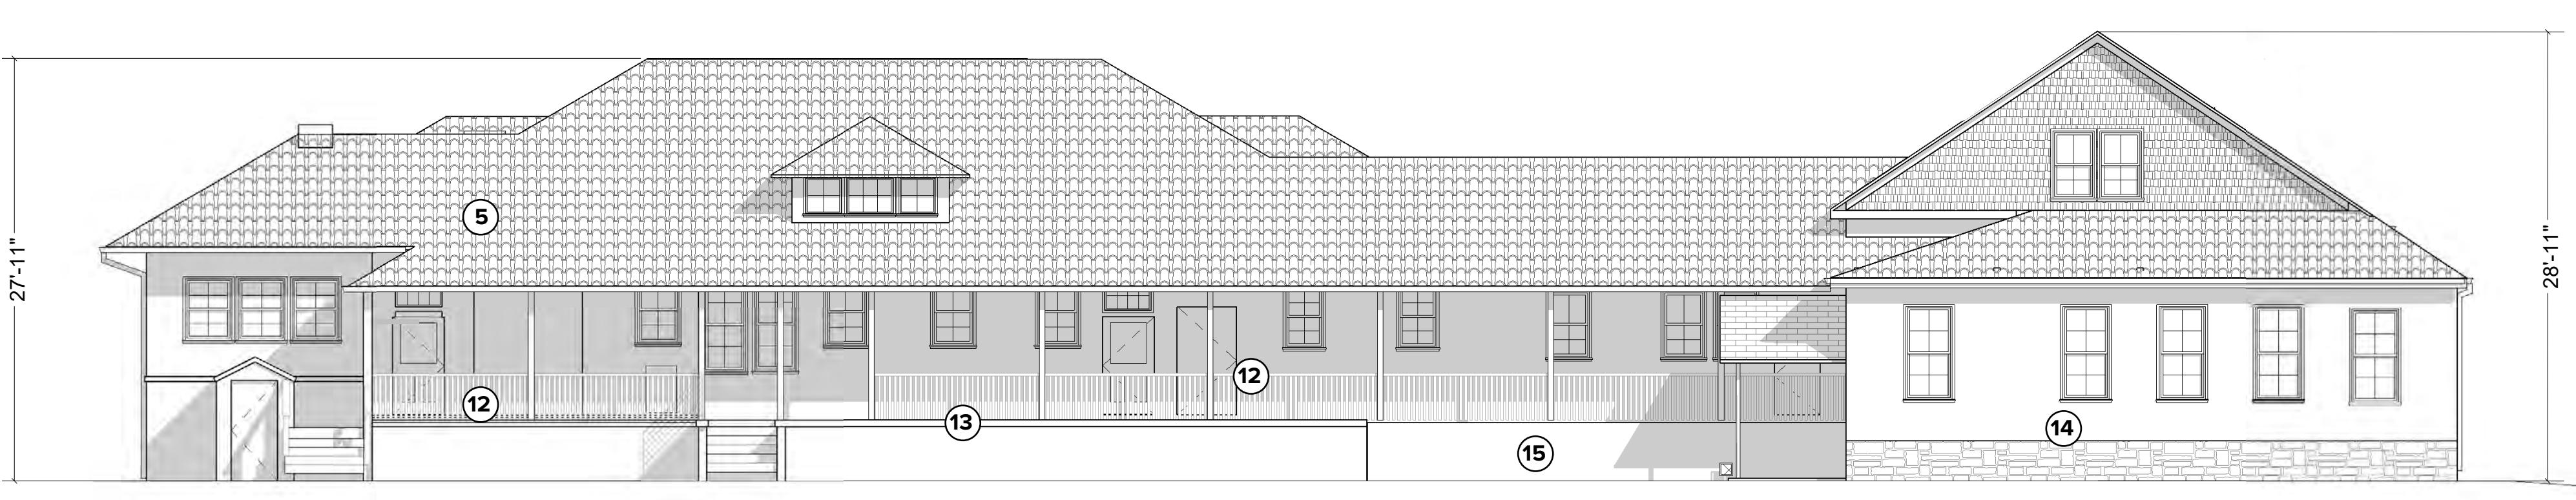
Building B Elevations

- ① REMOVE (E) RAMPS STAIRS AND PIPE RAILING TYP.
- ② REMOVE (E) INFILL WINDOWS AT (E) ENTRY PORCH
- ③ RESTORE ENTRY PORCH DETAILING INCLUDING ARCHWAYS
- ④ PROVIDE NEW CONCRETE STAIR AND RAILING AT FRONT ENTRY

- ⑤ REMOVE (E) ASPHALT SHINGLES. RESTORE TILE ROOF PER HISTORIC IMAGES. REPAIR RAFTER TAILS AND INTEGRAL GUTTER AS REQUIRED.
- ⑥ RESTORE (E) WINDOWS. NEW WOOD WINDOWS TO MATCH (E) DIVIDED LIGHTS, OVERHEAD OPERATION

14 REPAIR/ REFINISH (E) STONE FOUNDATION

15 LOCATE HVAC EQUIPMENT BELOW DECK

16 NEW RAISED WOOD DECK AND ADA RAMP

The only feature that is deteriorated is the cut stone, which is primarily exposed along the foundation and small sections of the east and west facades of the 1897 portion of Building B. The stone has been painted, which captured moisture. As a result, the outer surface is spalling, which has accelerated the weathering. The precise treatment of the stone has not been determined. A qualified building materials conservator will be retained to further assess the condition of the stone and recommend a treatment ranging from preservation to consolidation. At a minimum the stone will be preserved, which means the paint will be removed and a new permeable coating will be applied to stop future decay.

In addition, some stone units have fallen from the west facade as a result of seismic activity. To address both the fallen stones and the structural condition of the remaining stones, the architect and structural engineer have devised a solution that includes reinforcing the existing building walls with shotcrete installed on the interior side of the walls, and then attaching the existing stone (including stones that have fallen and will be re-installed) to the new shotcrete structure using reinforcing steel and epoxy (see **Figure 18**).

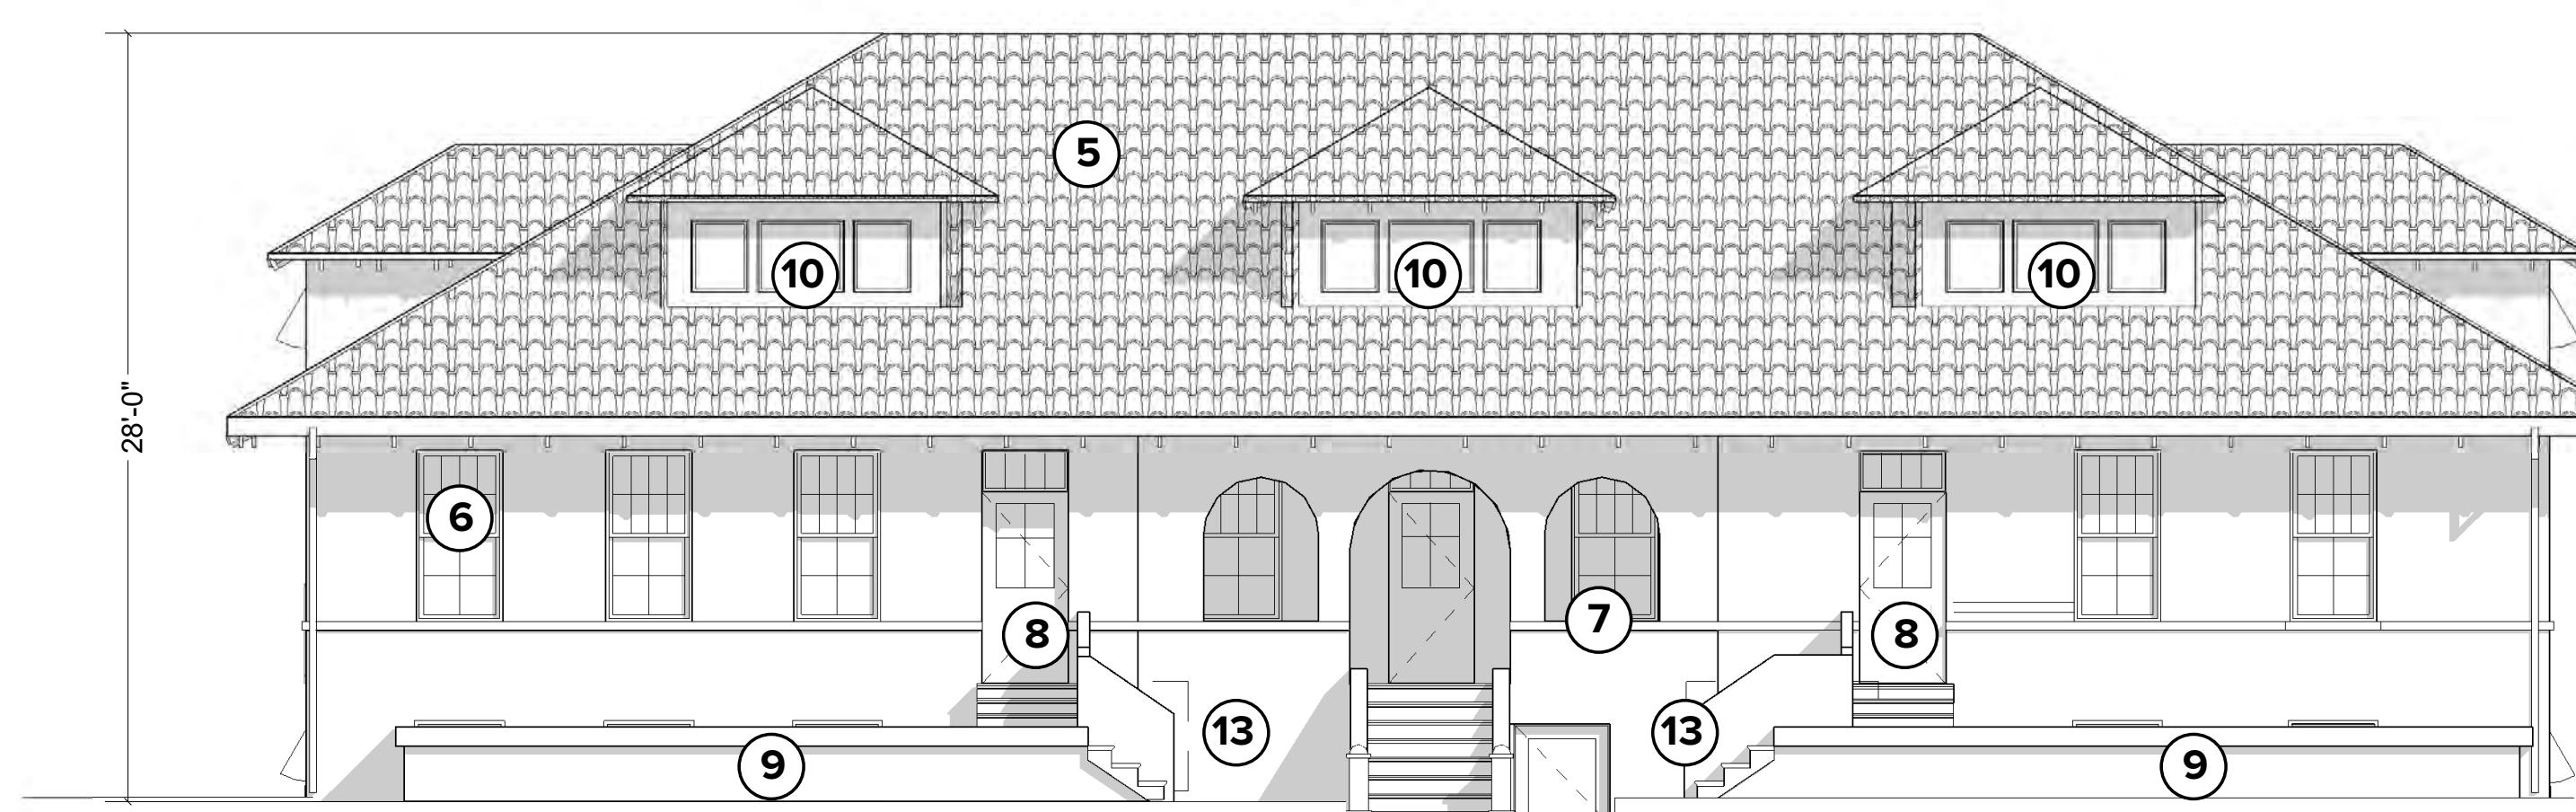
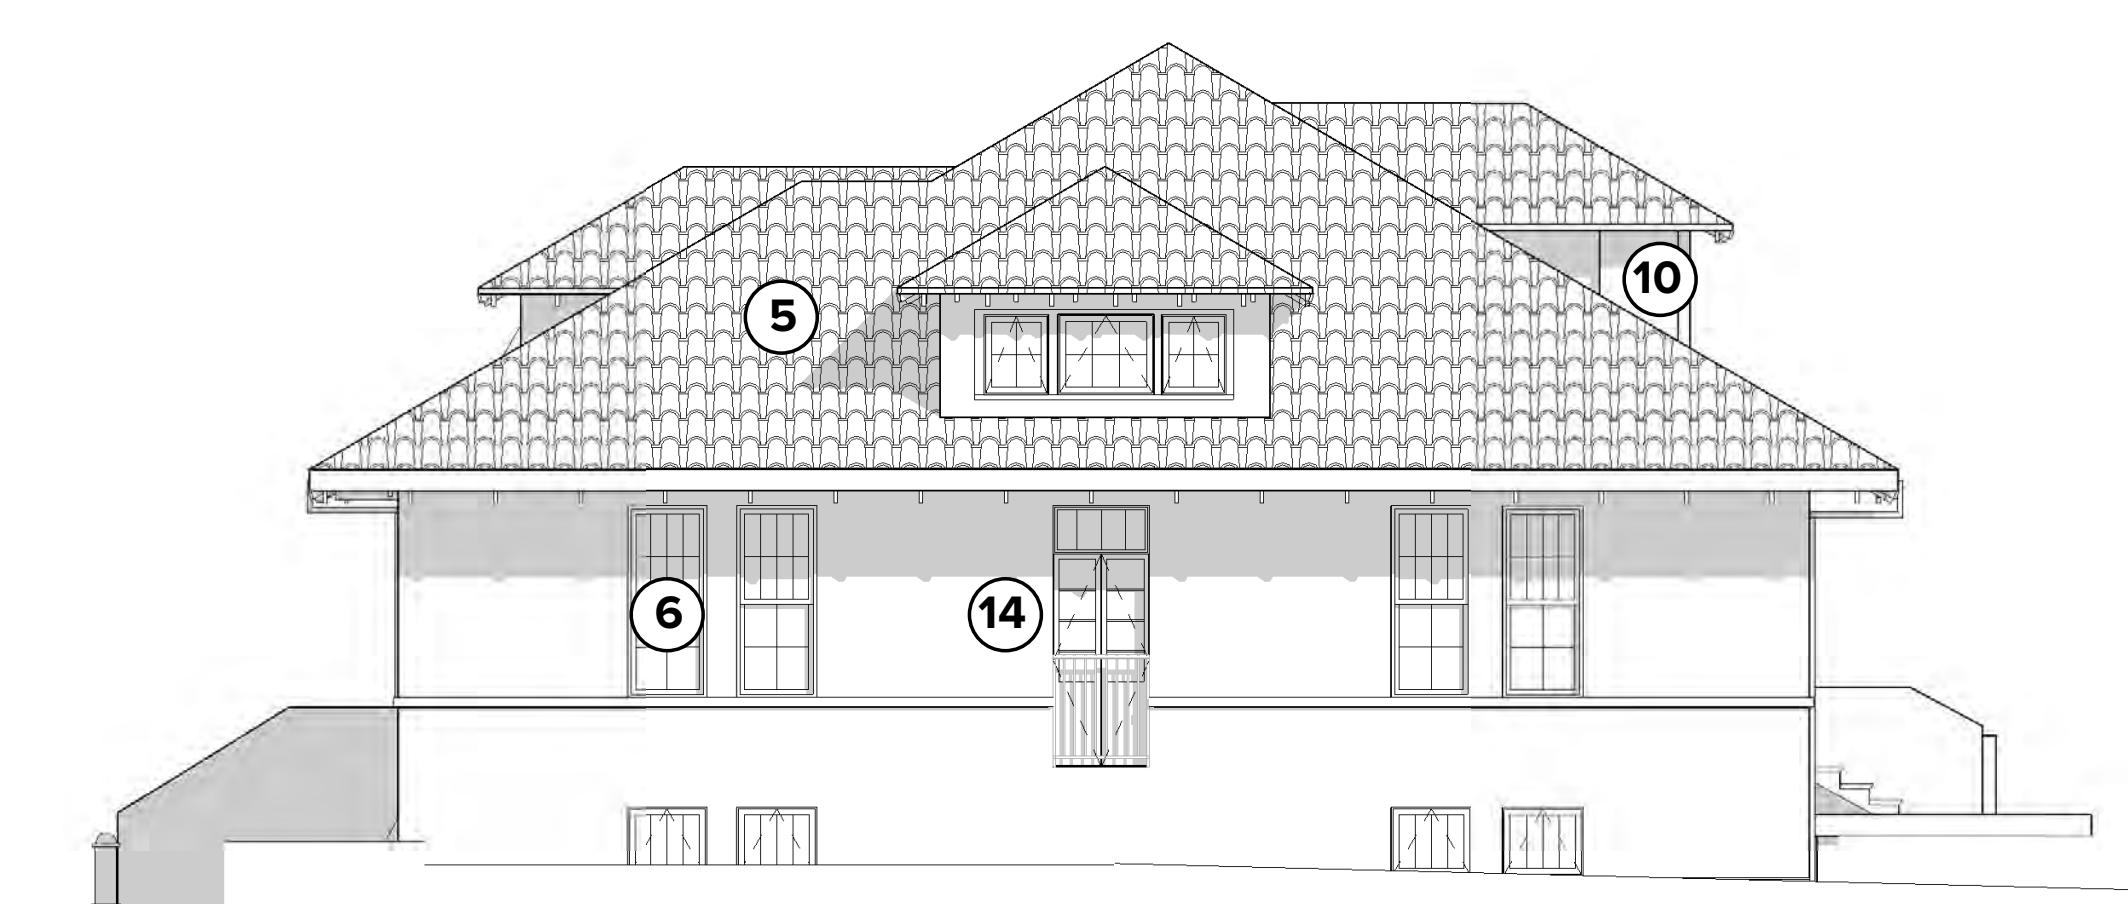
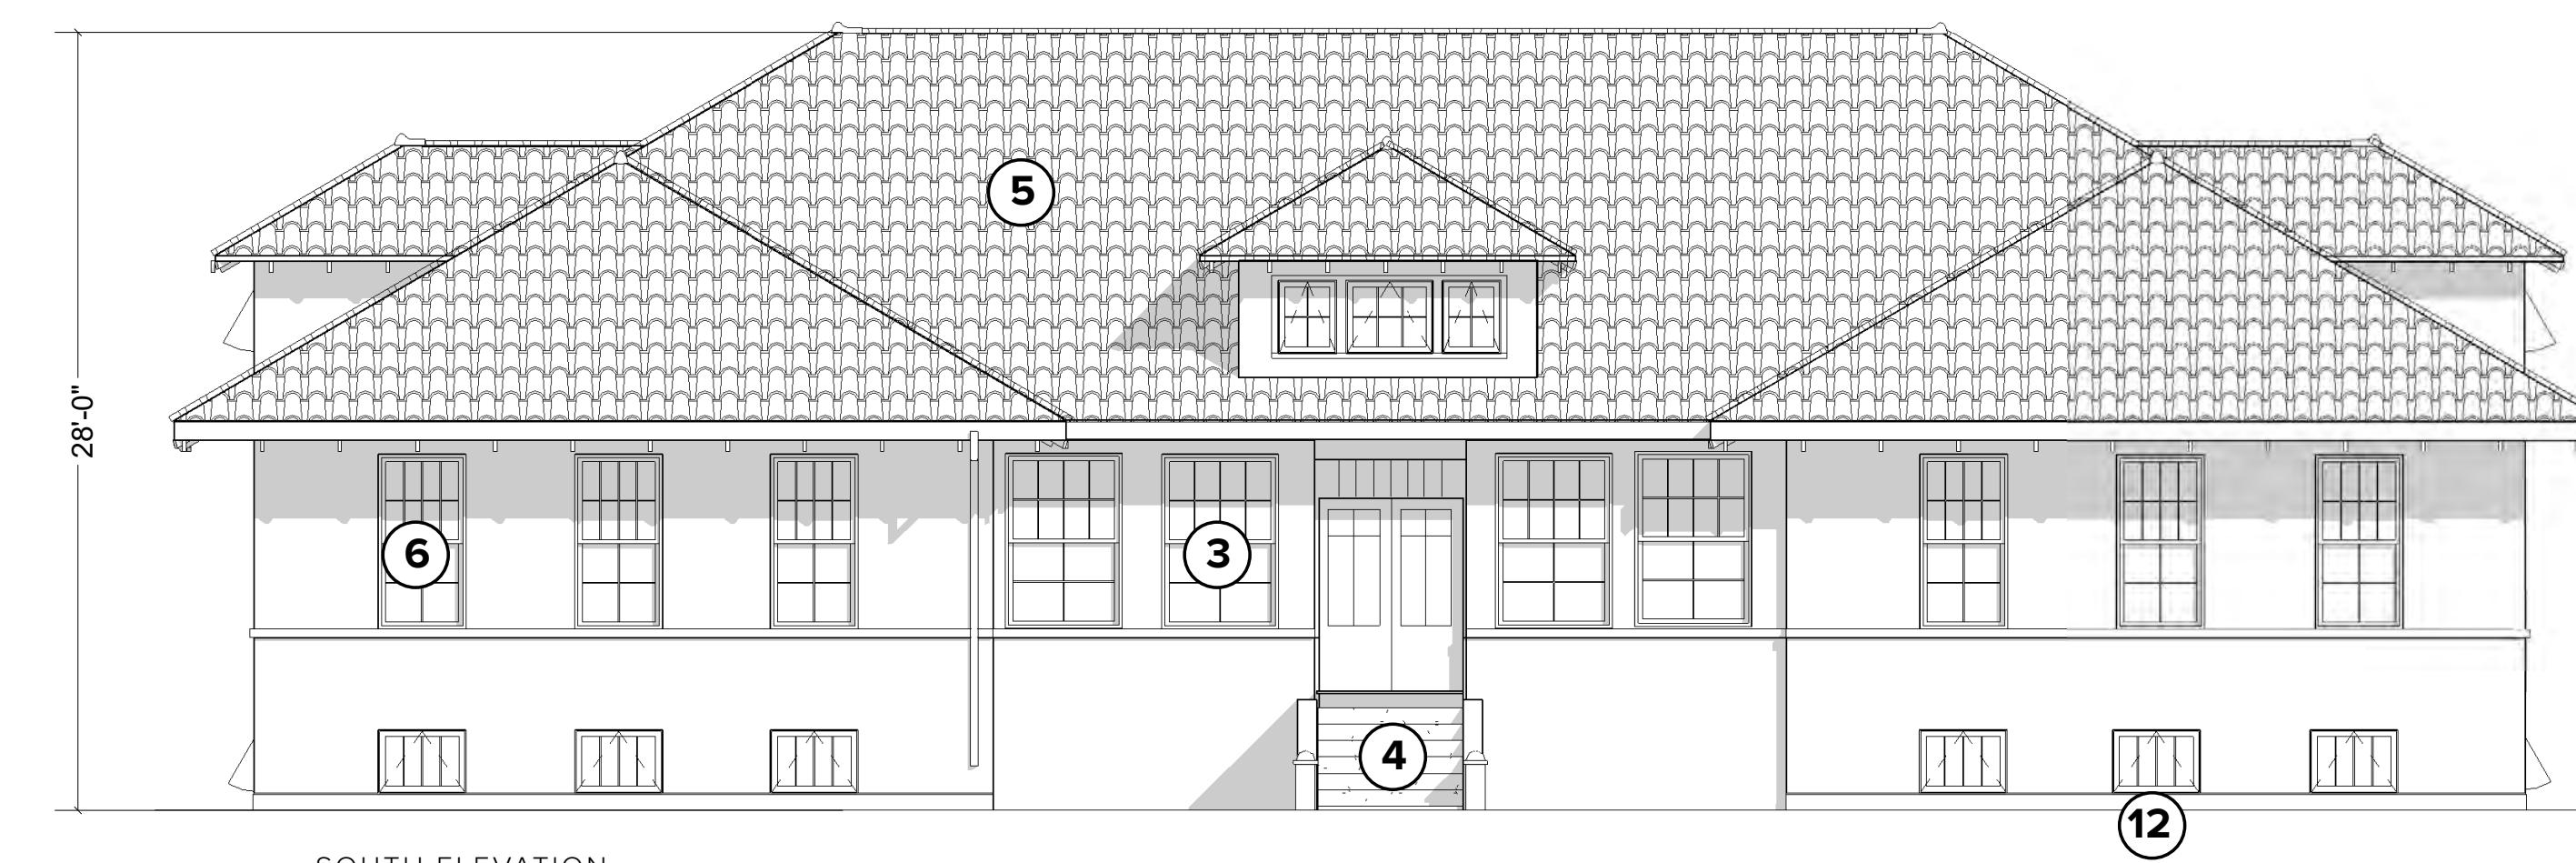
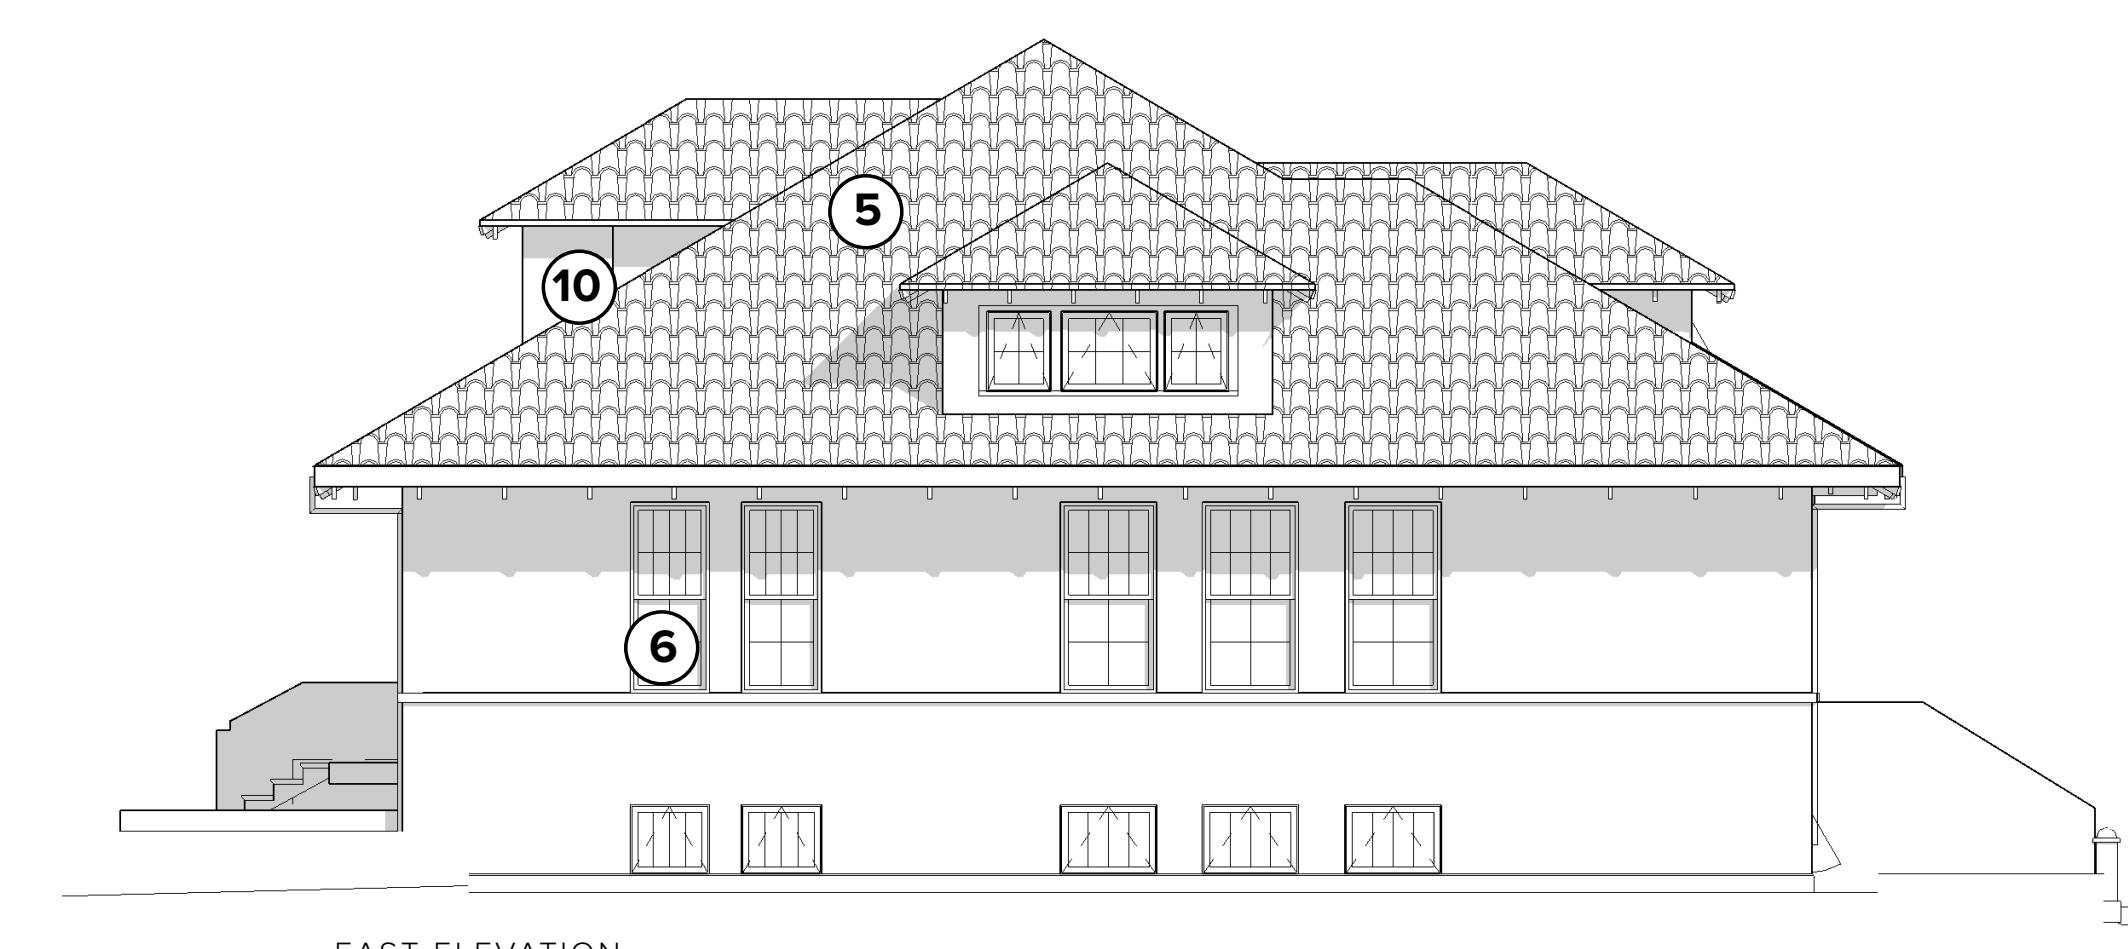
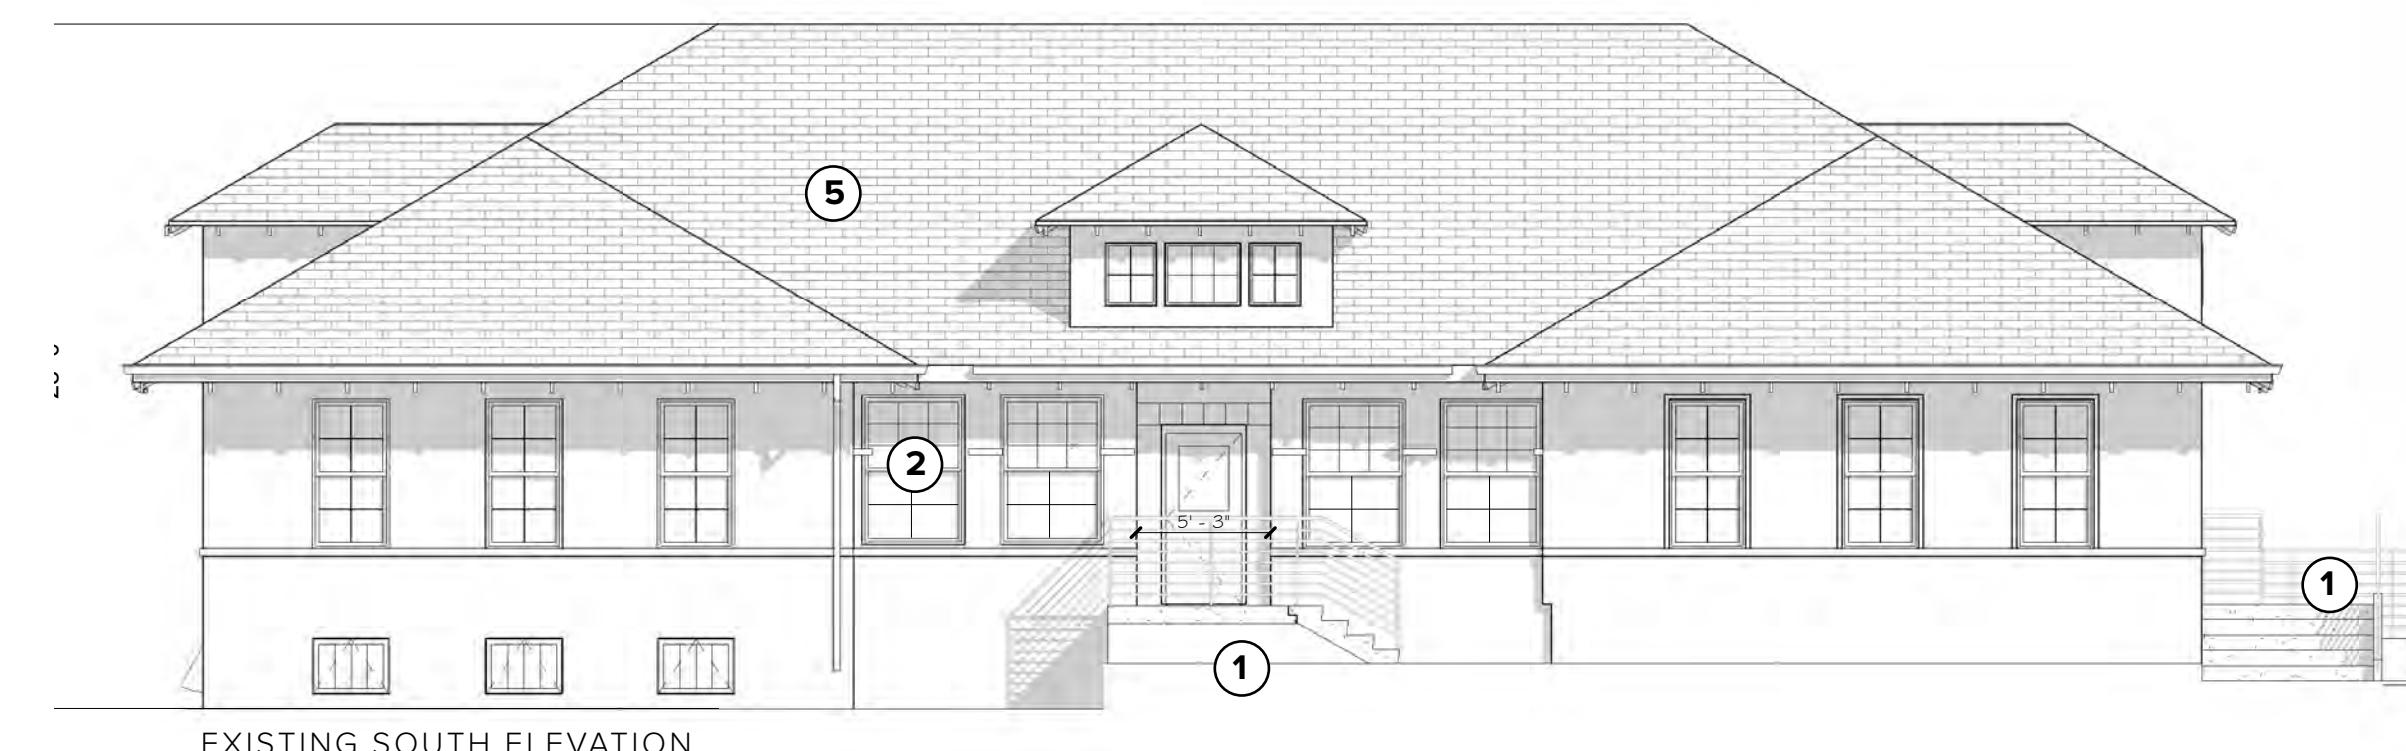
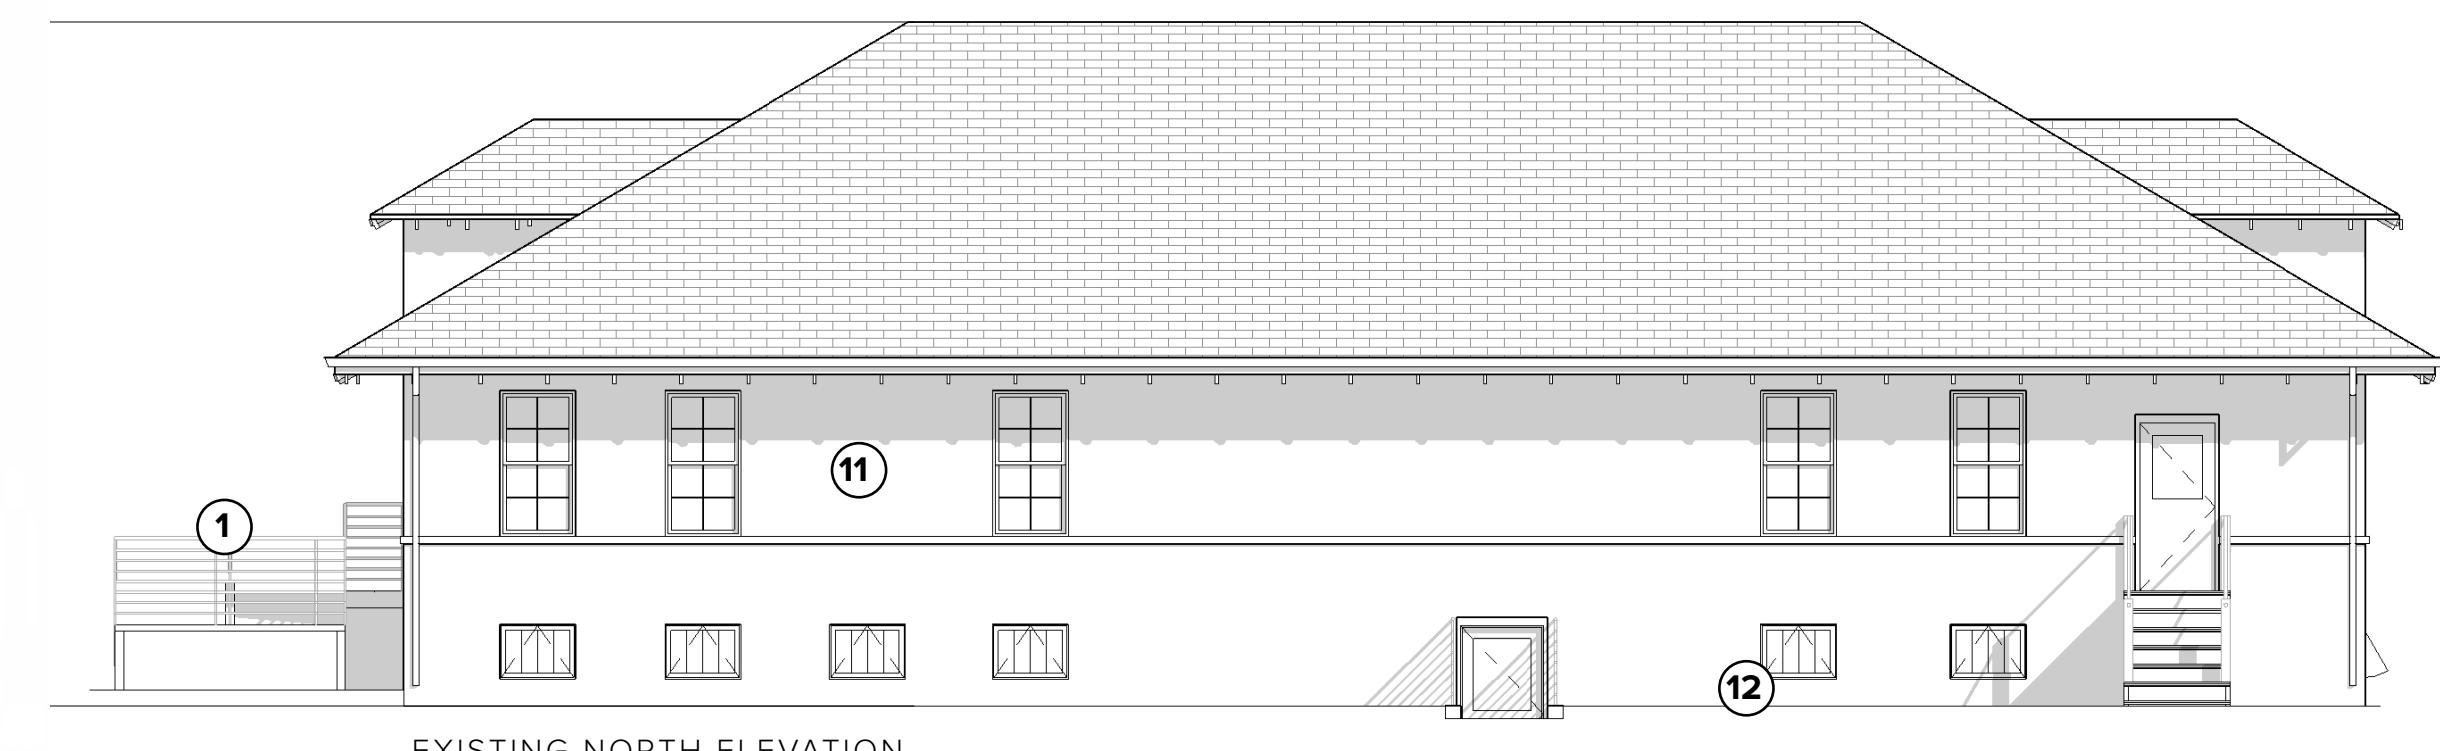
Building C Elevations

- ⑨ PROVIDE NEW STAIR AND RAISED DECK AT EACH UNIT ON THE BACK OF BUILDING
- ⑩ PROVIDE NEW DORMERS TO MATCH (E) AT EACH UNIT ON THE BACK OF BUILDING
- ⑪ UNCOVER INFILL WINDOWS WHERE FEASIBLE, PROVIDE NEW WOOD WINDOW TO MATCH (E)

- ⑫ REPAIR BASEMENT WINDOW VENTS TO MATCH (E)
- ⑬ LOCATE HVAC EQUIPMENT BELOW DECK
- ⑭ INFILL JULLIETTE BALCONY AT EXISTING DOOR OPENING

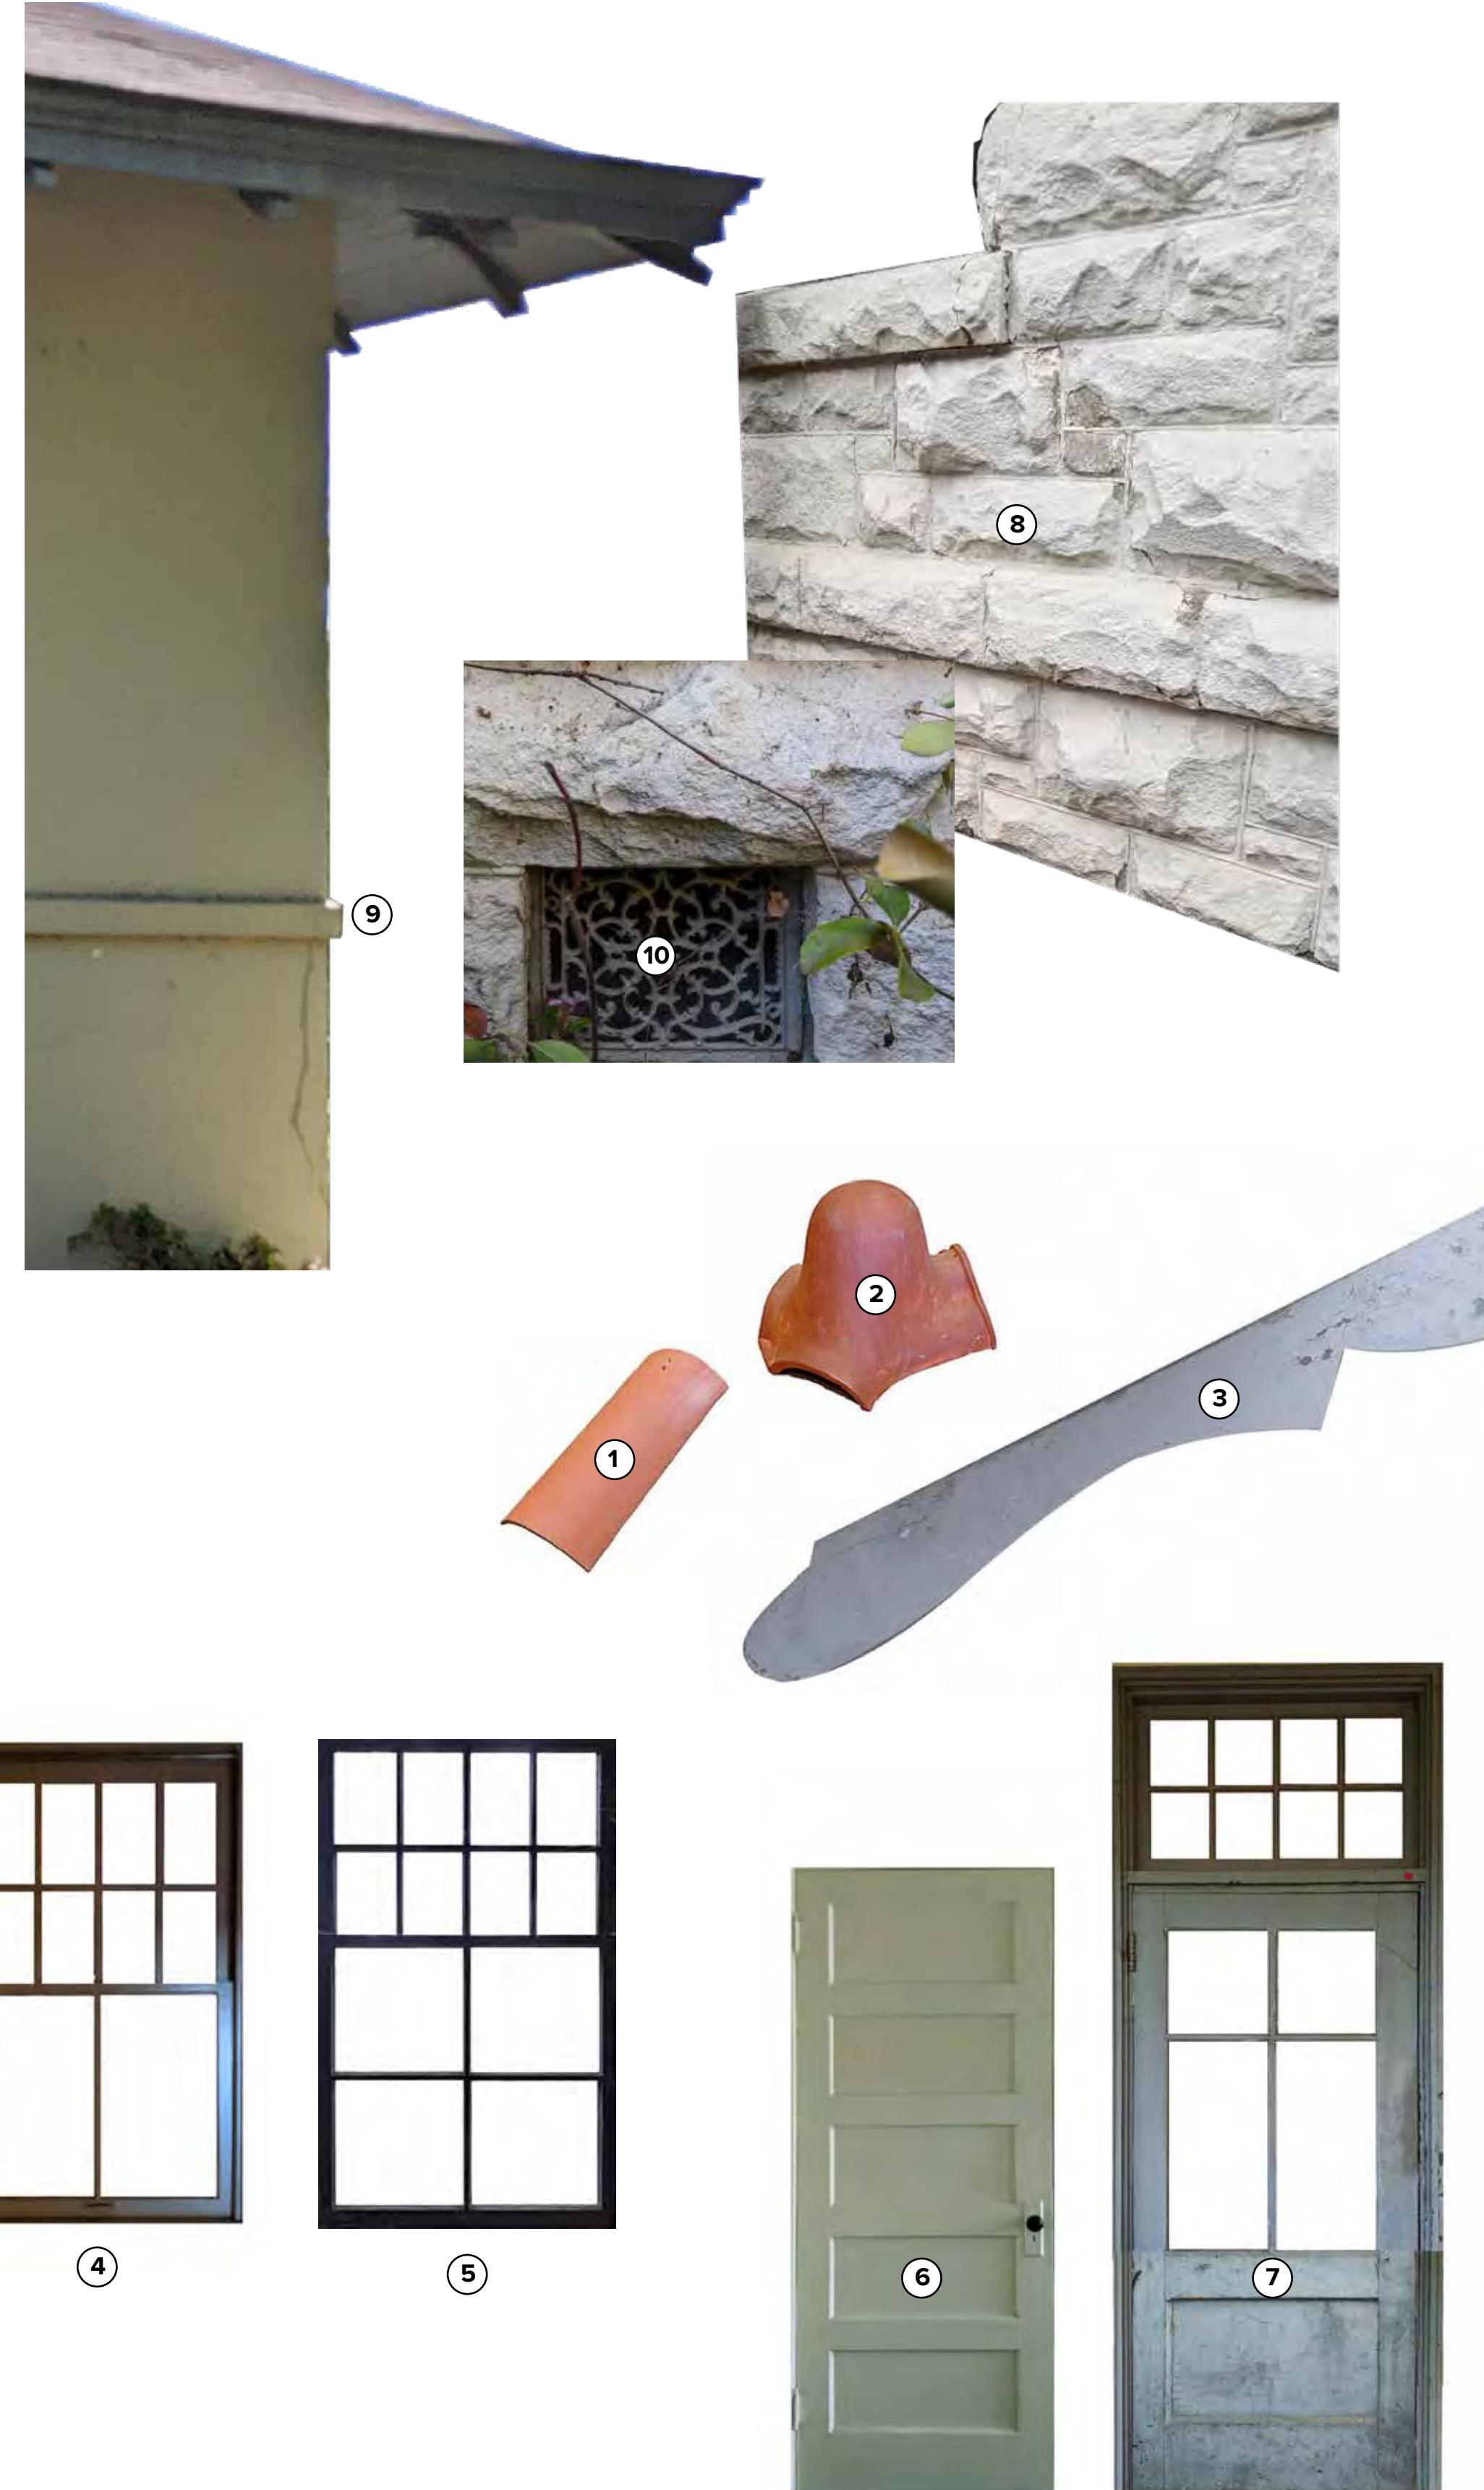
EXISTING DETAILS

- ① CLAY TILE ROOF: MISSION BARREL
- ② RAISED HIP CAP
- ③ SHAPED WOOD RAFTER TAIL
- ④ EIGHT OVER TWO DIVIDED LIGHT WINDOW
- ⑤ EIGHT OVER FOUR DIVIDED LIGHT WINDOW
- ⑥ FIVE PANEL DOOR EXTERIOR / INTERIOR
- ⑦ DIVIDED LIGHT DOOR WITH TRANSOM EXTERIOR
- ⑧ STONE BLOCK BASE : REMOVE PAINT / REPAIR
- ⑨ MID COURSE STUCCO DETAIL
- ⑩ METAL CRAWL SPACE VENTS
