MEMORANDUM

Subject: Certificate of Appropriateness, The Crescent, 2344 Old Sonoma Road

CERTIFICATE OF APPROPRIATENESS
DEC 15, 2022

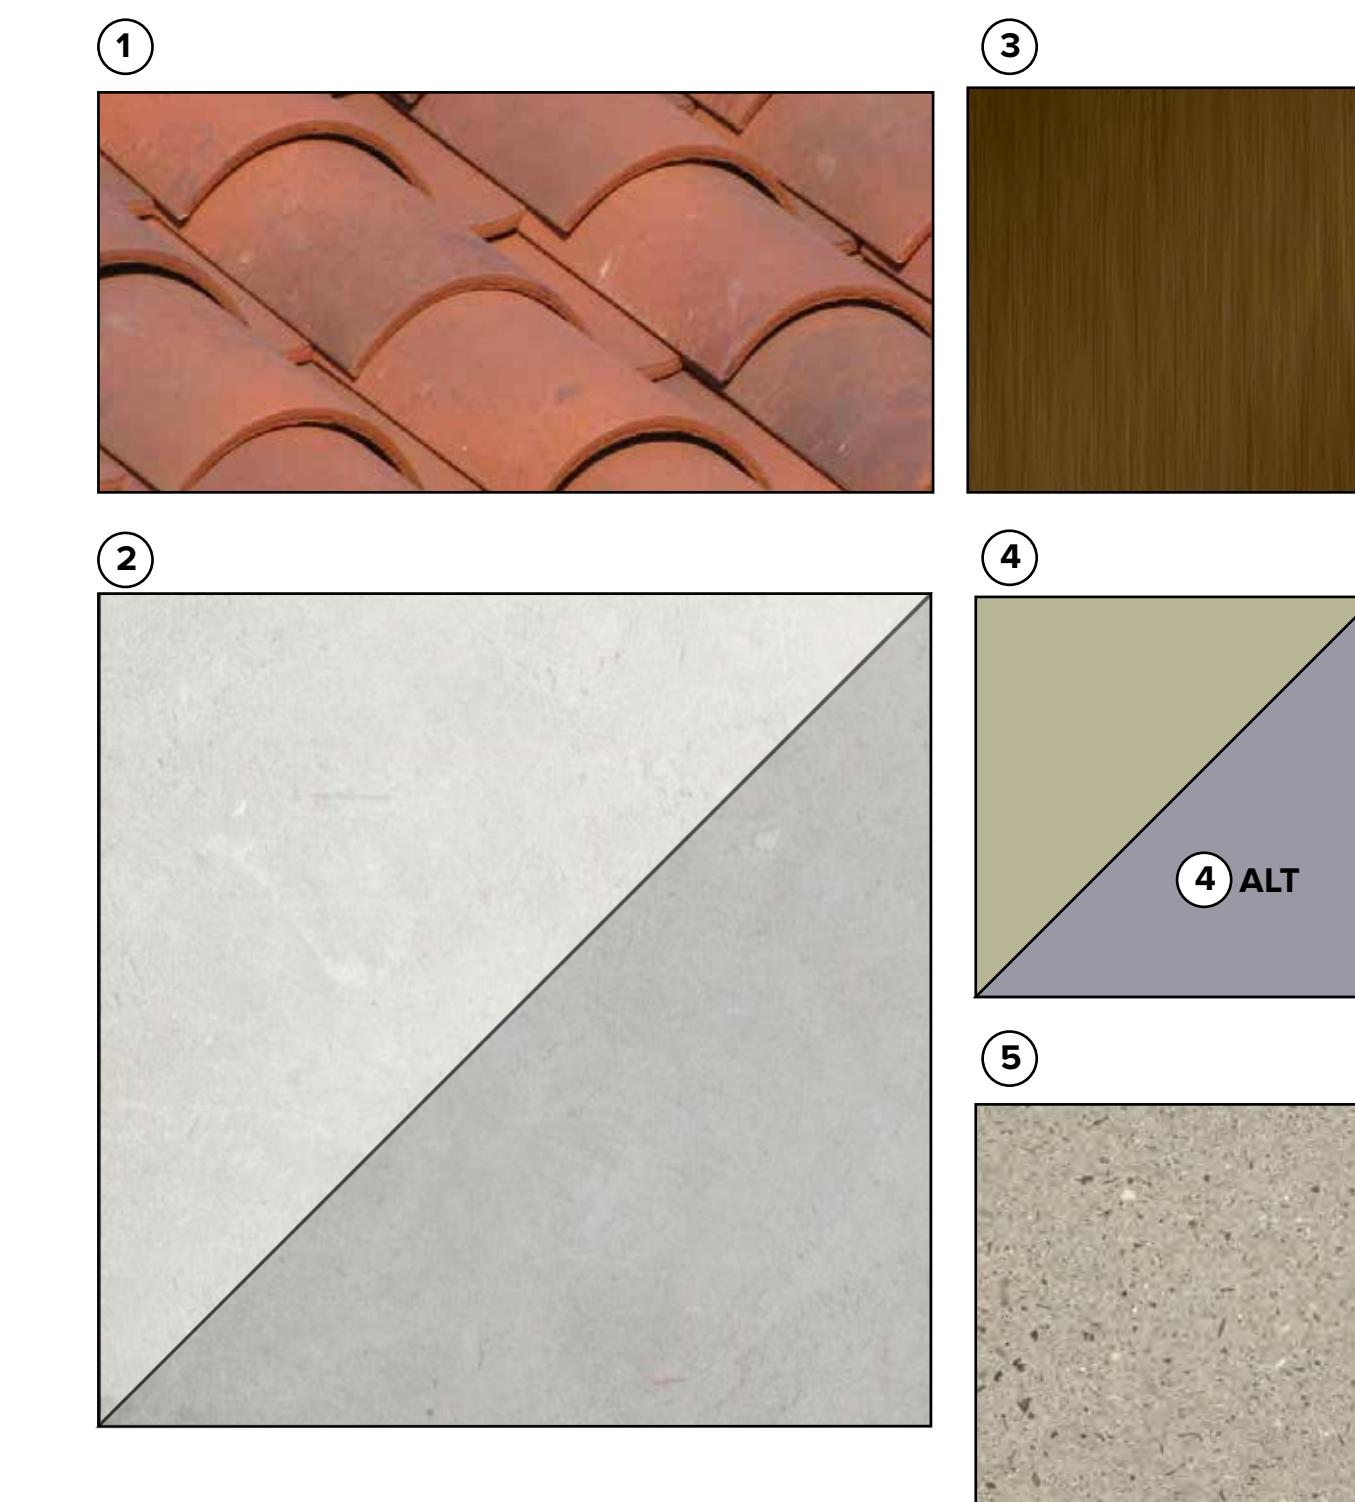
MATERIALS

- ① CLAY TILE ROOF
- ② SMOOTH STUCCO / OFF WHITE BASE STUCCO / PUTTY
- ③ METAL: OIL RUBBED BRONZE
- ④ WINDOW AND DOORS PT : PUTTY GREEN / ALT GREY BLUE
- ⑤ CONCRETE: ACID ETCH

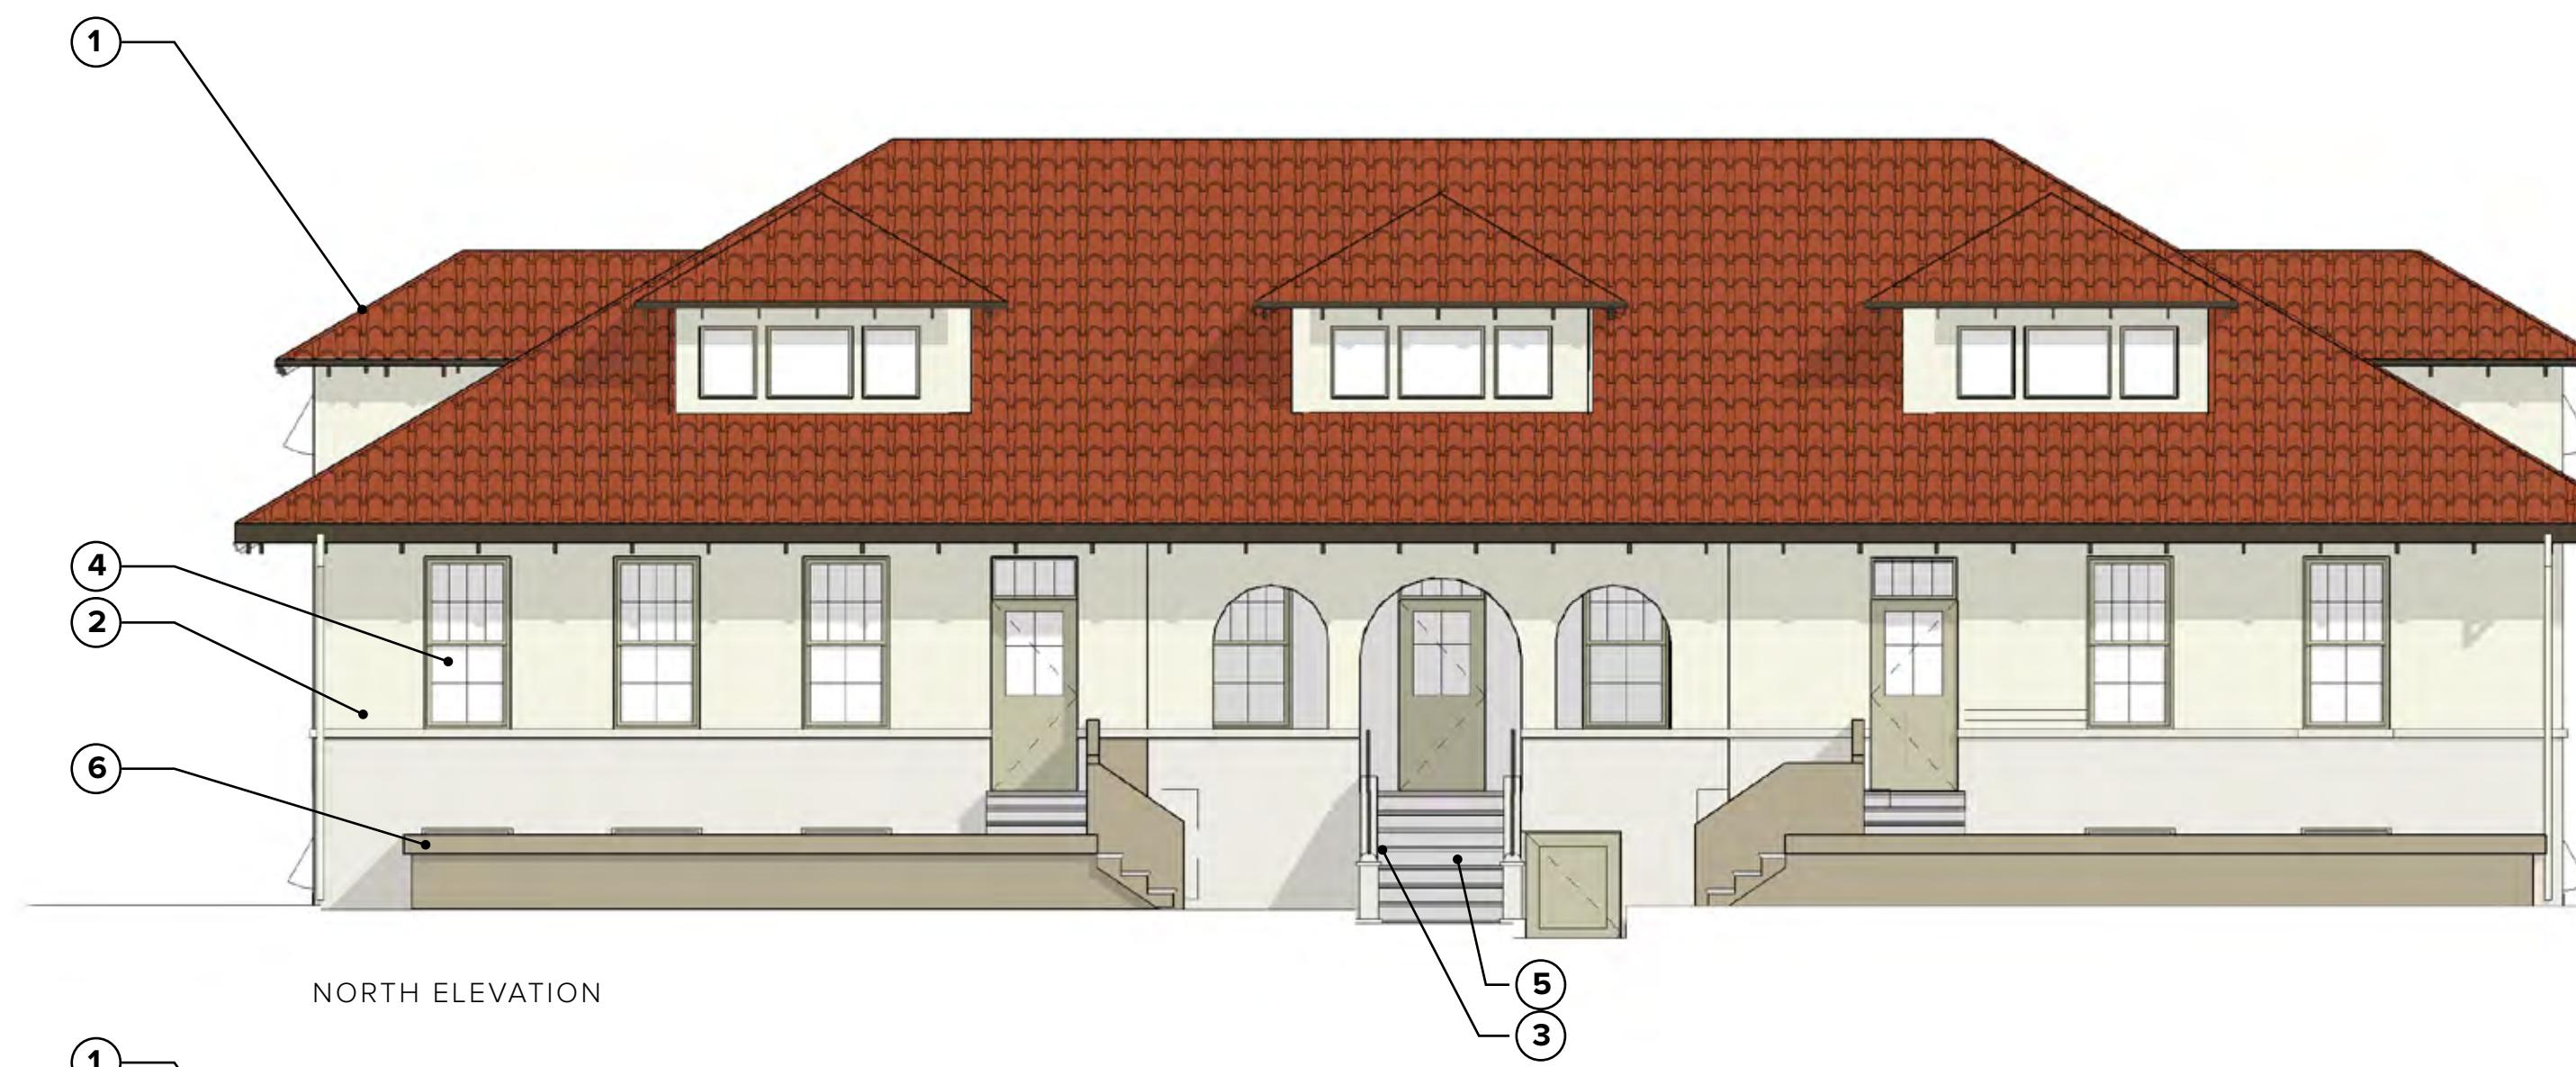
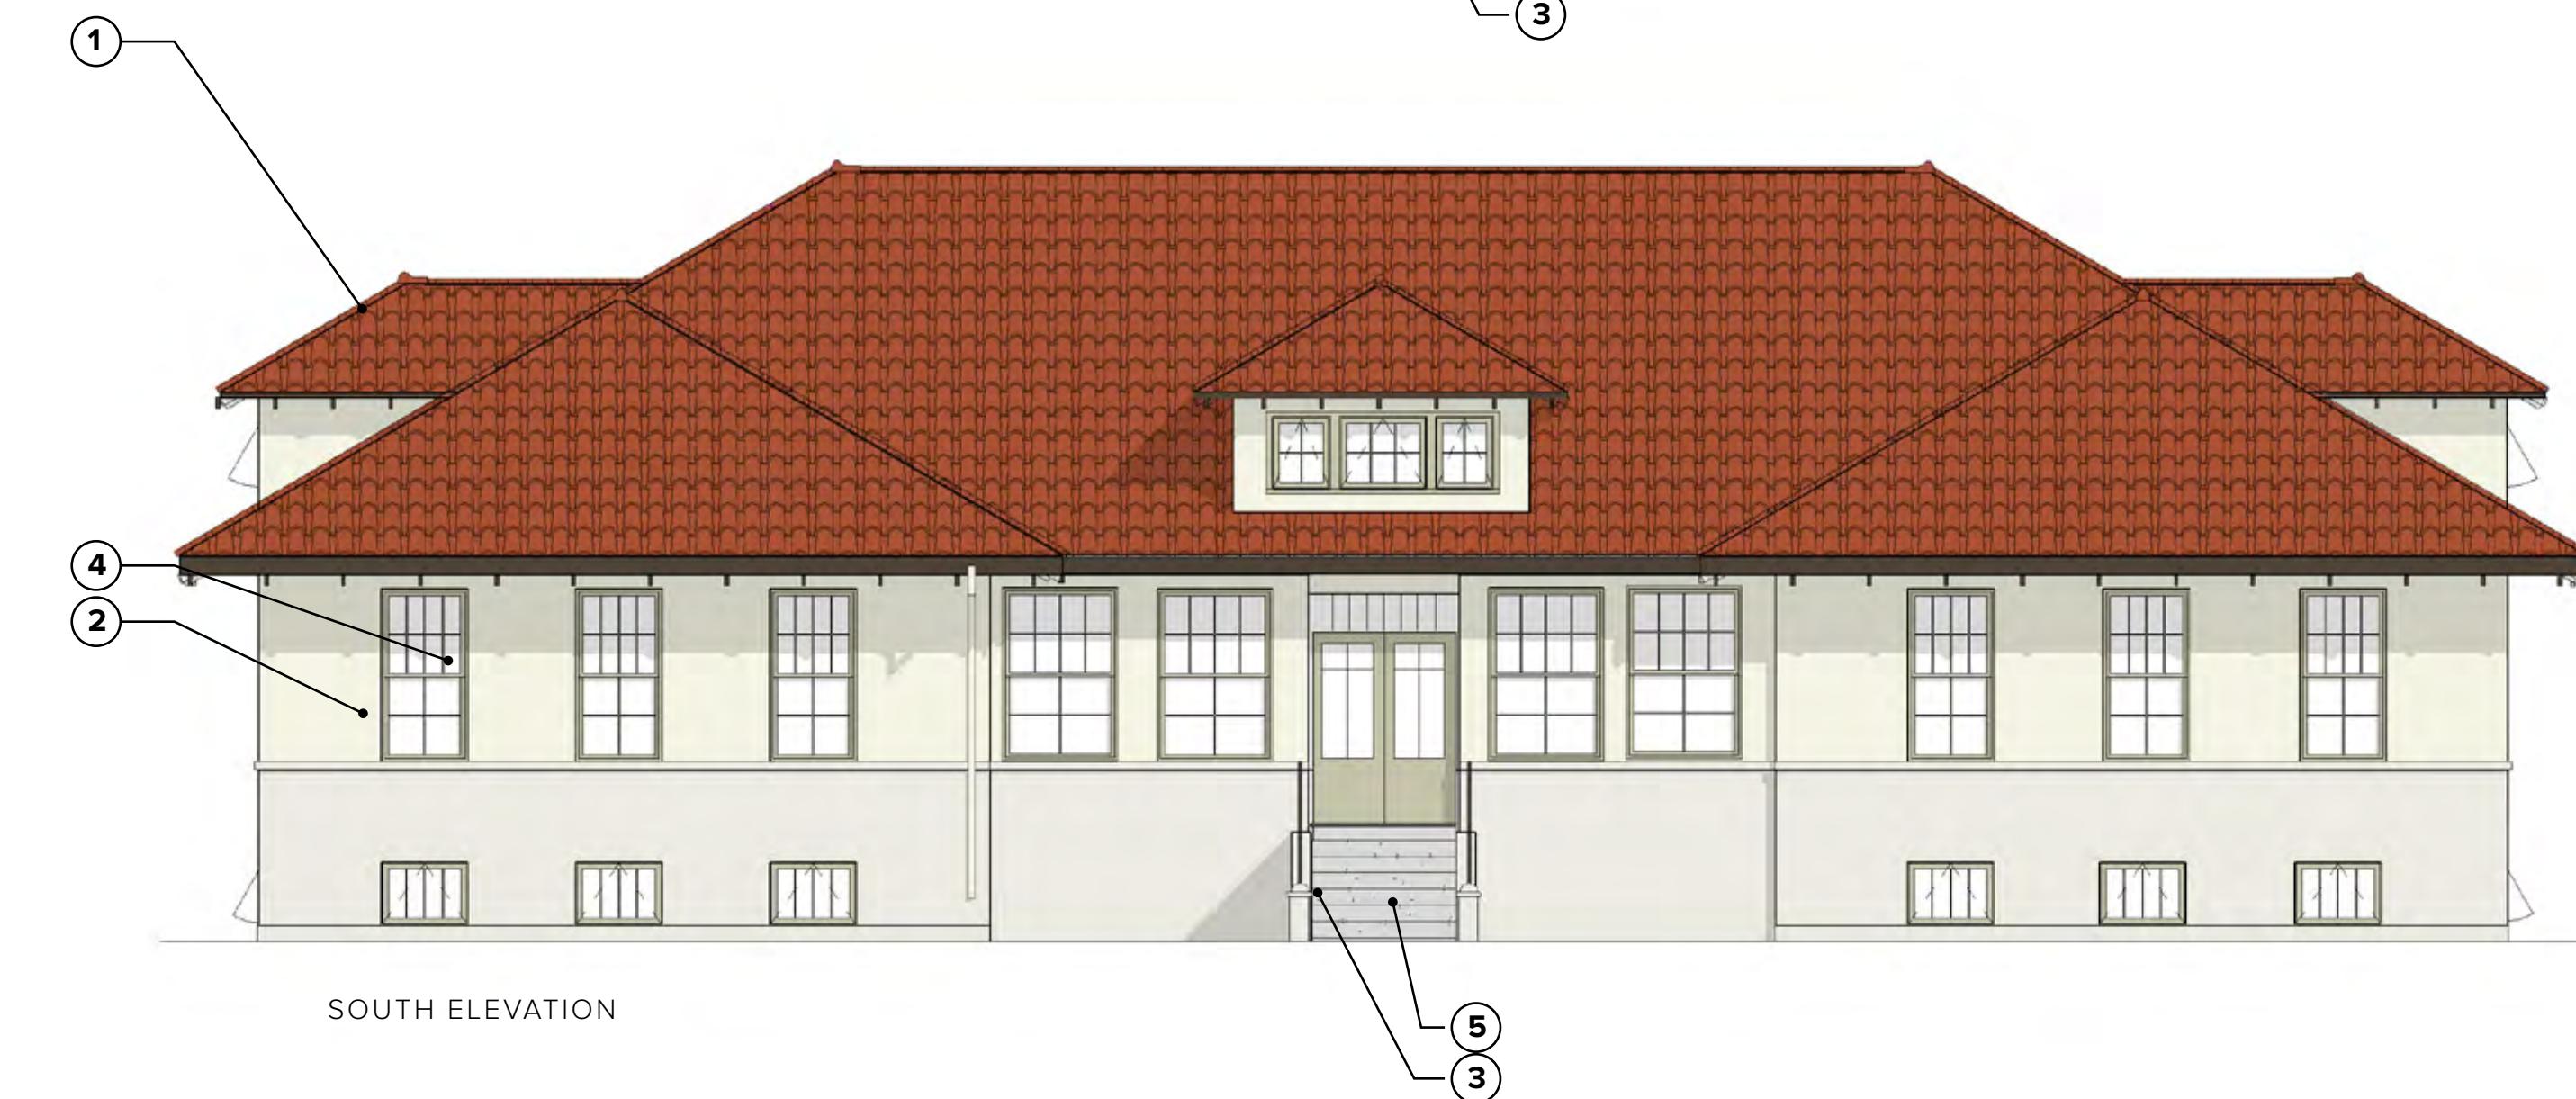
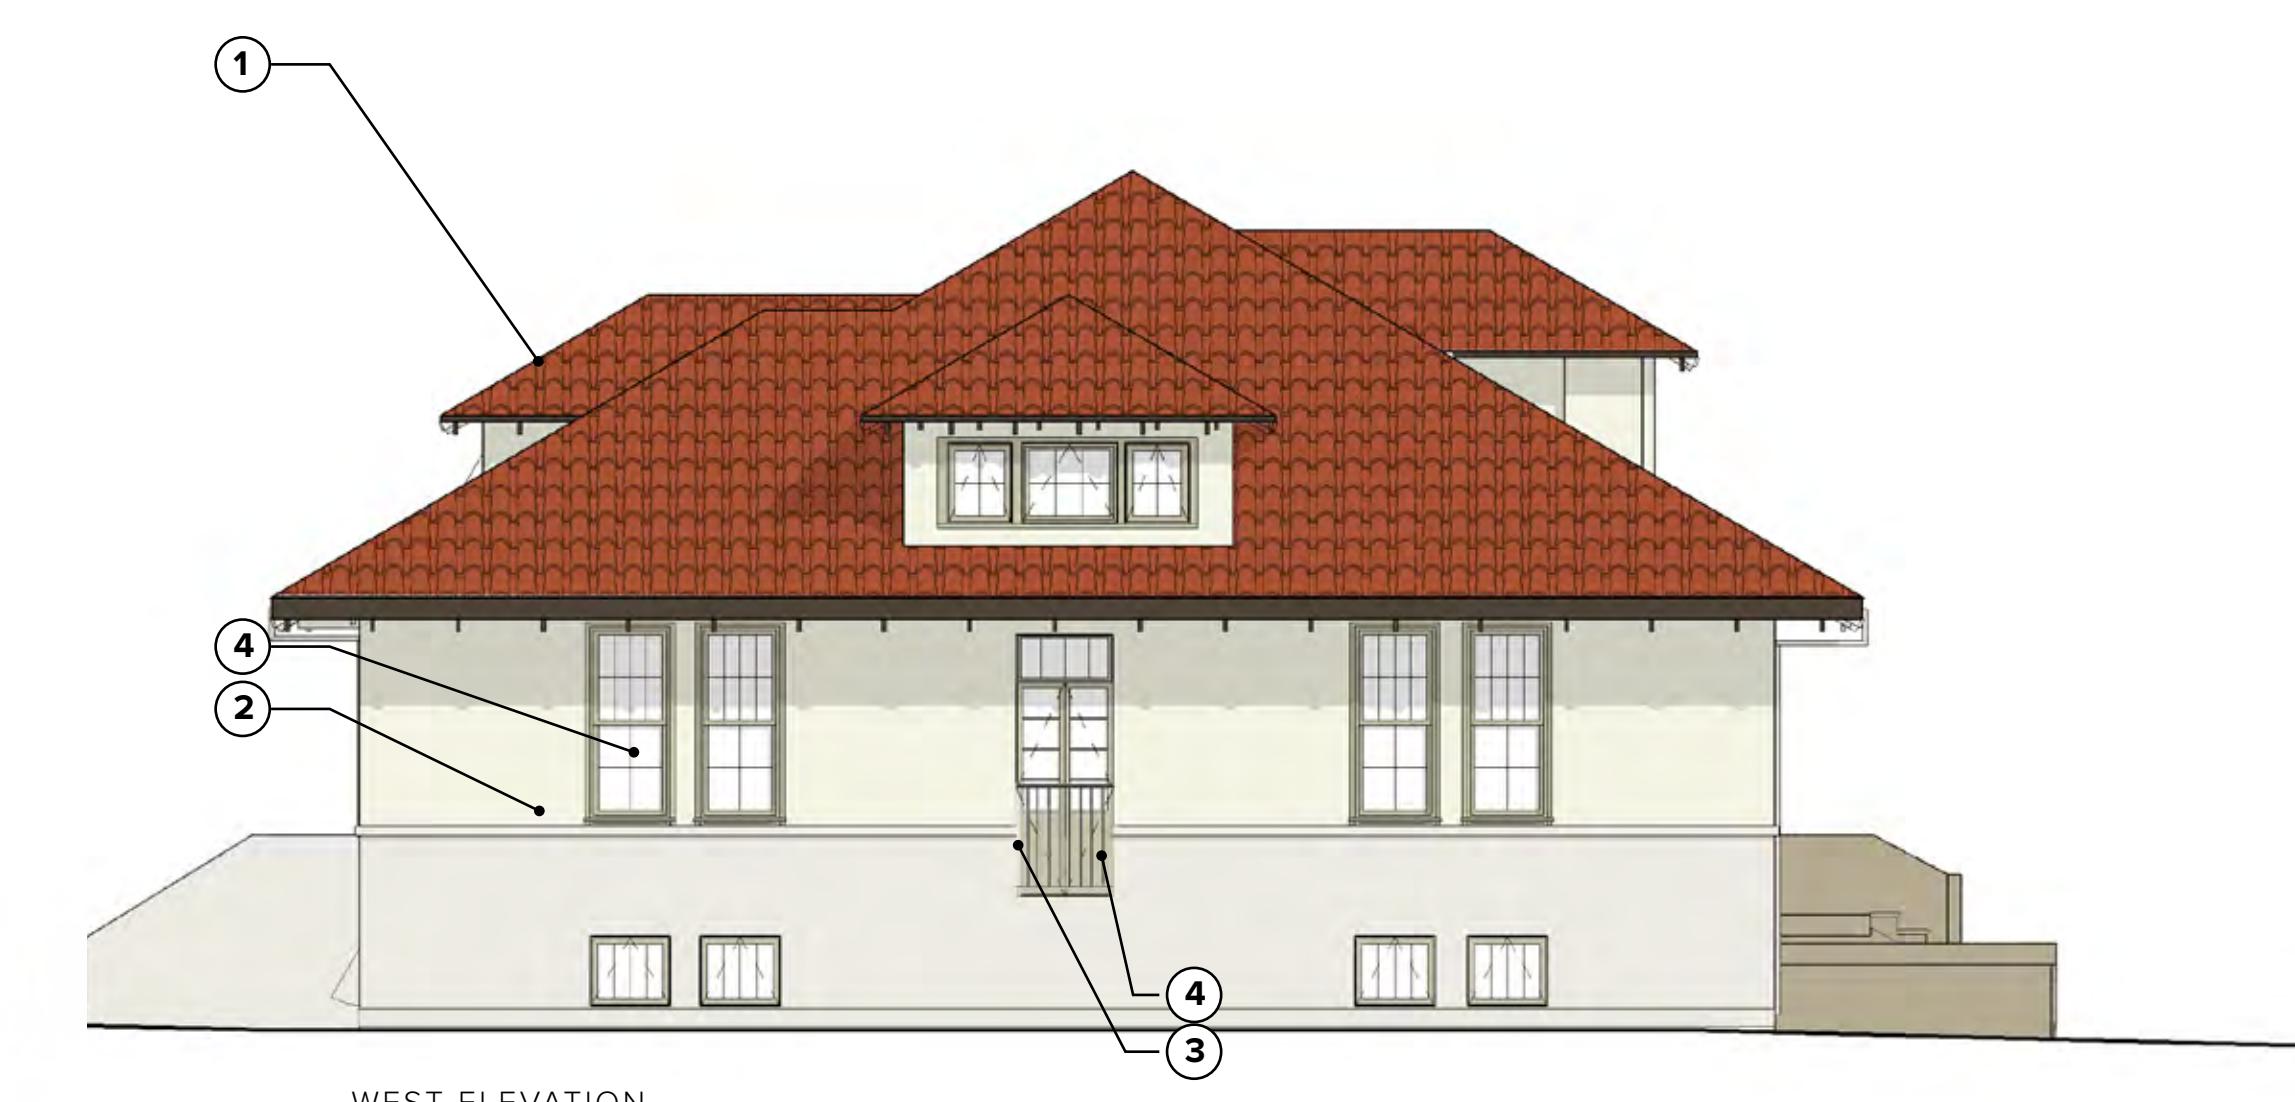
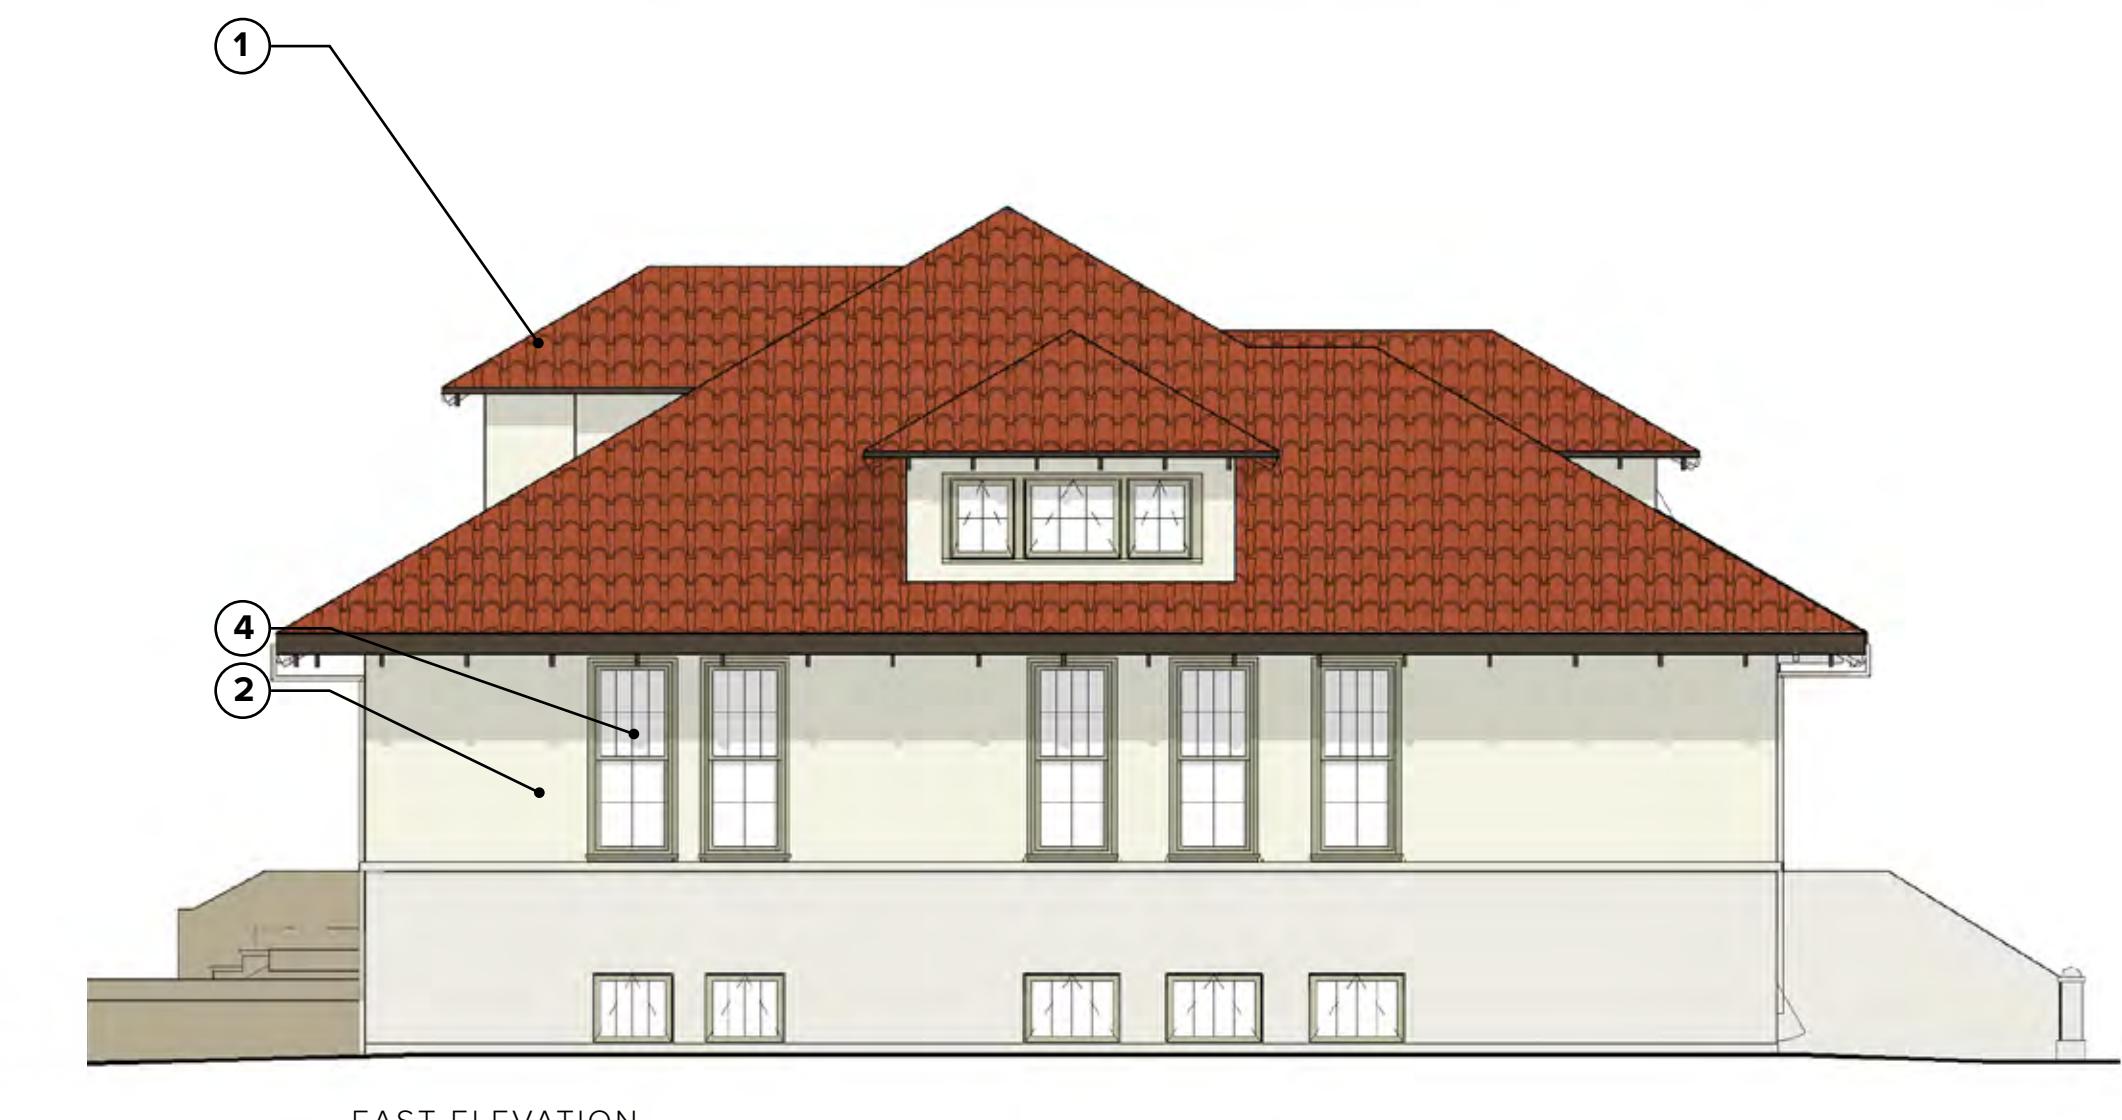
Building A&C Rendered Elevation

- ① CLAY TILE ROOF
- ② SMOOTH STUCCO / OFF WHITE
BASE STUCCO / PUTTY
- ③ METAL: OIL RUBBED BRONZE
- ④ WINDOW AND DOORS PT :
PUTTY GREEN / ALT GREY BLUE
- ⑤ CONCRETE: ACID ETCH
- ⑥ WOOD DECK

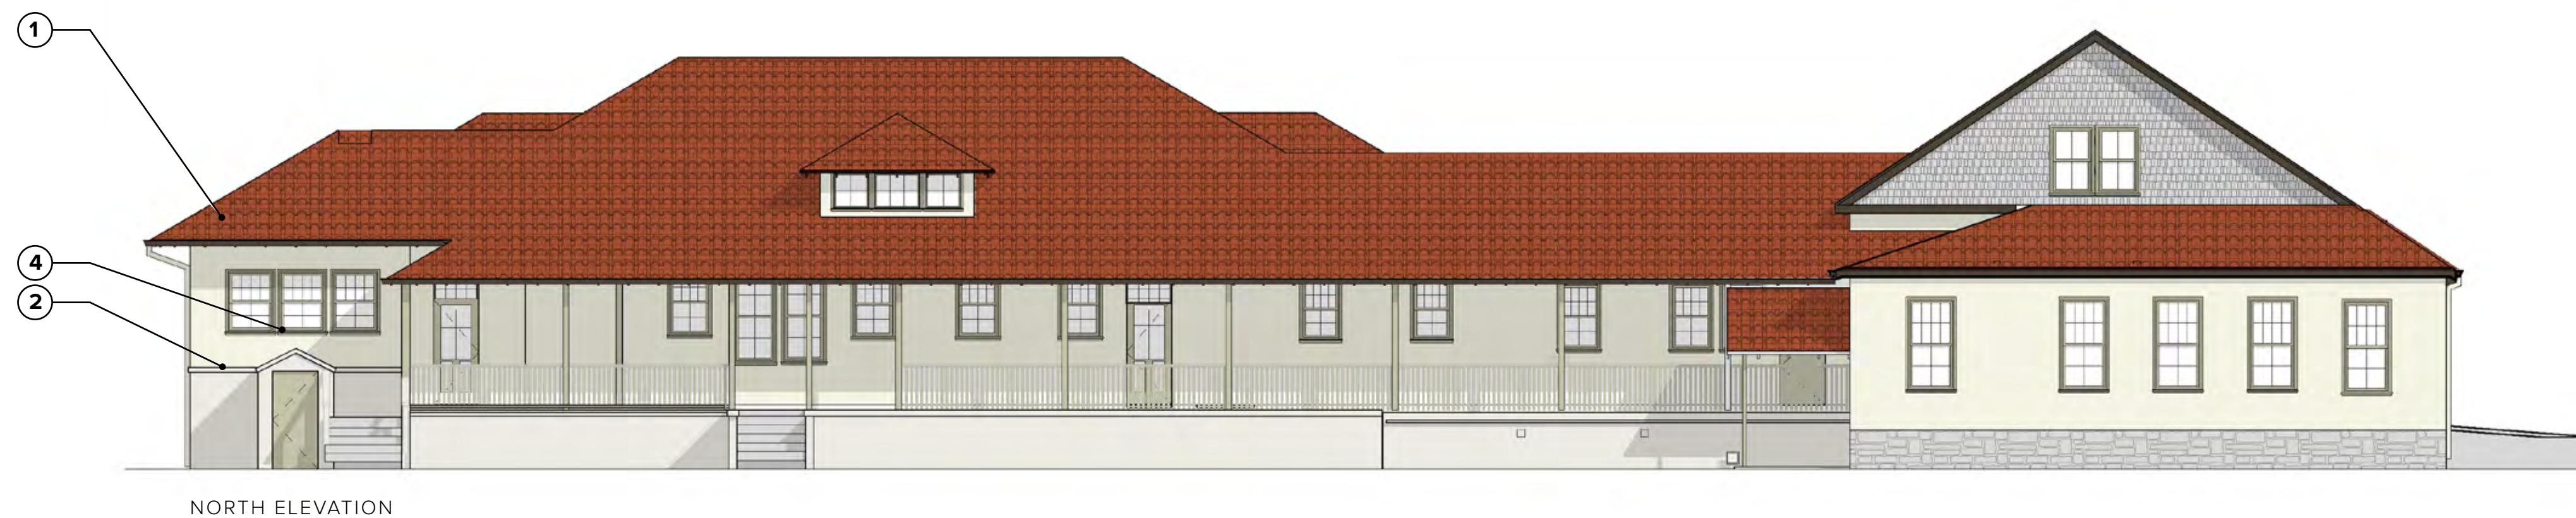
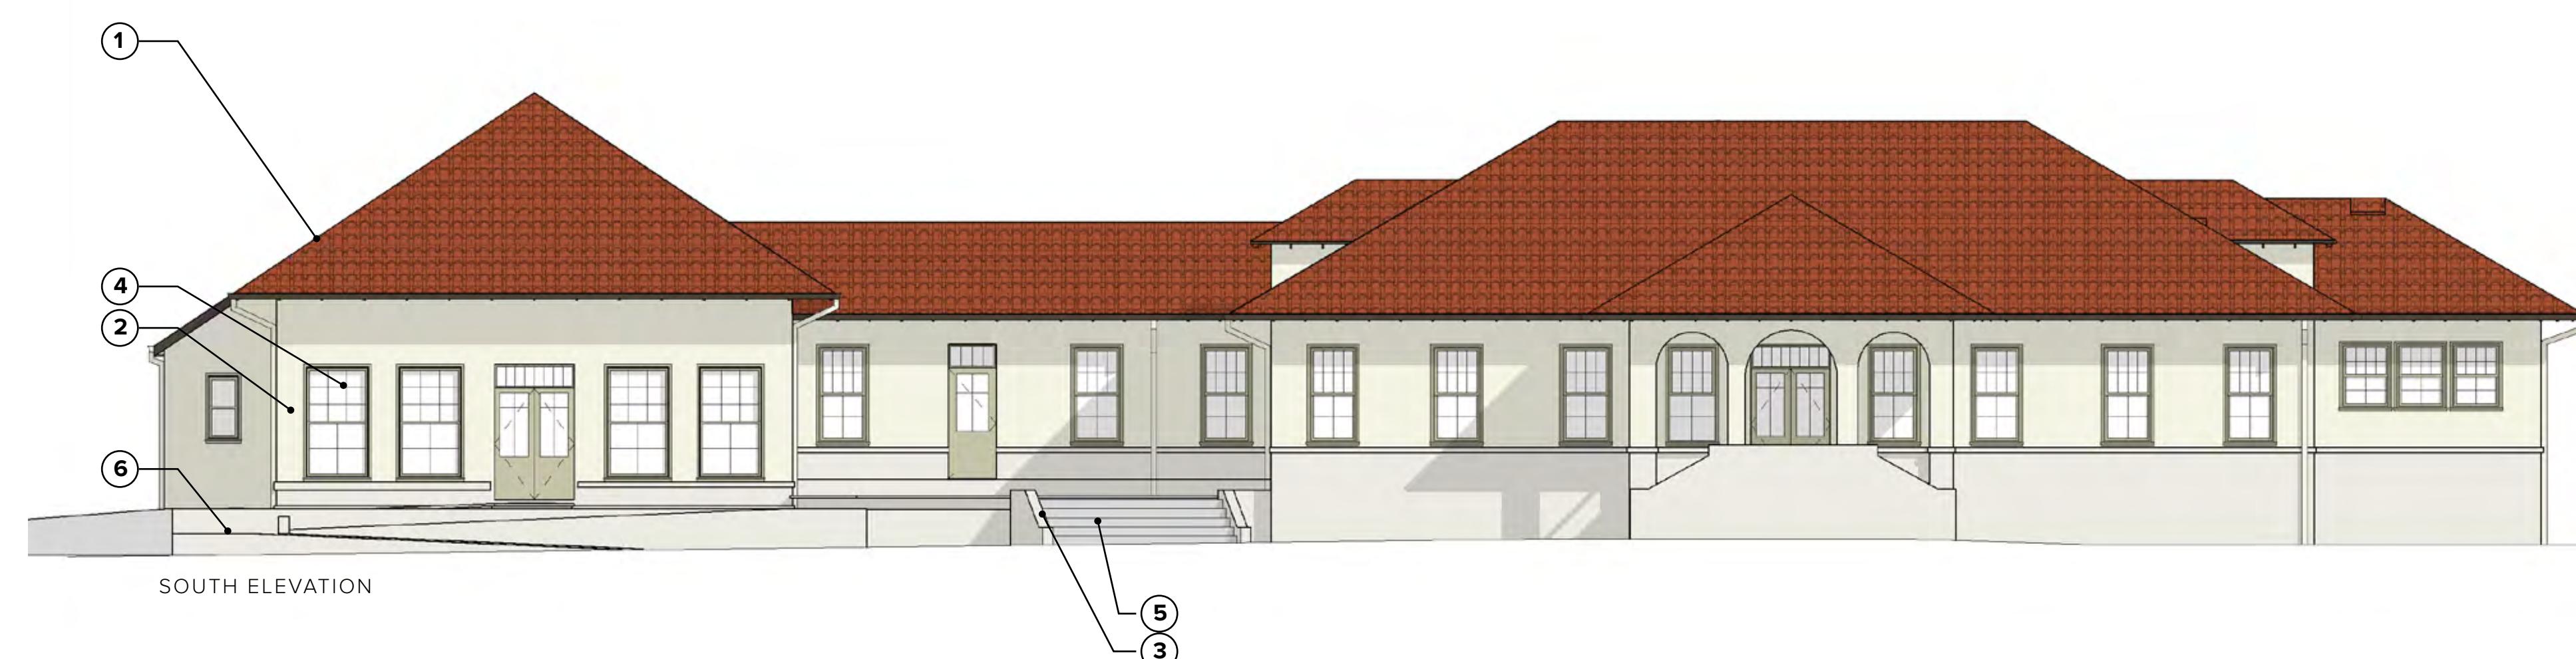
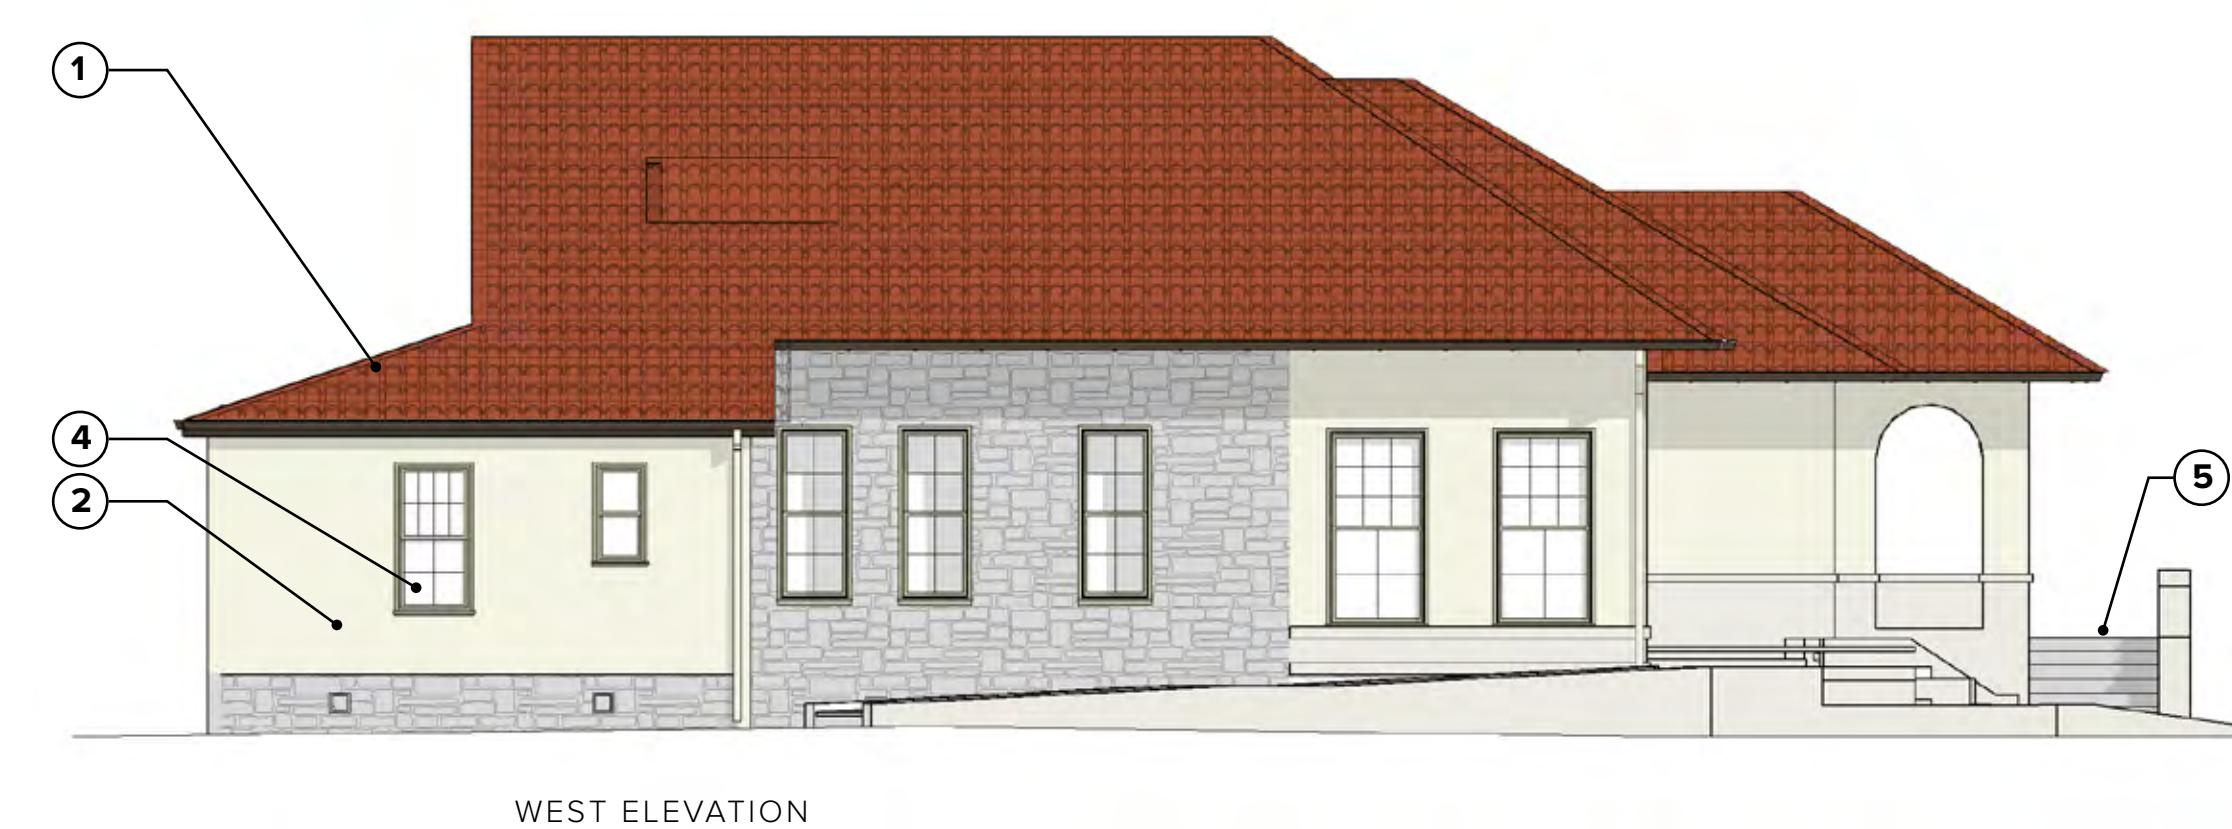
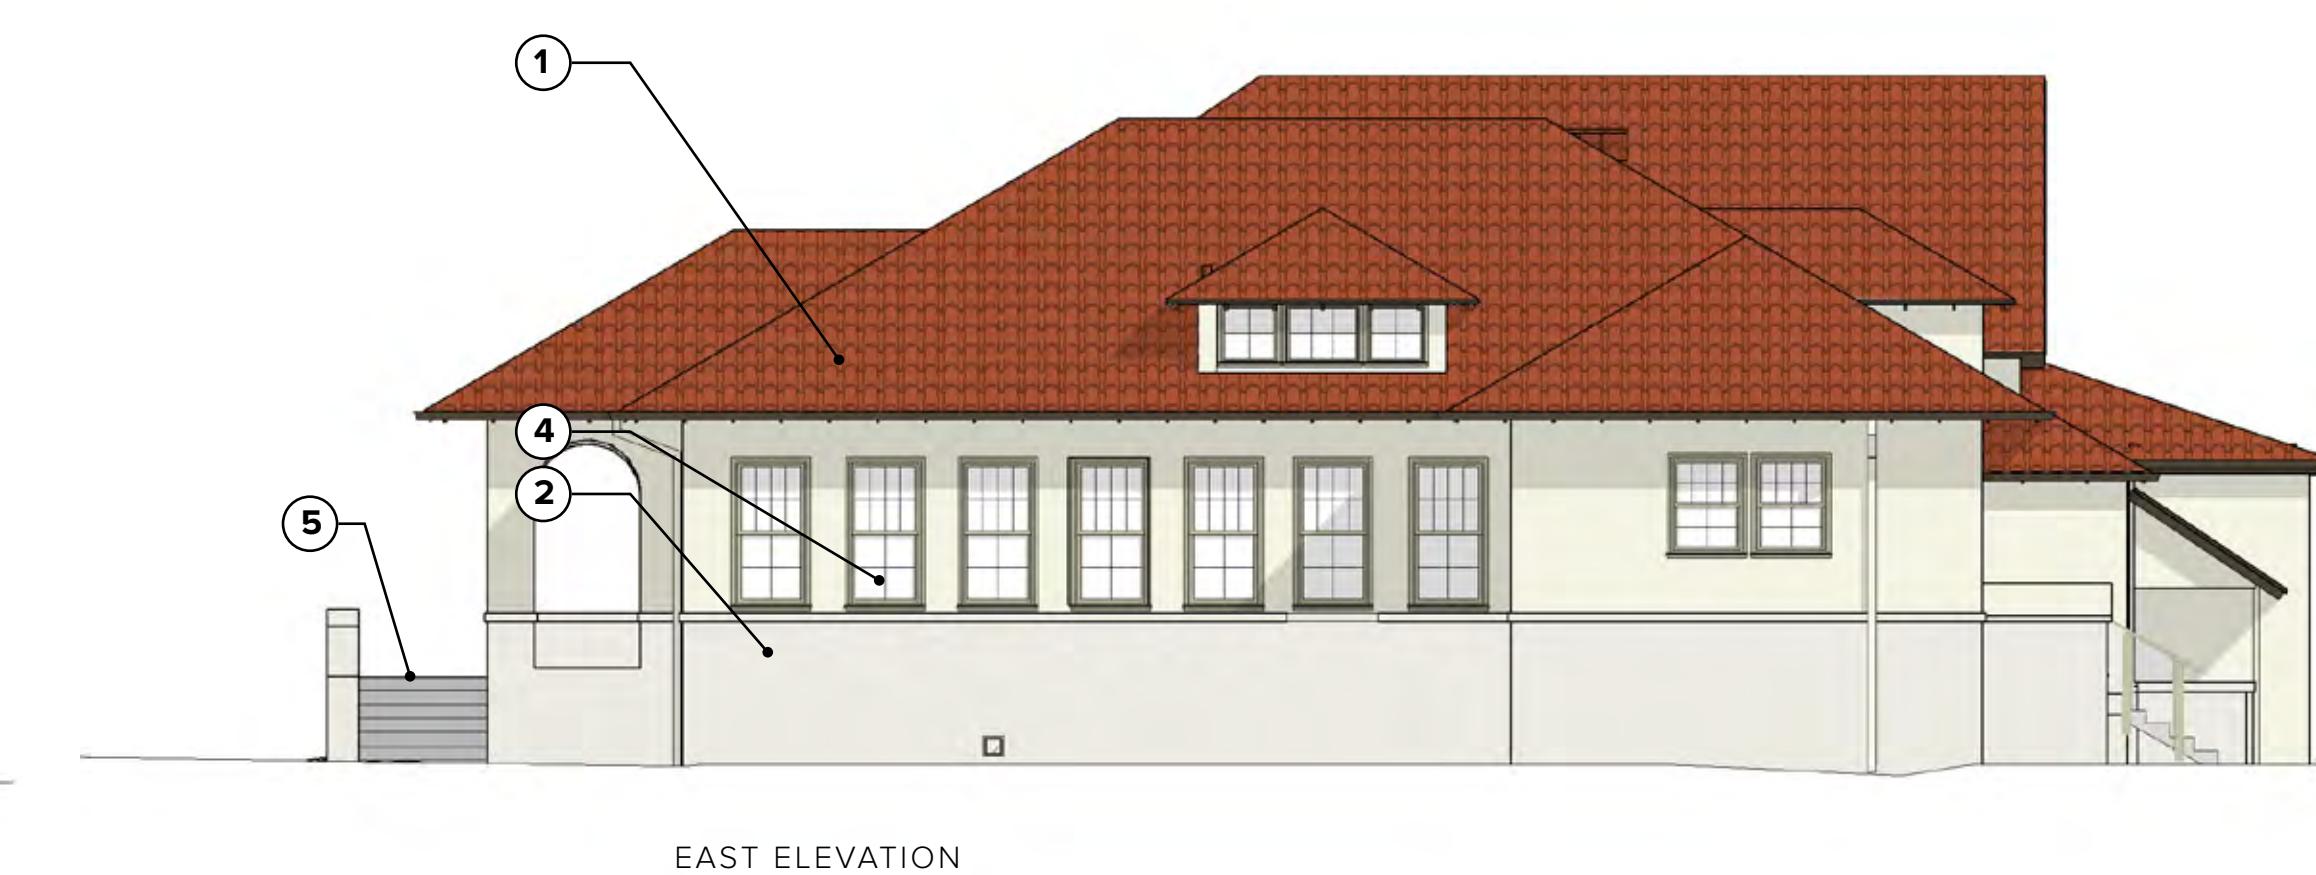
Building B Rendered Elevation

- ① CLAY TILE ROOF
- ② SMOOTH STUCCO / OFF WHITE
BASE STUCCO / PUTTY
- ③ METAL: OIL RUBBED BRONZE
- ④ WINDOW AND DOORS PT :
PUTTY GREEN / ALT GREY BLUE
- ⑤ CONCRETE: ACID ETCH
- ⑥ WOOD DECK
