MEMORANDUM

Subject: Certificate of Appropriateness, The Crescent, 2344 Old Sonoma Road

CERTIFICATE OF APPROPRIATENESS
DEC 15, 2022

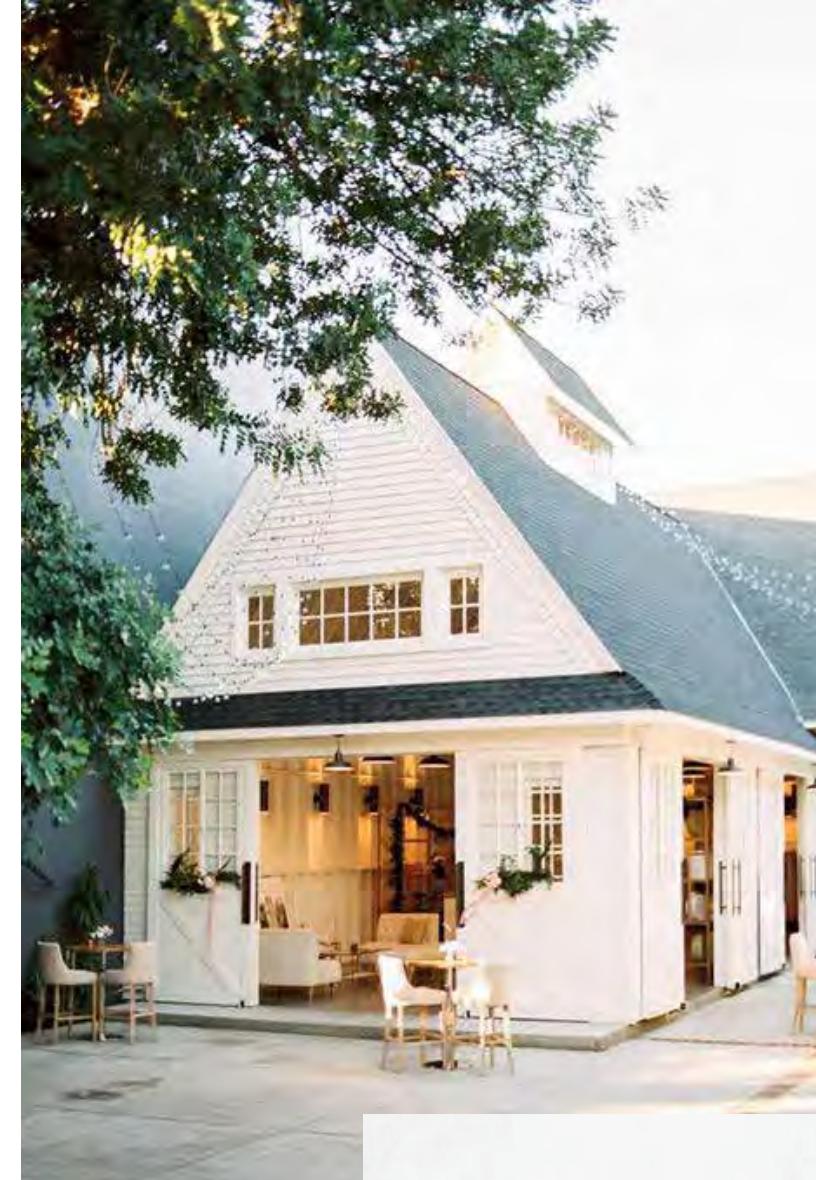
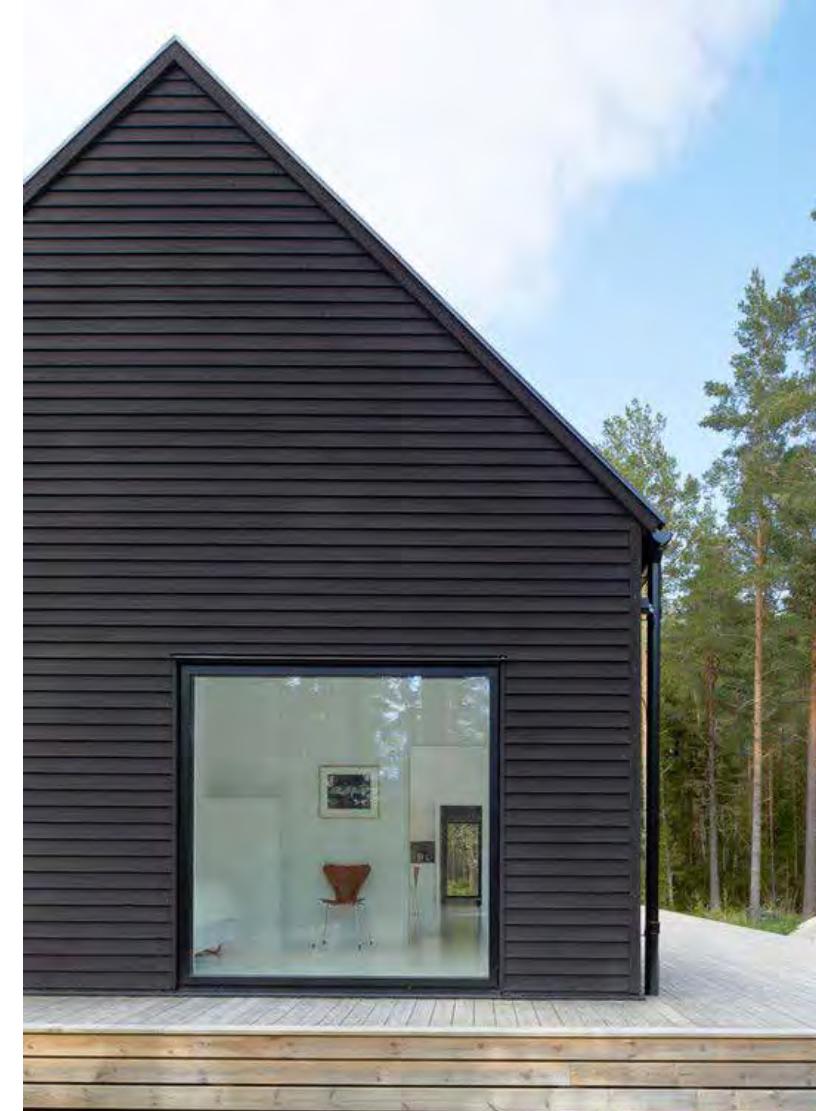
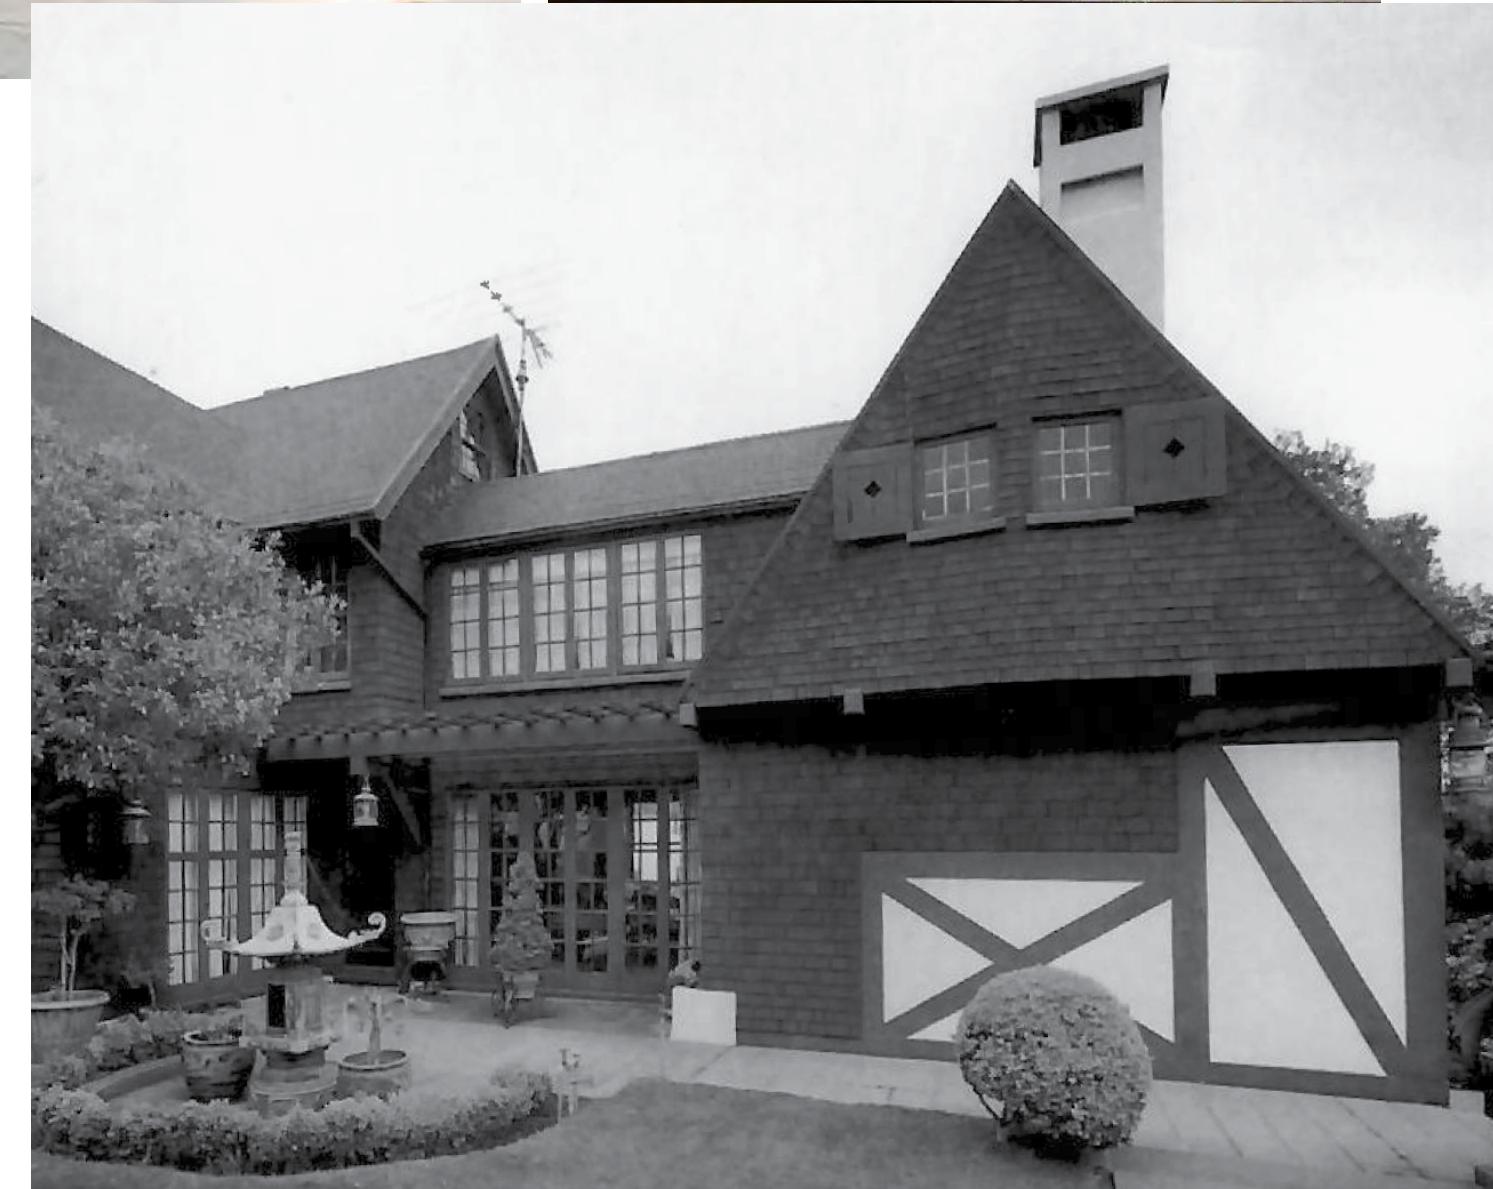
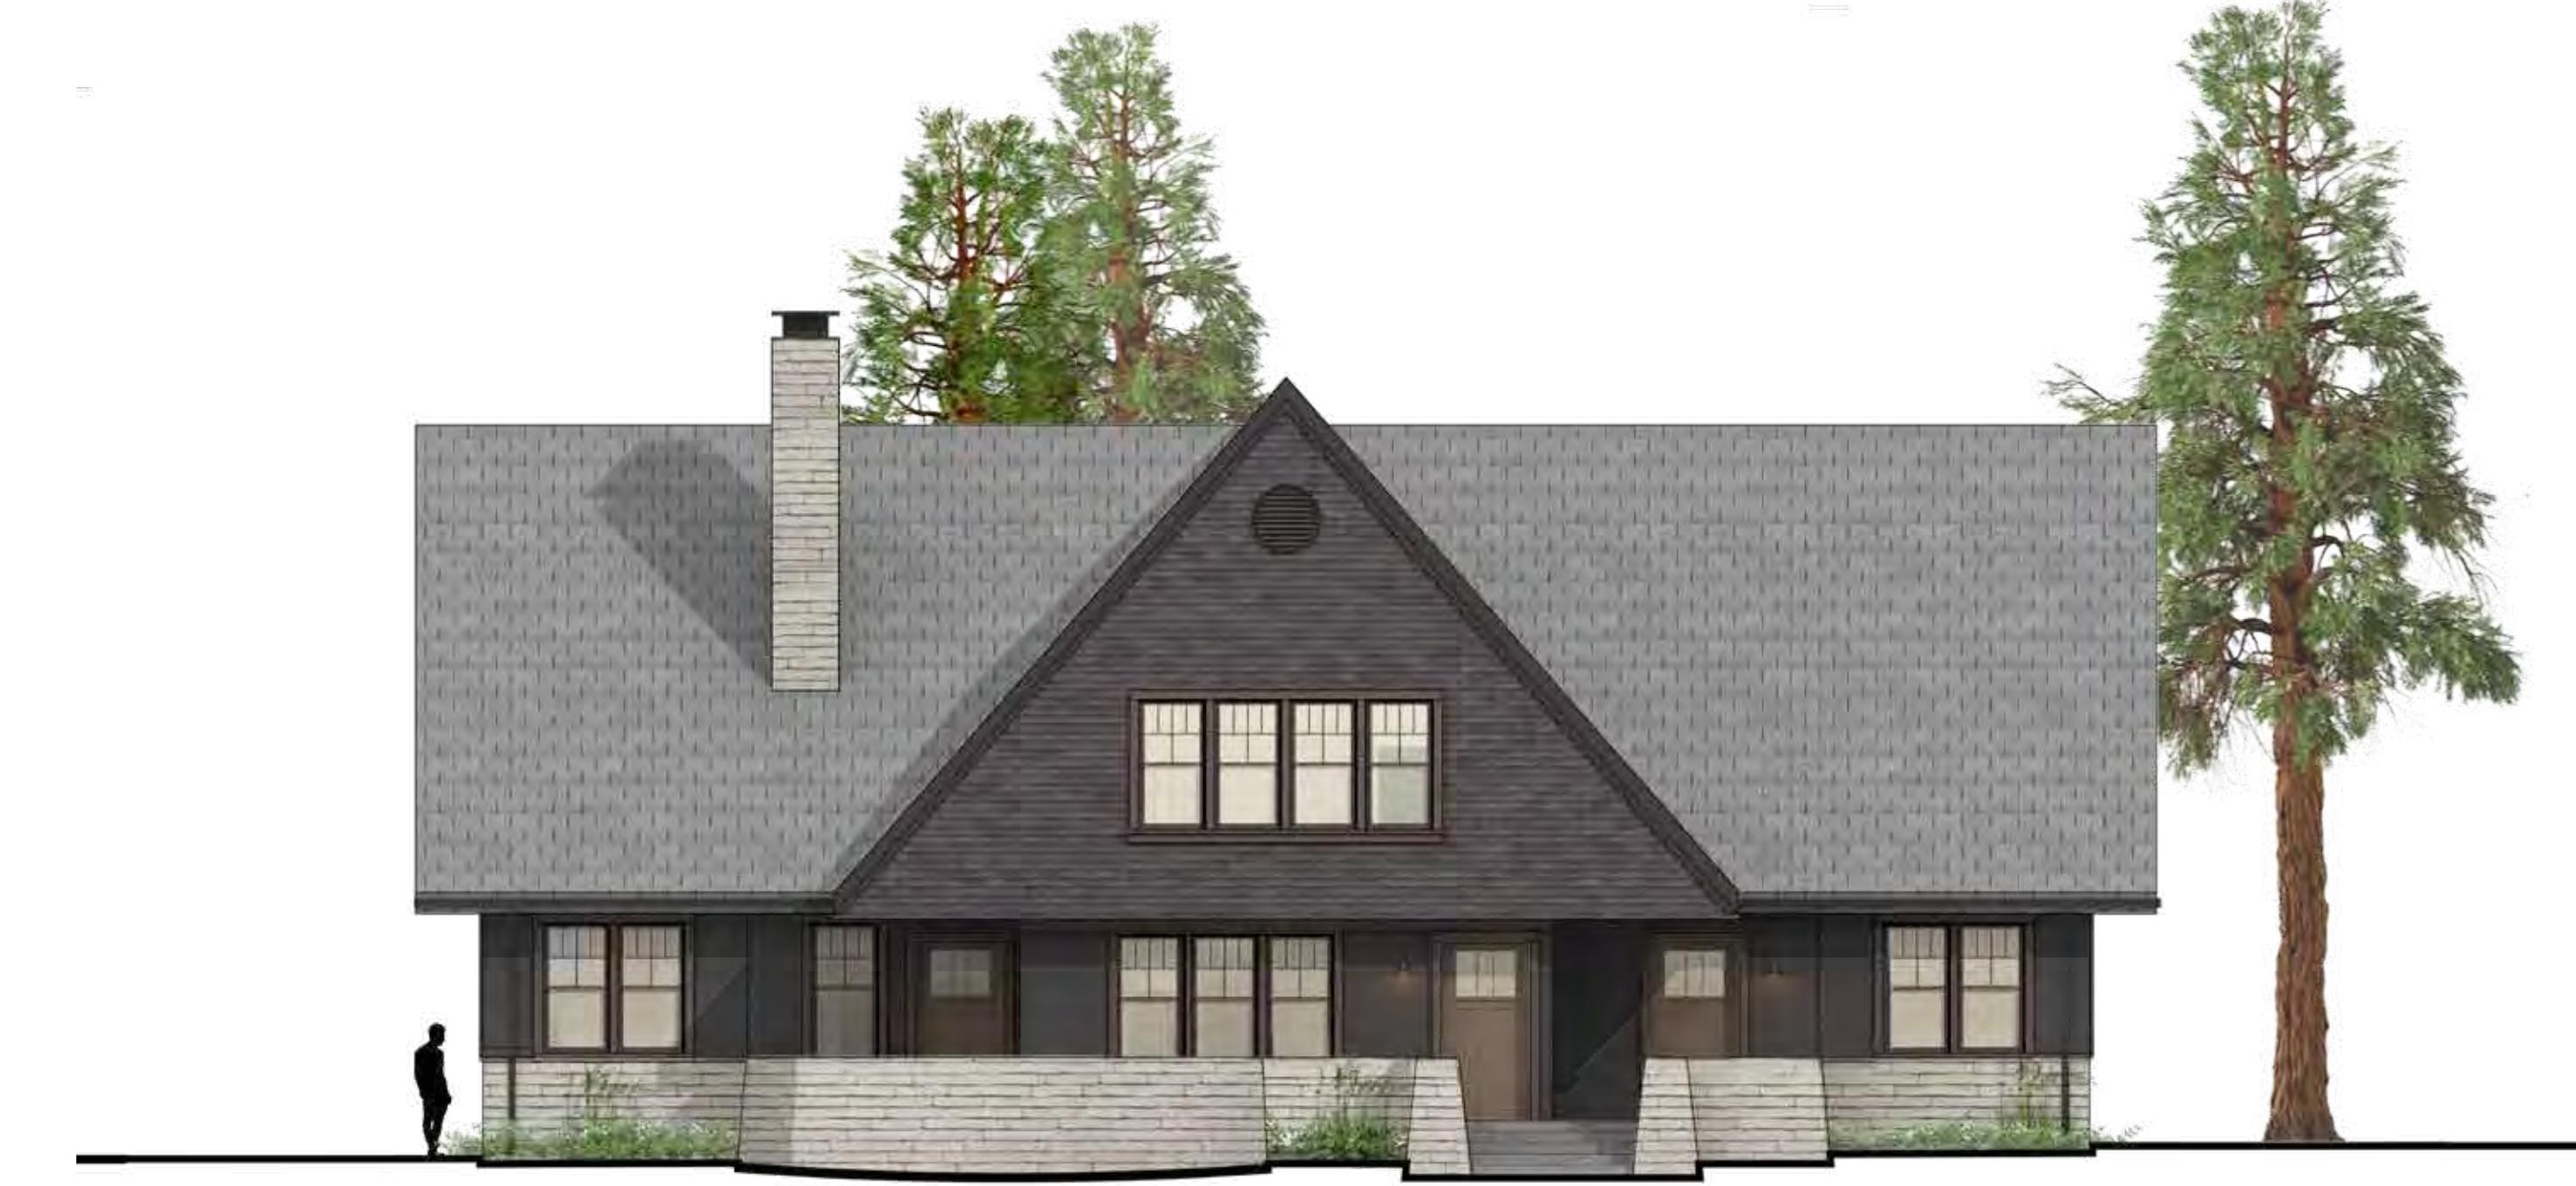
CARRIAGE BUILDING

EAST ELEVATION
