**Napa Franklin Station
1351 Second Street**

**Napa, Napa County, CA 94559-9991 (the "Property") National Register Information System
#85000133 OHP Ref. USPS_2015_0629_001**

Historic Resource Summary and Project Evaluation

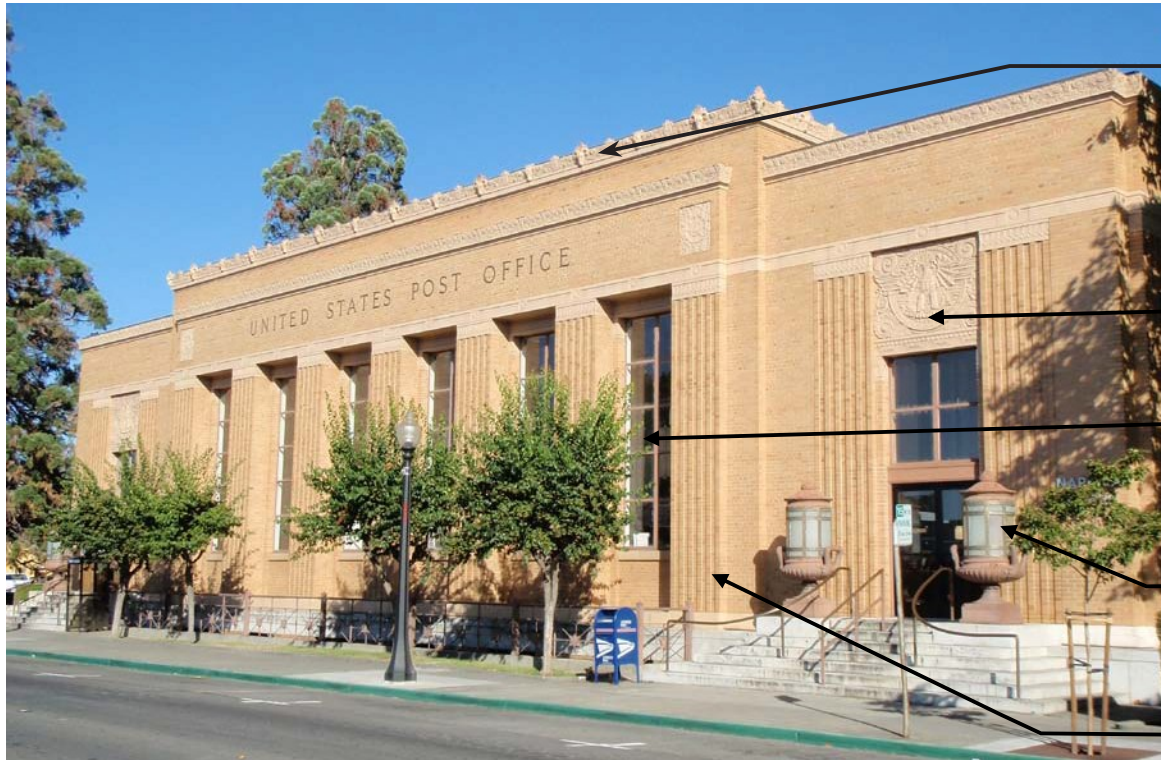
U.S. POST OFFICE, FRANKLIN STATION 1351 Second Street

Conserve the cornice extending from the roofline formed of terracotta rams and cow heads, along with the ornamentation that consists of decorative brickwork and terracotta panels in a geometric motif.

Retain Art Deco/WPA Moderne details, including fluted pilasters and stylized terracotta eagle panels above each door.

Retain the bronze and milk glass urn-shaped light fixtures adjacent to the entryways.

Retain the seven piers topped by a terracotta capital in a stylized floral motif.

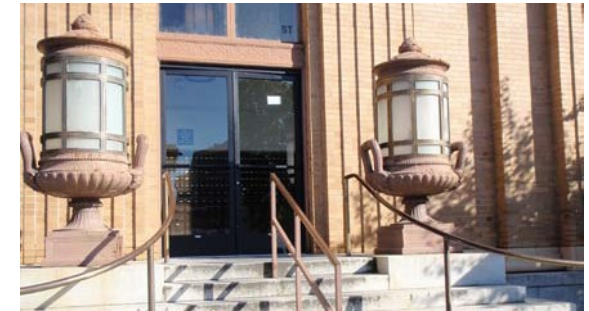
Detail of non-historic doors, granite stairs, and lanterns
