# FACILITY CONDITION ASSESSMENT

FACILITY CONDITION ASSESSMENT  
OF  
FIRE STATION 1  
930 SEMINARY STREET  
NAPA, CALIFORNIA 94559

October 24, 2019

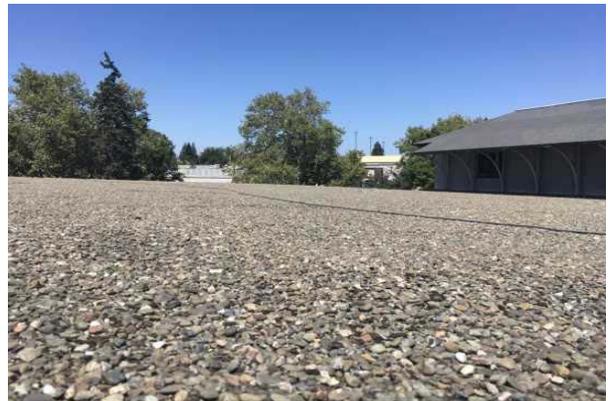
#6	ROOF, BUILT-UP
----	----------------

The built up roof has rust and corrosion built up and have frequent leaks. - AssetCALC ID: 1342190

Uniformat Code: B3011  
Recommendation: **Replace in 2019**

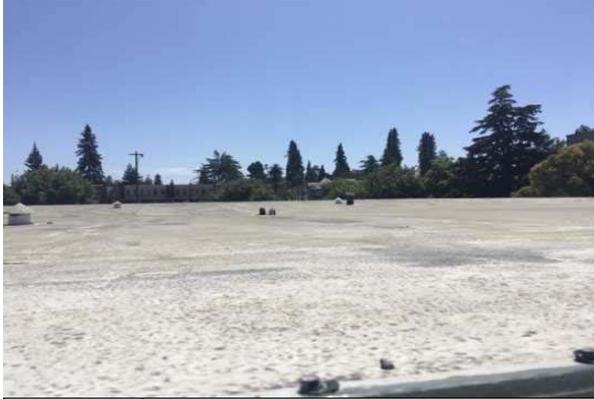
#7	ROOF, SINGLE-PLY TPO/PVC MEMBRANE
----	-----------------------------------

The majority of the roofing was replaced in 2013, however, water damage was observed on the ceiling tiles of the gym and the laundry room. The gutters, downspouts, and drains require cleaning. Several areas of the fascia were damaged due to moisture infiltration at the rear of the building. The majority of the windows are single-paned and drafty. Some windows on the south side have ongoing maintenance issues. The kitchen and dorms floor tile is likely asbestos-containing material. The kitchen cabinetry is in poor condition with missing handles and warped cabinets. Interior finishes have been periodically replaced as needed over the years.

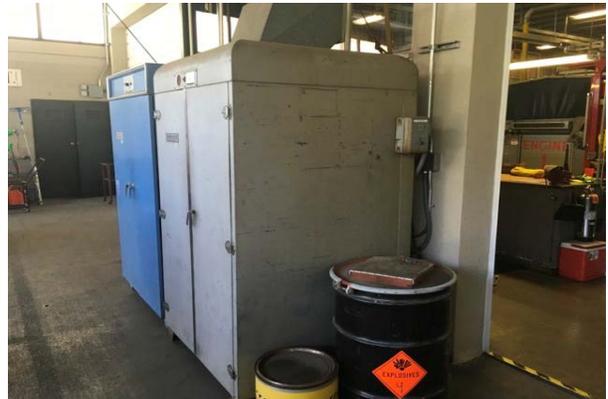
#22	CLOTHES DRYER
-----	---------------

There is no fire suppression system. Commercial appliances including the dryer and the icemaker were observed to be damaged or leaking. There is no oil-water separator for the apparatus bay.

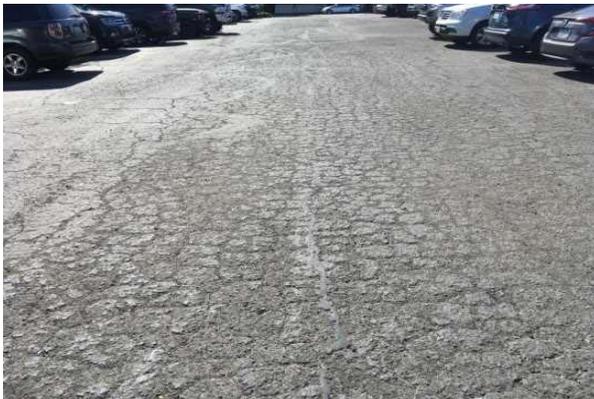
#35	PARKING LOT
-----	-------------

There were multiple alligator cracks and potholes observed in the asphalt parking lot. The lot on the south side is shared with the Police Station and City Hall.

Pavement is cracked and needs to be sealed. - AssetCALC ID: 1342179

Uniformat Code: G2022  
Recommendation: **Repair in 2019**
