THE GORDON BUILDING

Building Shell Eart
Repair and Restic
for Historic
Gordon Building

1130 First Street Napa,
CA 94559

EXISTING BASEMENT
PLAN W/ REPAIR AND
IMPROVEMENTS NOTED

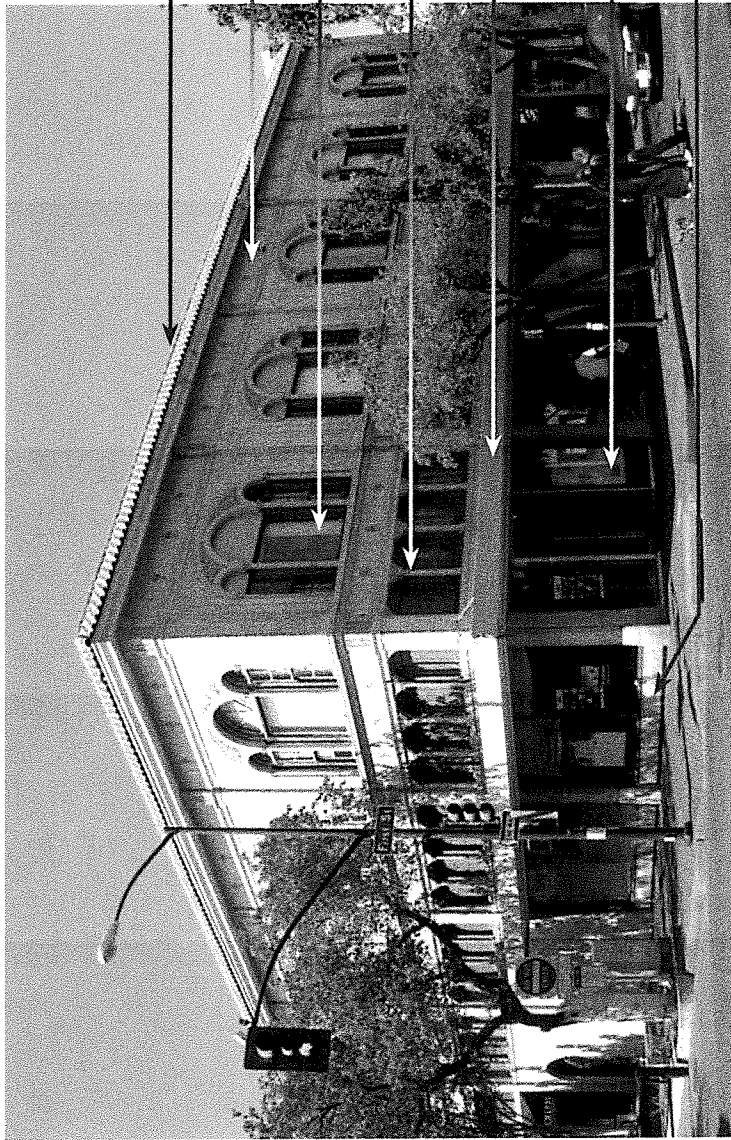
GORDON BUILDING
1130-1146 First Street (1014 Coombs Street)

- Tiled pent roof parapet
- Decorative terra cotta and brick facade
- Palladian windows
- Multi-light mezzanine windows with terra cotta details
- Remove non-historic metal canopy
- Non-historic storefronts separated by terra cotta pilasters
- Decorative tiled base
