# THE GORDON BUILDING

**PROJECT:**  
Building Shell Eart  
Repair and Restic  
for Historic  
Gordon Building  
1130 First Street Napa,  
CA 94559  
APN: 003-166-004

**EXISTING BASEMENT  
PLAN W/ REPAIR AND  
IMPROVEMENTS NOTED**

SHEET:  
**A2.1**

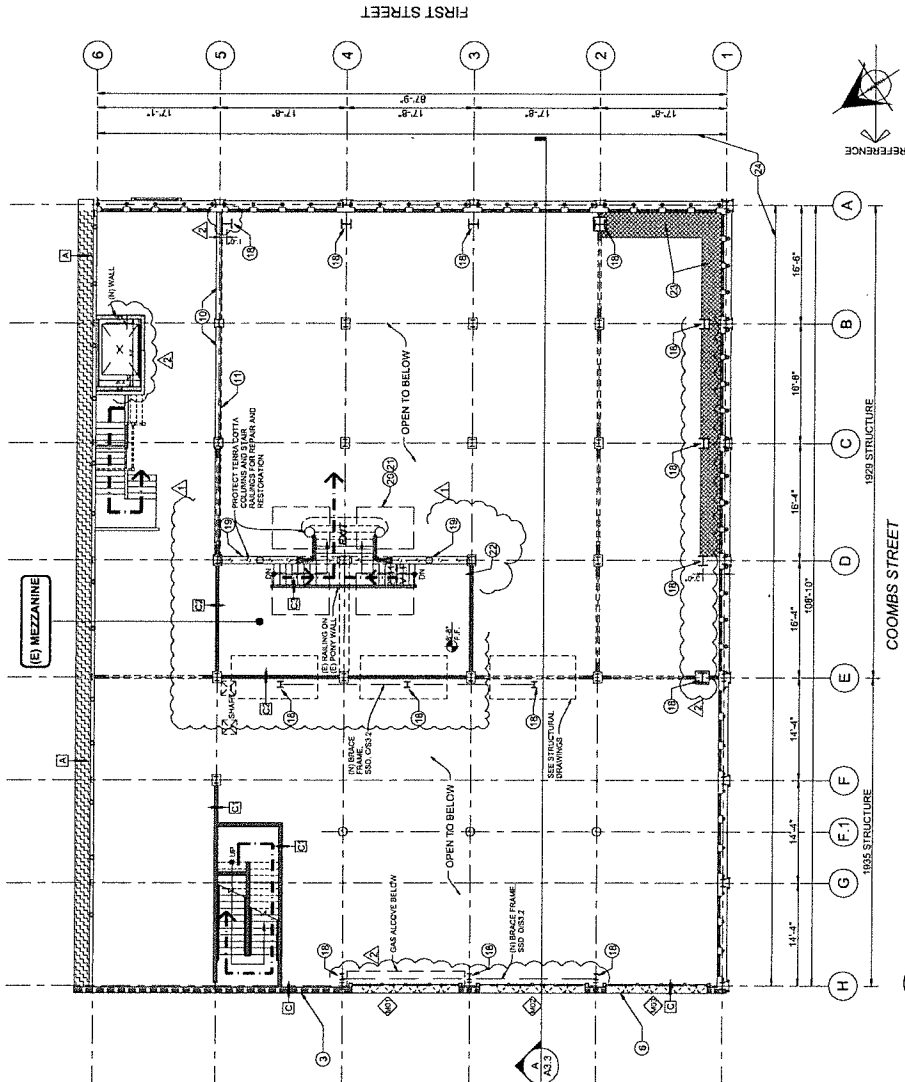
**A MEZZANINE FLOOR RESTORATION PLAN: REPAIR AND IMPROVEMENTS**

SCALE: 1/8" = 1'-0"

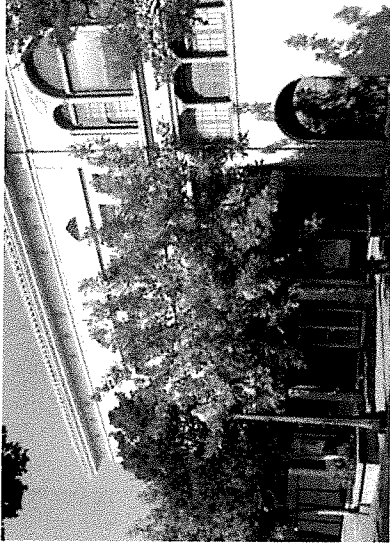
*Rear half of Gordon Building was formerly used as the Empire Theatre. Note simple decoration and alterations to storefronts.*

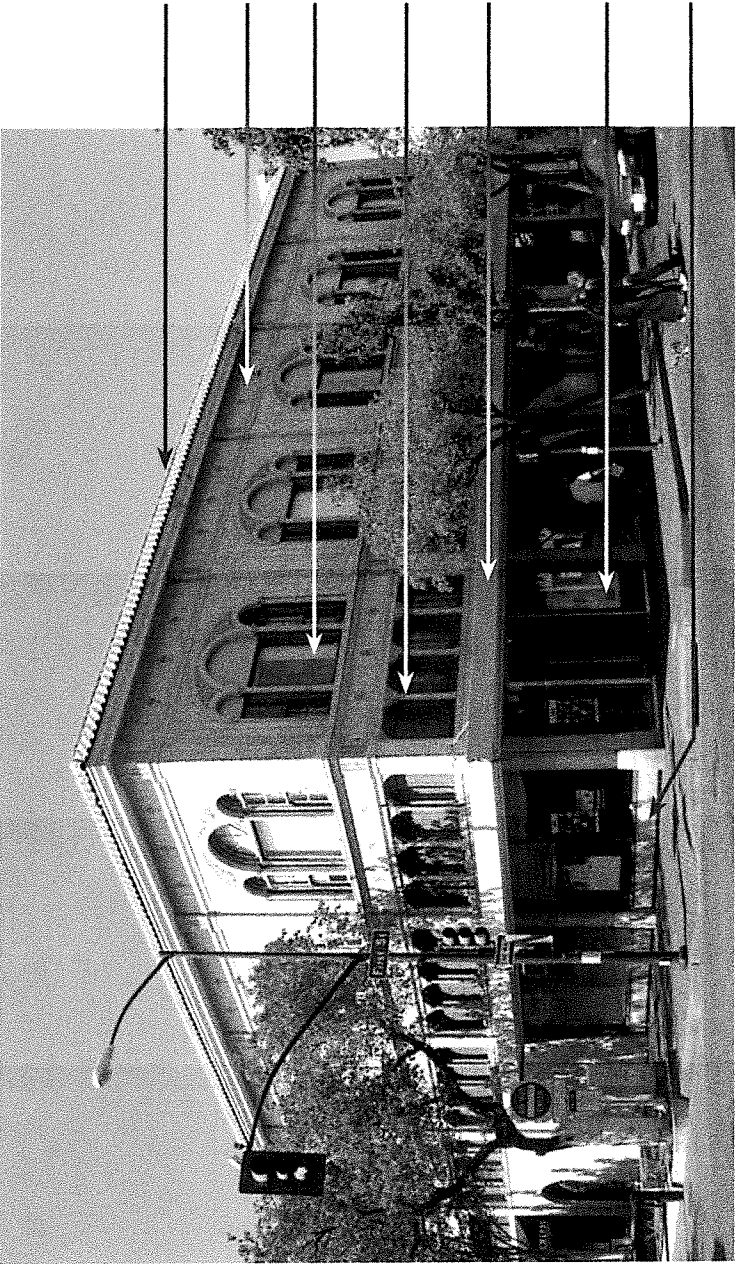
**GORDON BUILDING**  
1130-1146 First Street (1014 Coombs Street)

- Tiled pent roof parapet
- Decorative terra cotta and brick facade
- Palladian windows
- Multi-light mezzanine windows with terra cotta details
- Remove non-historic metal canopy
- Non-historic storefronts separated by terra cotta pilasters
- Decorative tiled base
